FULL-SCALE DYNAMIC CRASH TEST
OF A
LOCKHEED CONSTELLATION MODEL 1649 AIRCRAFT

TECHNICAL REPORT

OCTOBER 1965

TECHNICAL REPORT
ADS - 38

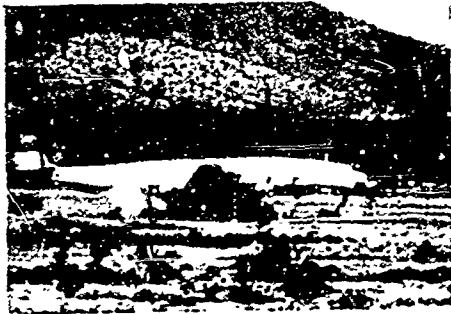
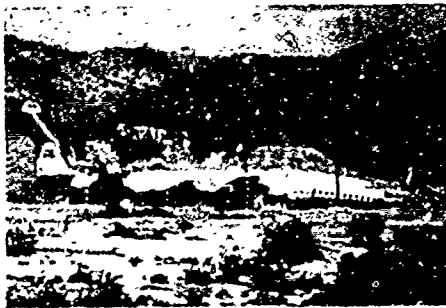
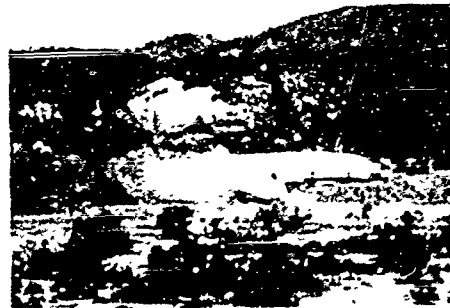
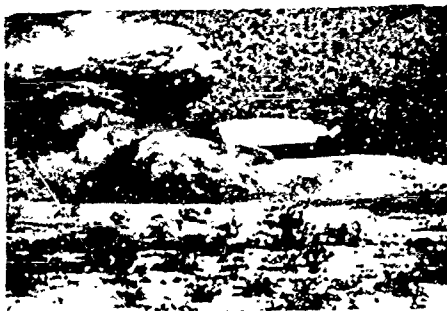
Fig. 19 Right Side View of Crash Sequence. (Time correlated with data presented in Appendix VI.)

Figures 19 and 20 show side and head-on views of the crash sequence from the moment of initial impact.

The nose of the airplane contacted the ground at the foot of the 6 degree slope and slid into the hill, as shown in pictures D, E, and F, Figures 19 and 20. No major breakup of fuselage structure occurred during this impact.

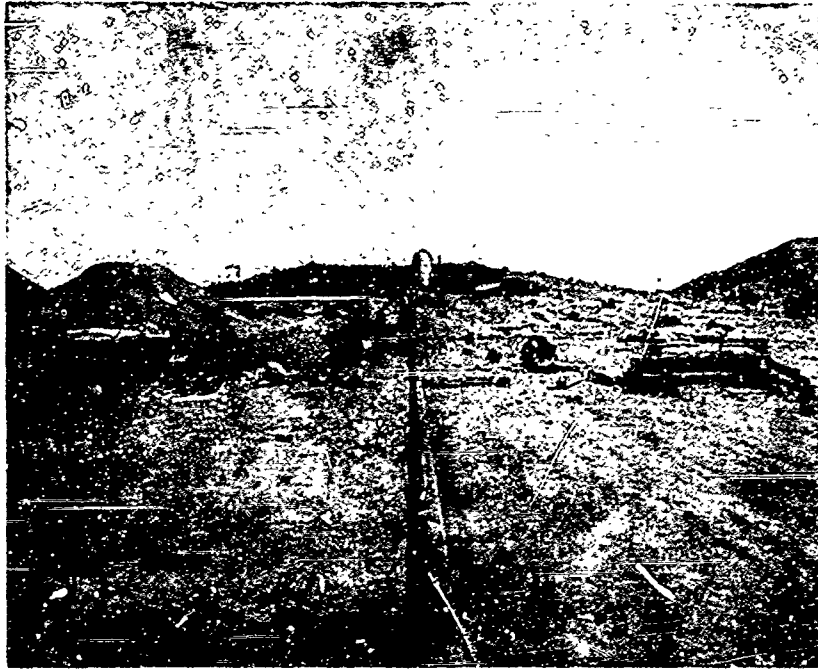
Figures 21 through 27 show how the aircraft broke up as it progressed through the crash barriers leaving a trail of small parts, pole splinters, and spilled liquids (engine oil and simulated fuel). Except for the engines, main landing gear and the right vertical stabilizer, the major parts of the aircraft came to rest on the second impact slope in a small area with the fuselage nearly aligned with the original path from the guide rail.

FIG. 21 POSTCRASH POSITION OF FUSELAGE IN RELATION
TO ALIGNMENT WITH GUIDE RAIL

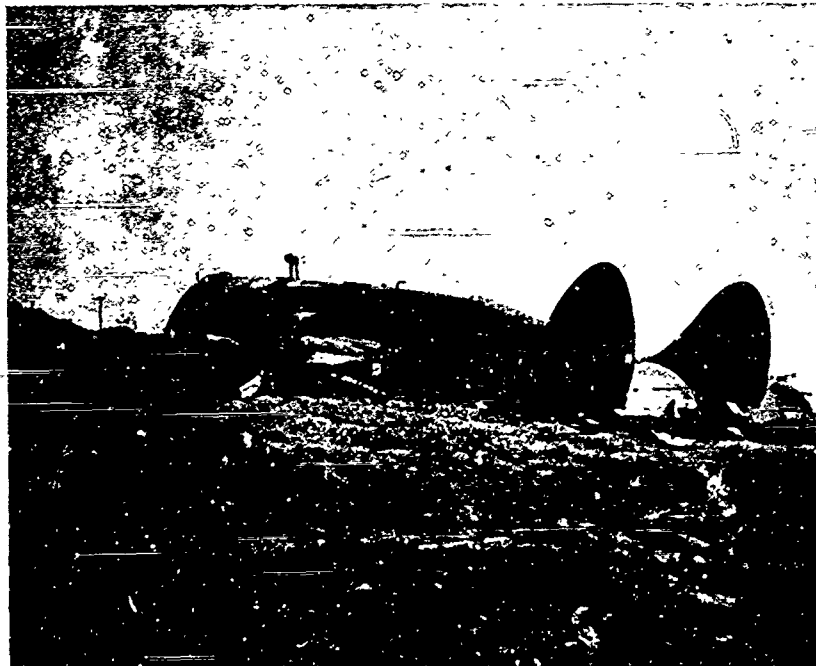
FIG. 24 LEFT SIDE VIEW OF WRECKAGE

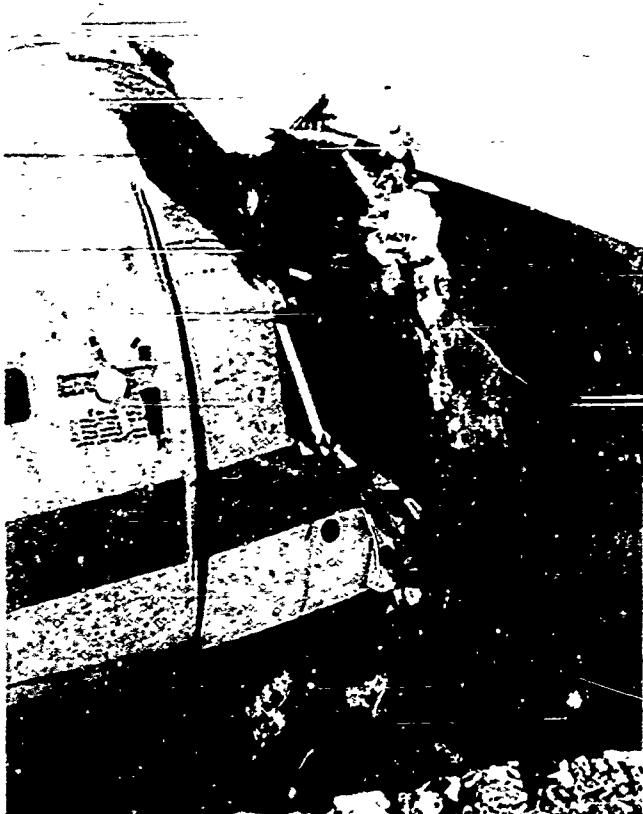
FIG. 32 FUSELAGE
STATION
380 BREAK,
LEFT SIDE

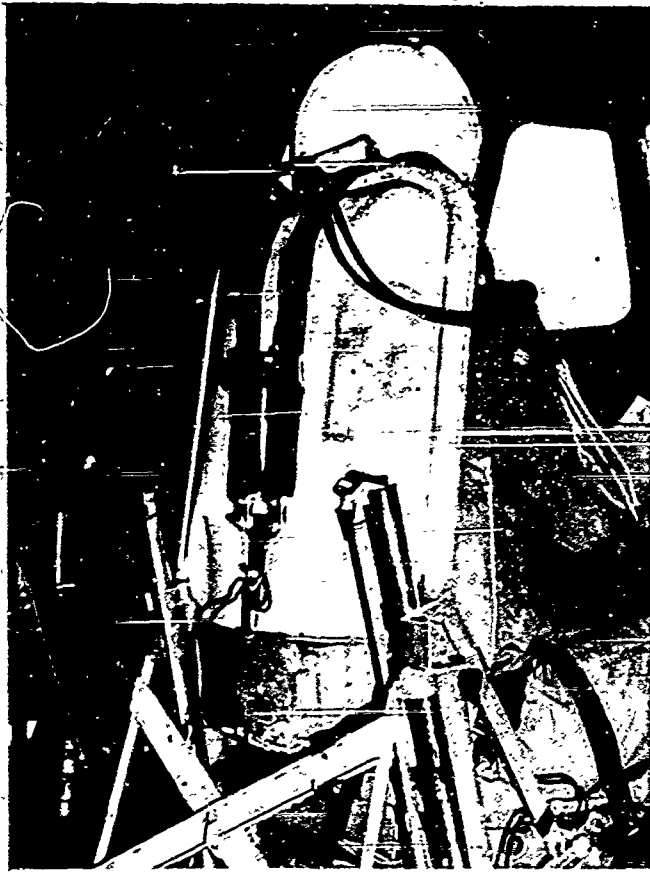
FIG. 54 POSTCRASH
VIEW OF PILOT'S
SEAT SHOWING
FORWARD
BENDING OF
SEAT BACK

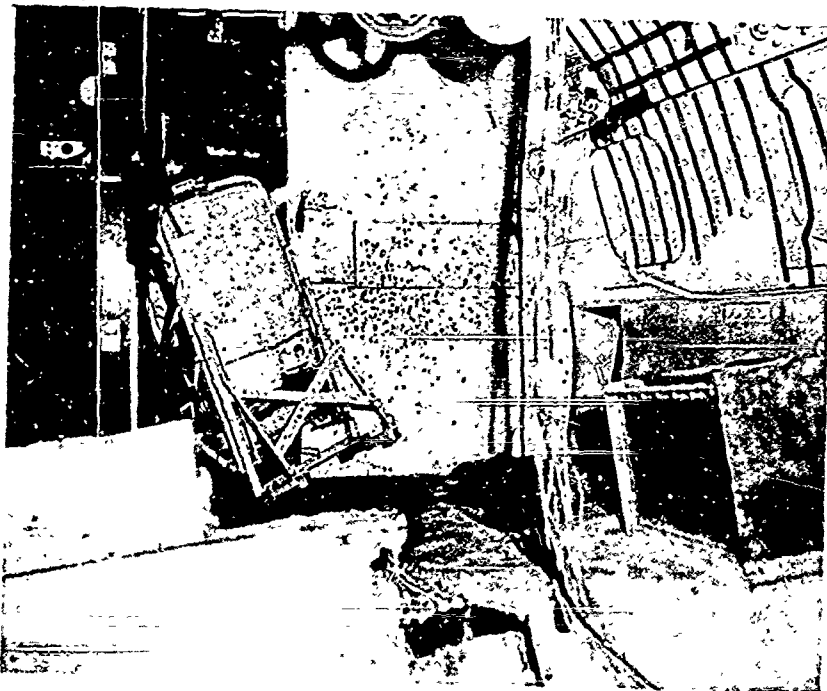
FIG. 59 POSTCRASH RESTING POSITION OF THIRD
CREW MEMBER AND SEAT

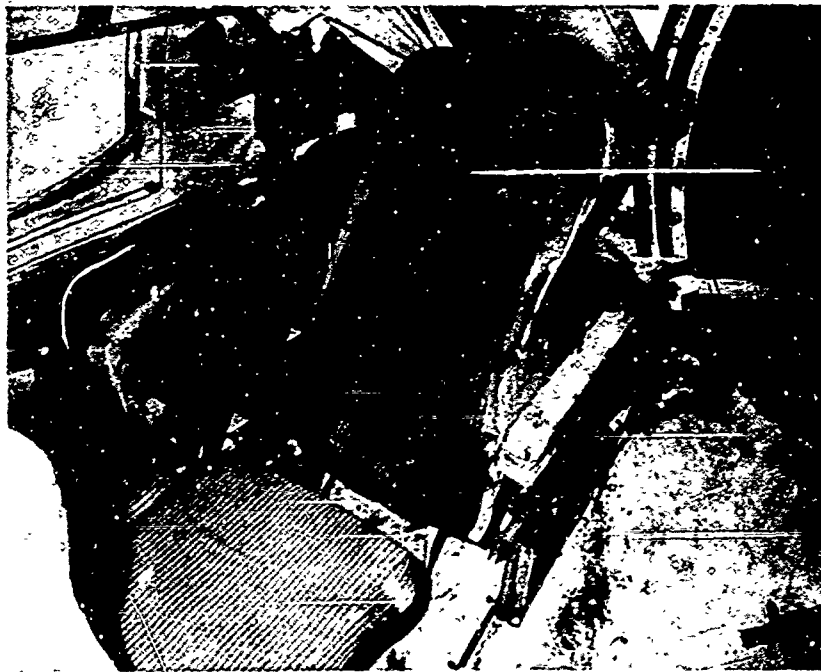
The forward and center seats remained in place during the crash, but the aft seat came loose from the floor-tracks and rotated backwards. The forward seat was deformed toward the aisle due to loads applied by the fuselage side wall which was deformed inwardly just aft of the fuselage break. Figure 66 shows the deformation and seat positions.

FIG. 66 BACK OF FORWARD CONSTELLATION SEAT AFTER REMOVAL OF CENTER SEAT DUMMIES

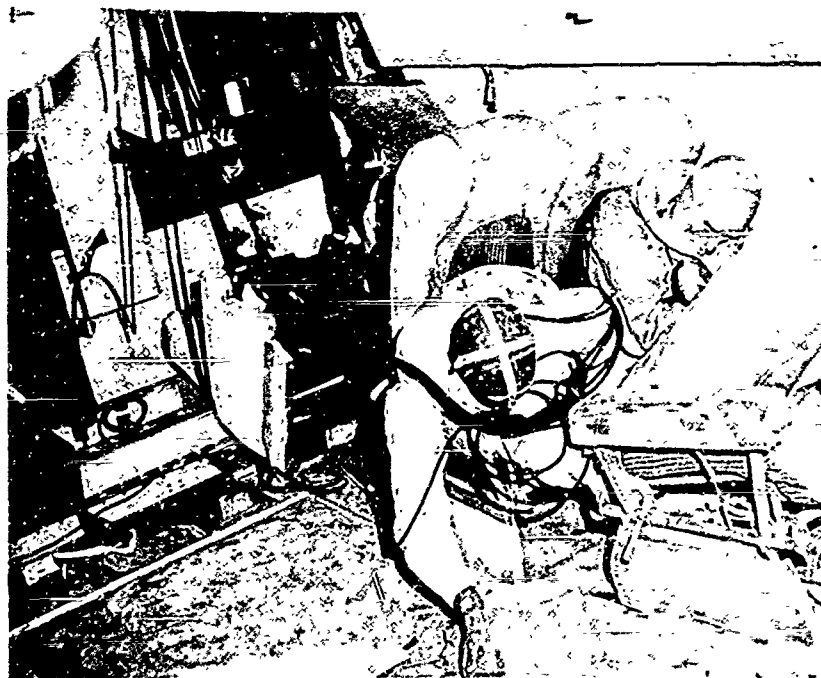
The center seat experienced no lateral deterioration. Vertical loading caused slight downward bending of both front and aft lateral seat frame tubes. Figures 67 and 68 show the seat and occupants. The armrest supports failed allowing the armrest to rotate toward the aisle approximately 30 degrees. Both lap belts remained intact and fastened. The dummy seated next to the wall was still in place with feet and legs approximately in the normal riding position. The dummy was bent forward so that his chest was resting against his thighs and his head had contacted the seat back of the forward outboard seat. The dummy seated next to the aisle remained in the seat, bent forward, with head out in the aisle. Both legs of this dummy were extended under the forward seat, up to the knee for the left leg and halfway to the knee for the right leg. Examination of the forward inboard seat back indicates that contact between the inboard dummy and the seat back was very slight.

FIG. 67 POSTCRASH VIEW OF CENTER CONSTELLATION SEATS AND OCCUPANTS

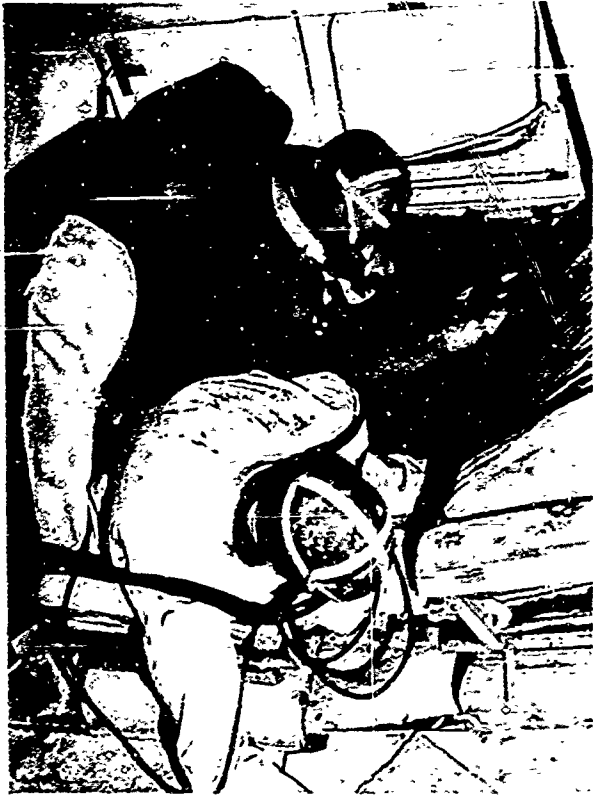
FIG. 68 OVERHEAD VIEW
OF CENTER
CONSTELLATION
SEAT EXPERIMENT

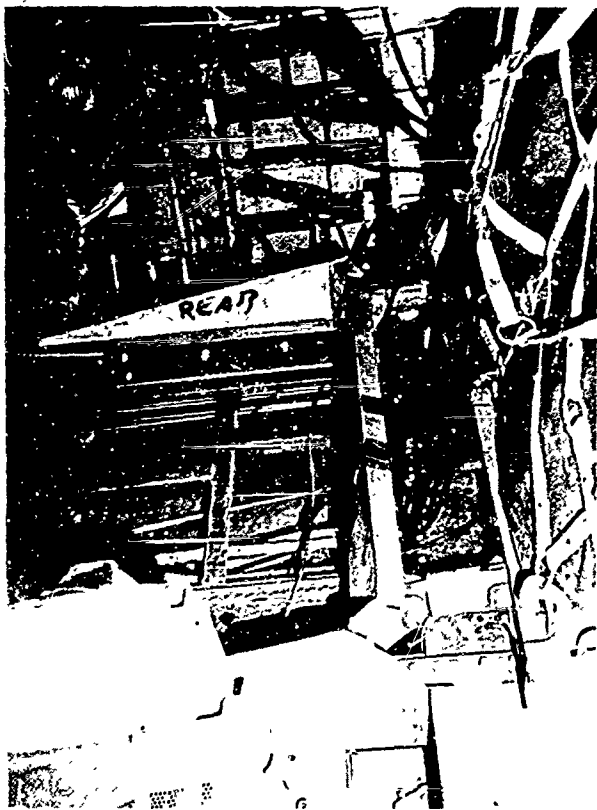
During the crash, neither pallet nor cargo separated from its original tiedown, however, both of the longitudinal restraint installations of the cargo pallets deformed approximately 2 inches forward as shown in Figure 77. The flexible nets survived the crash with no load ring deformation, and no failures occurred in either of the cargo tiedown systems. The rigid cargo stack slid forward on the pallet approximately 4 inches while the crushable cargo remained in place and programmed forward ten inches. An illustration of the cargo action is shown in Figure 78.

FIG. 77 FORWARD
DEFORMATION
OF LONGITUDINAL
LOAD LINK
ATTACHMENT

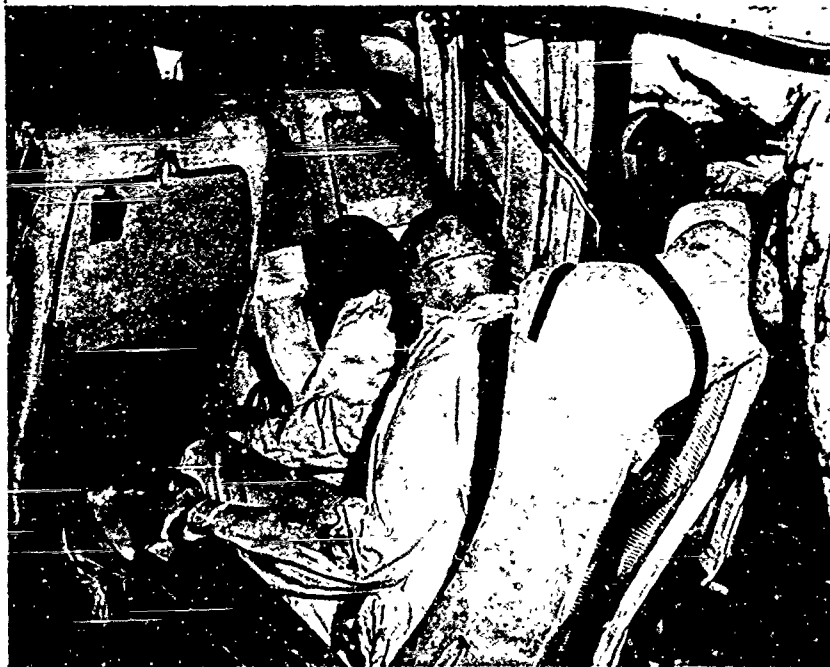
FIG. 81 POSTCRASH POSITION OF FORWARD FACING SEAT DUMMIES

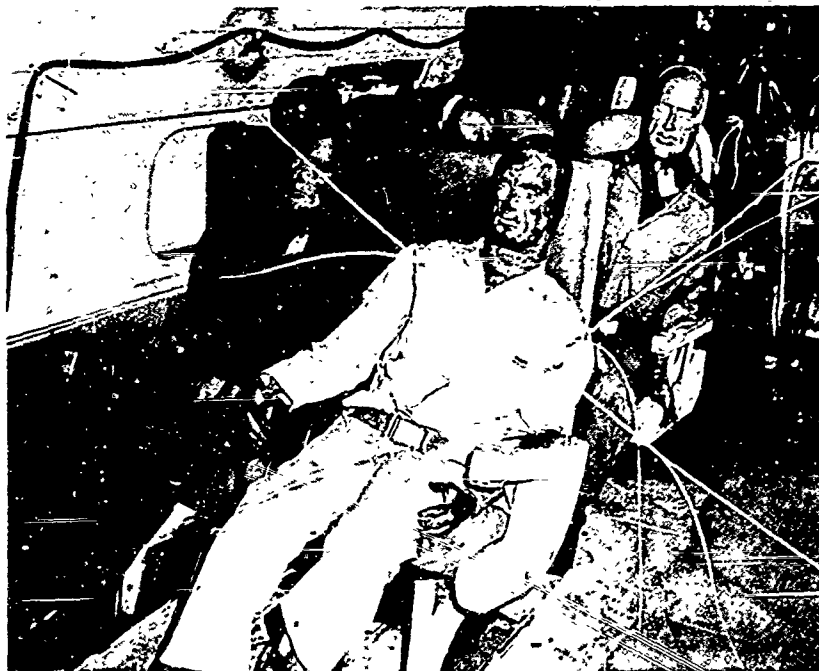
FIG. 83 POSTCRASH OVERALL VIEW OF REAR FACING SEATS

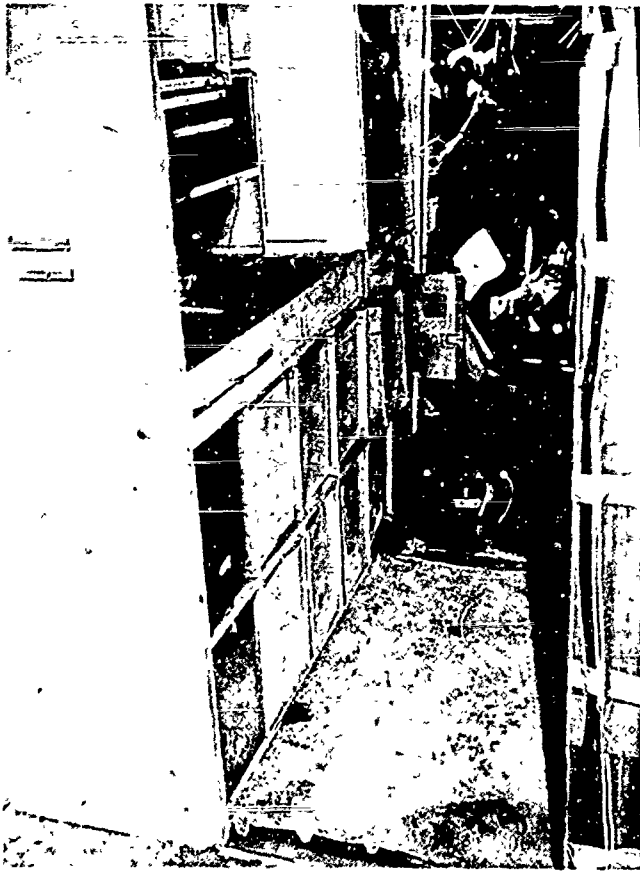
FIG. 89 RIGHT SIDE OF GALLEY, POST-CRASH, VIEW LOOKING AFT

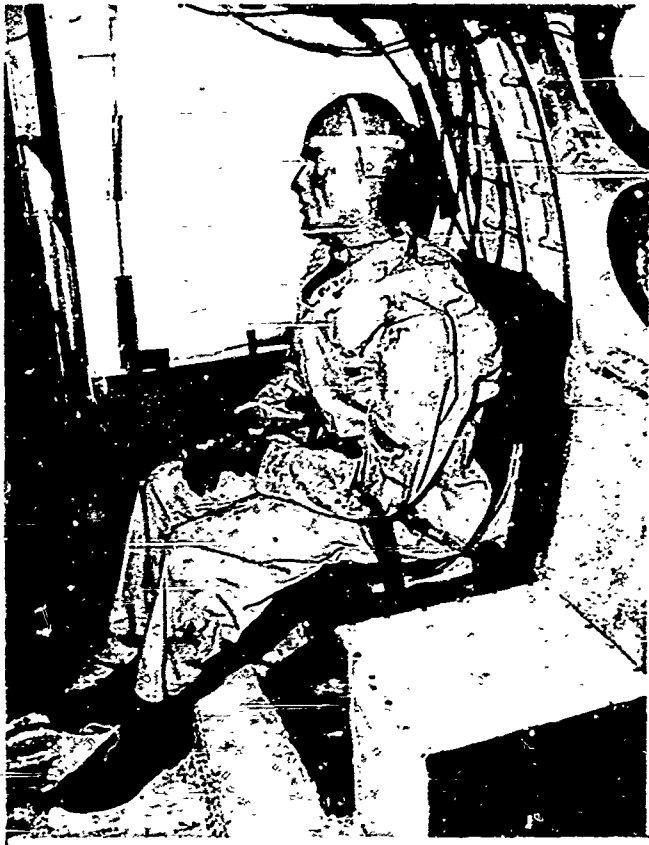
FIG. 92 DUMMY
OCCUPANT OF
SIDE FACING
SEAT

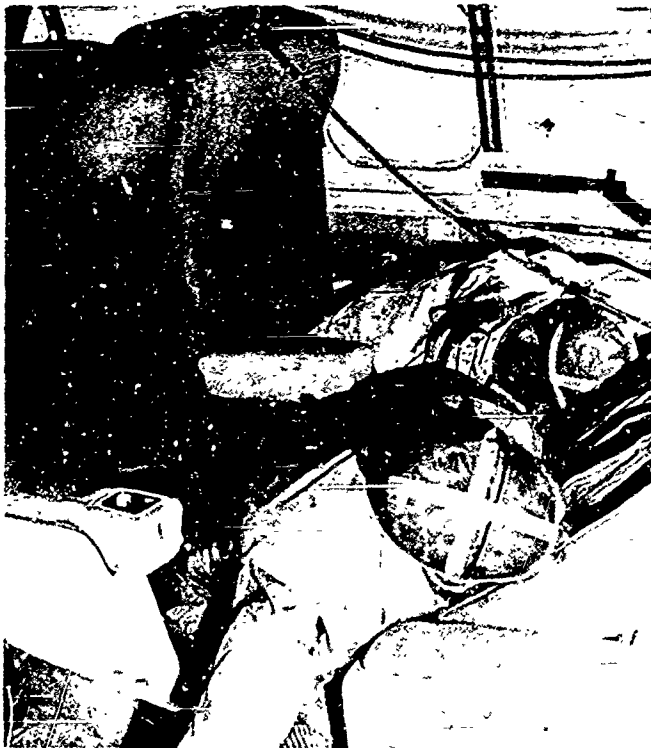
FIG. 97 VIEW SHOWING UPPER BODY CONTACT WITH FORWARD SEAT BACKS OF AFT CONSTELLATION SEAT EXPERIMENT

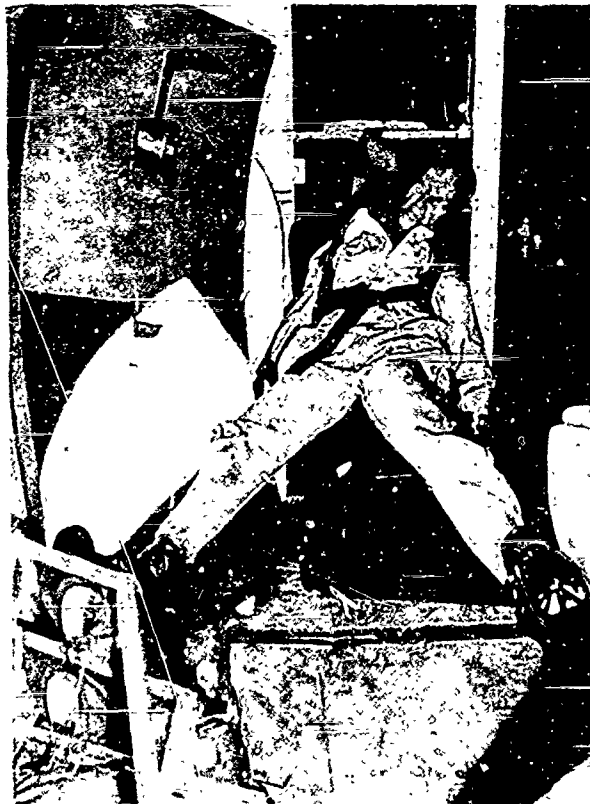
The shoulder harness and lap belt, remained intact and attached to the installation points, however, this did not prevent the occupant from submarining. The dummy submarined until the lap belt was around its chest, up to the armpit on the left side and halfway up the rib cage on the right. The legs were sprawled outward and forward, and the dummy's head was impaled on the upper right corner of the seat back. (See Figure 101). The rubber skin of the dummy's head was torn extensively, and the skin separated completely from around the neck. The attachment of the seat back to the center partition failed, and the bar that acted as a brace for the aft part of the seat was found to be forward of the center lavatory partition to which it normally attaches. The right front seat leg was buckled inward at the floor approximately three inches from its normal position as shown in Figure 102.

FIG. 101 OVERALL POSTCRASH
VIEW OF STEWARDESS
SEAT EXPERIMENT
