TECHNICAL REPORT N-70-10

**SURVEY OF GULF COAST  
STRUCTURAL DAMAGE RESULTING FROM  
HURRICANE CAMILLE, AUGUST 1969**

Final Report

April 1970

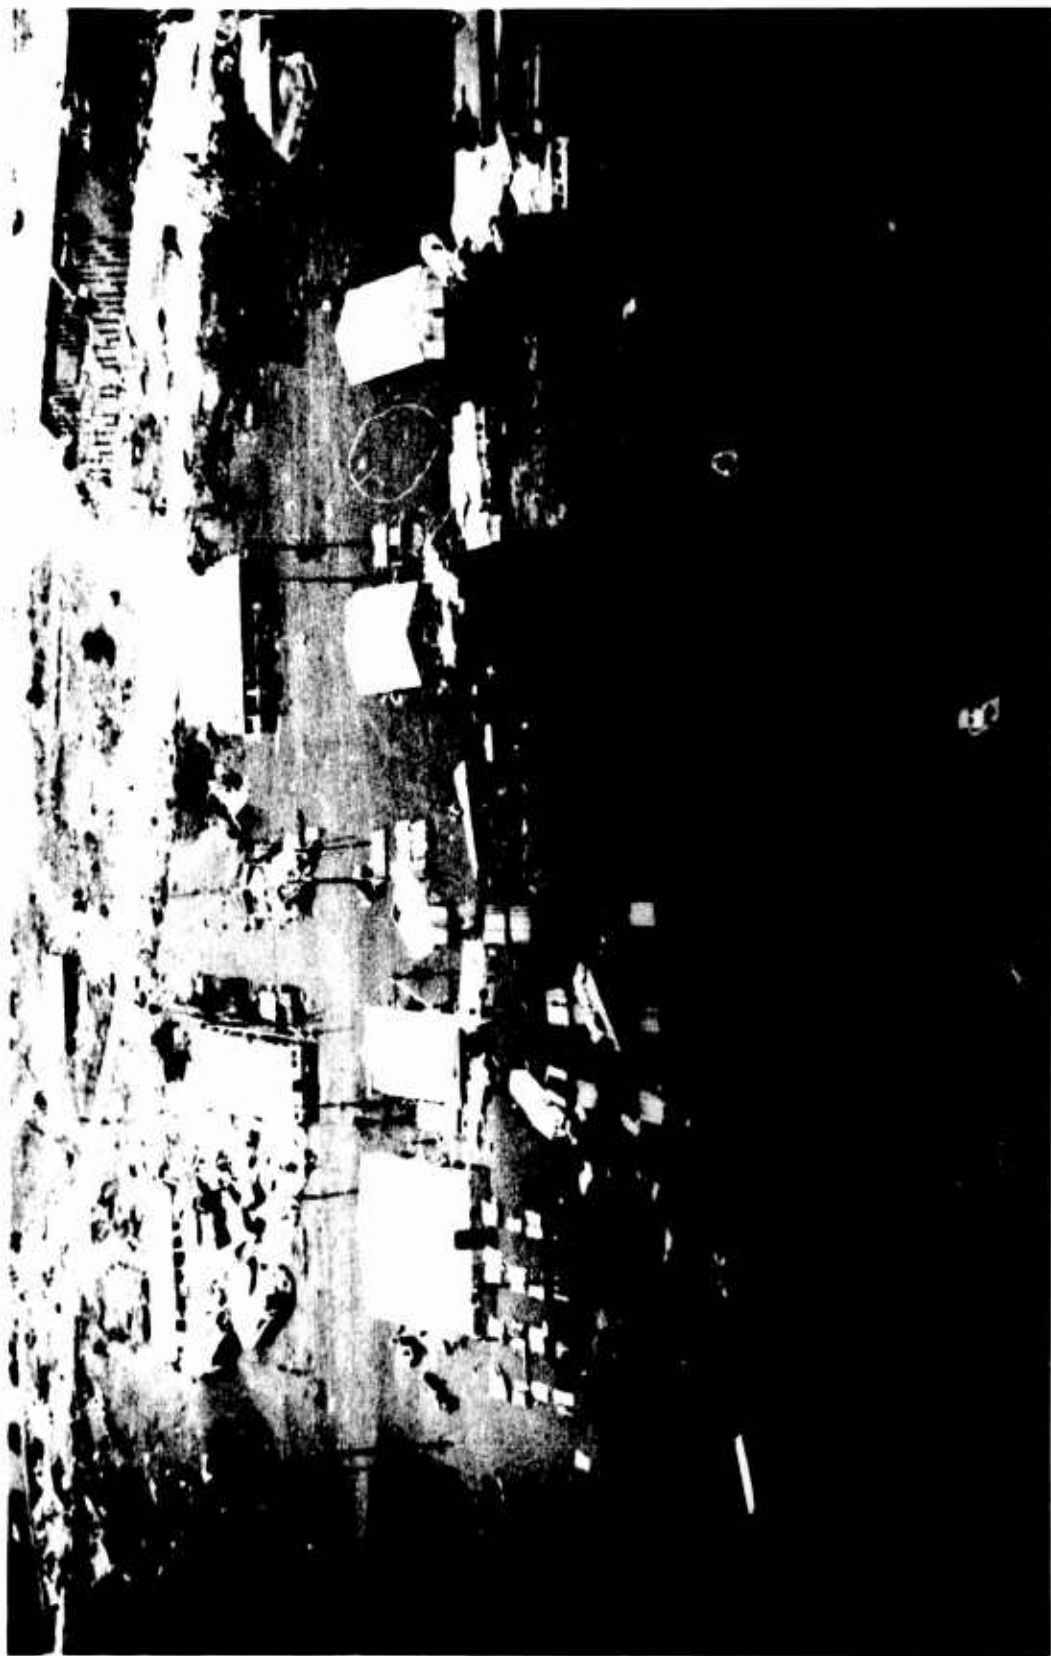
Figure 2.9 Buras area in Louisiana.

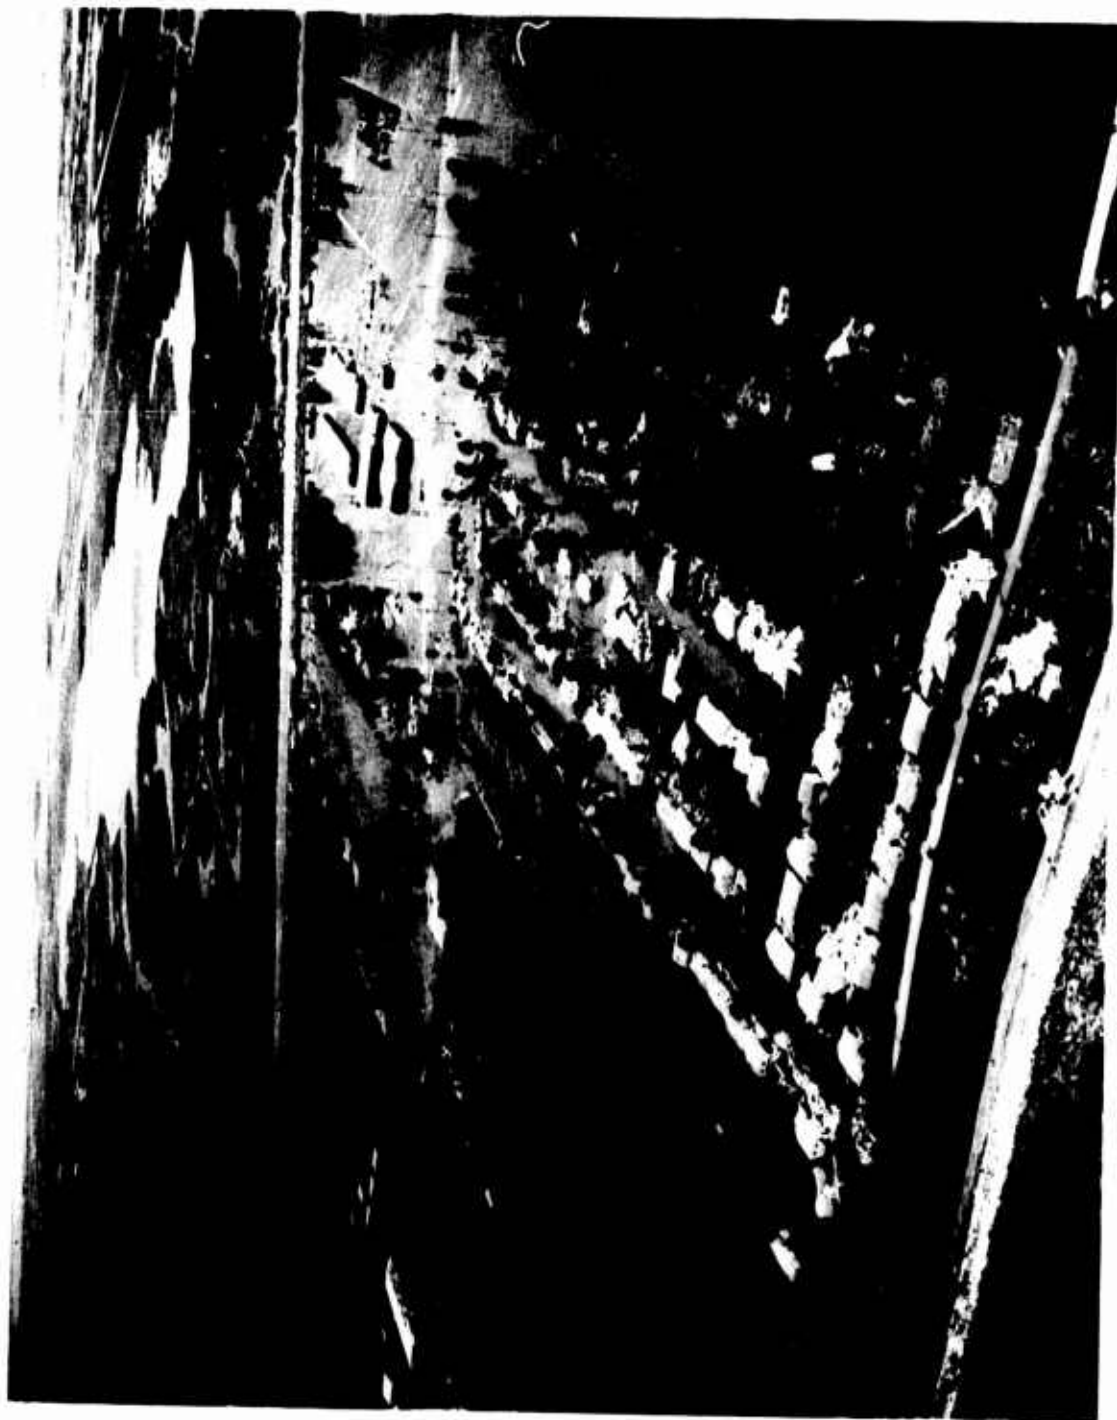
Figure 2.13 Below Buras, Louisiana.

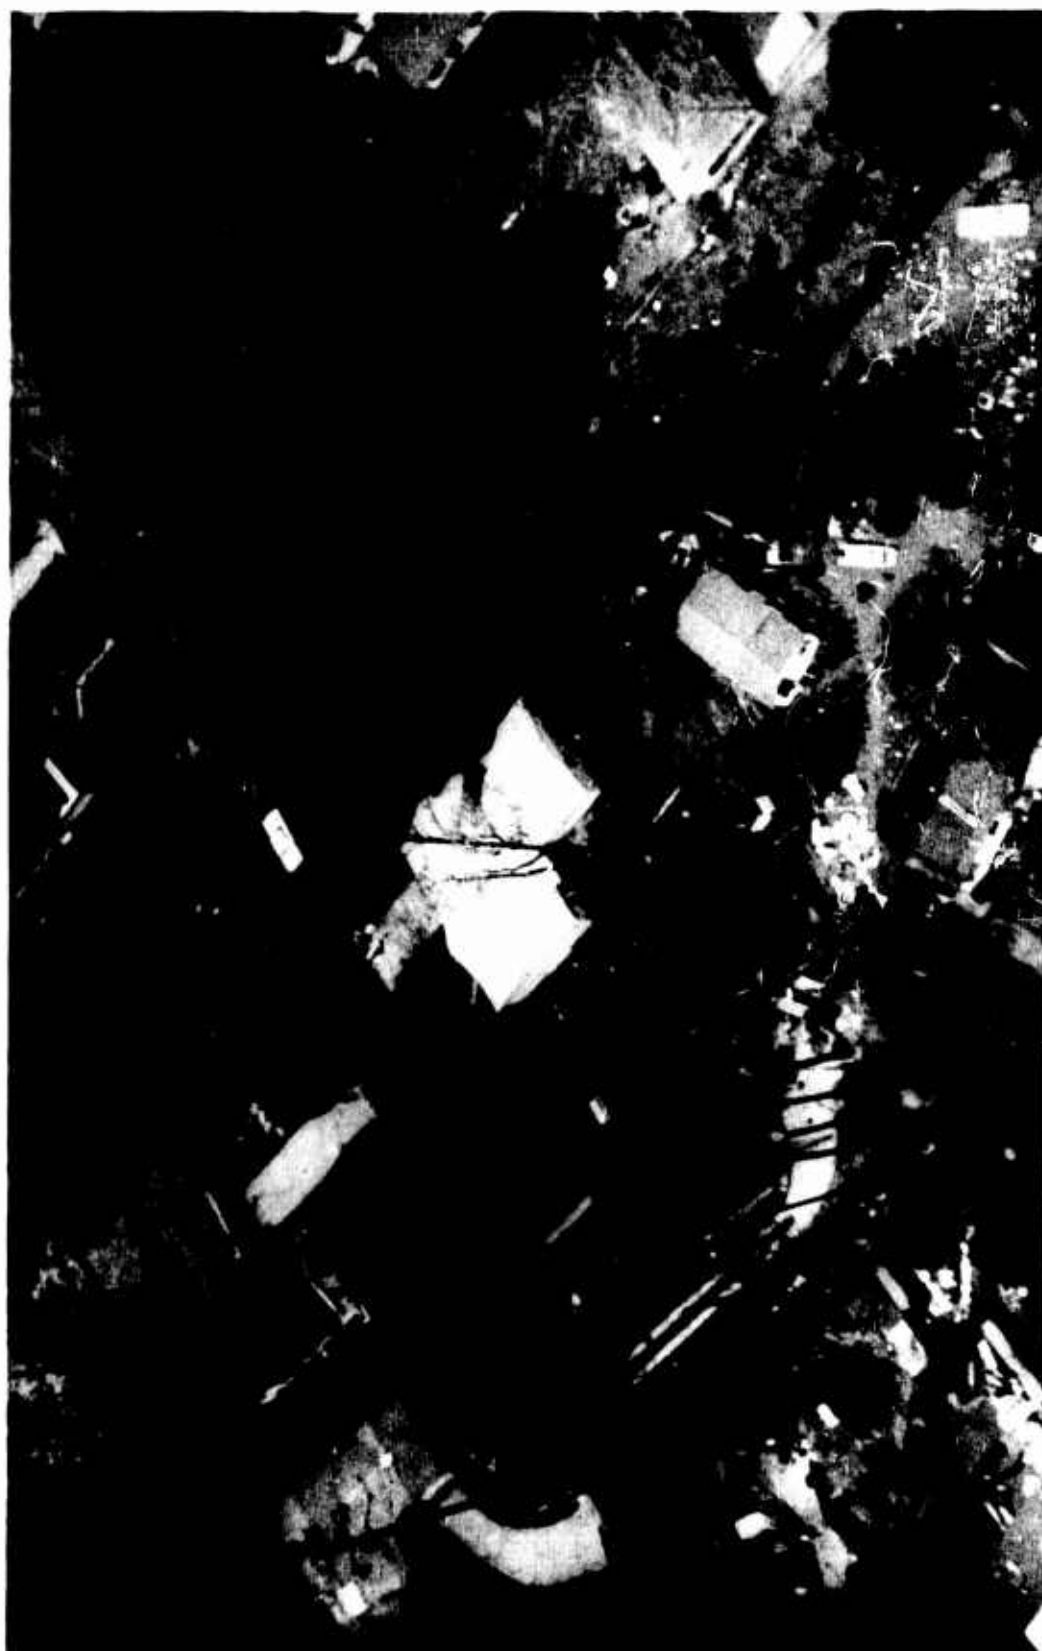
Figure 2.15 Residential area in west Gulfport, Mississippi.

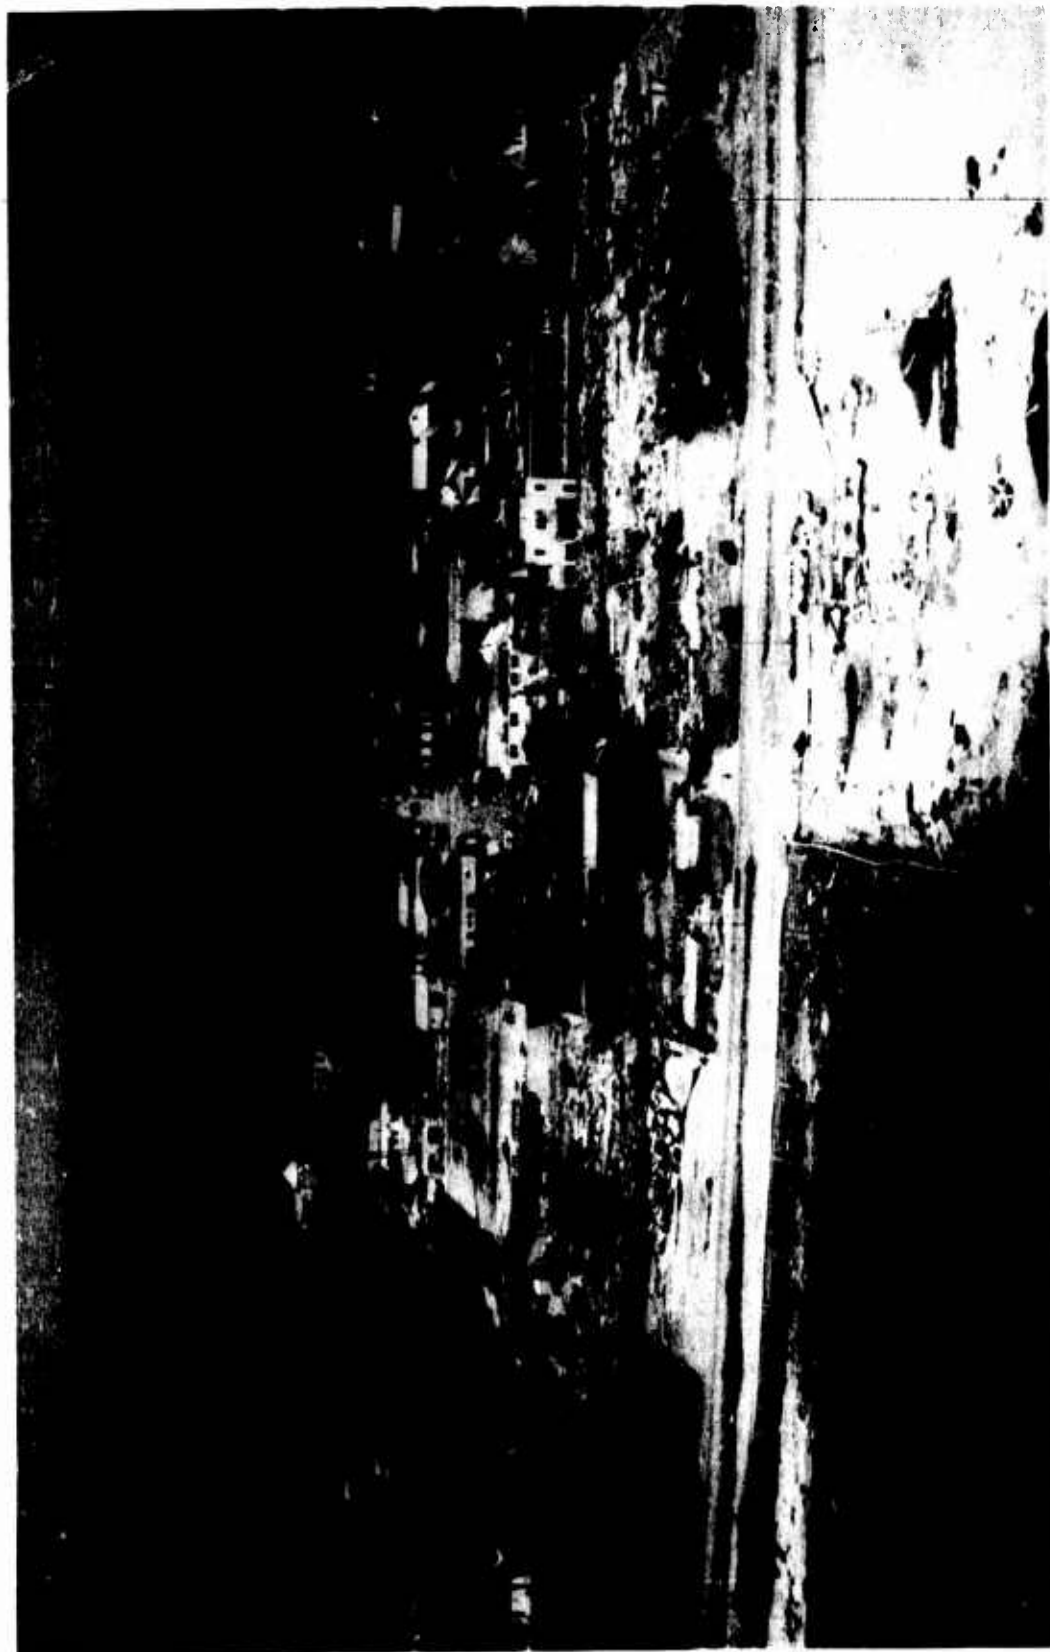
Figure 2.22 Pass Christian, Mississippi.

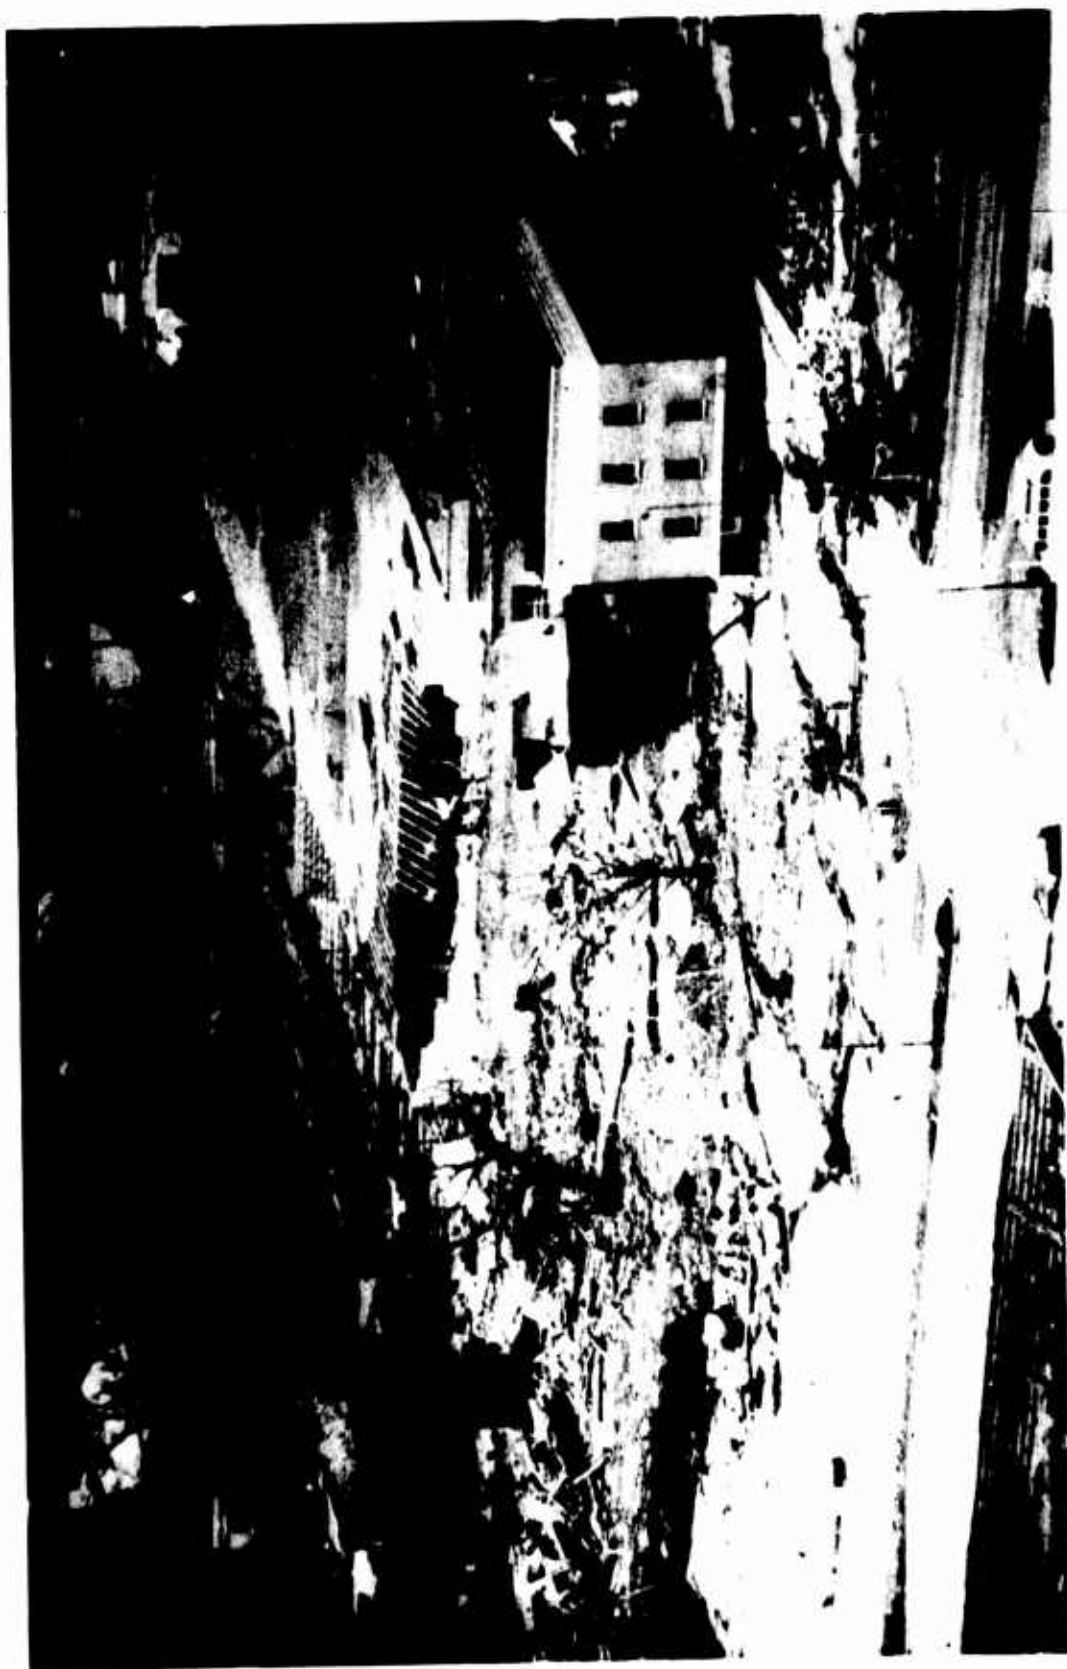
Figure 2.23 Pass Christian, City Hall in foreground.

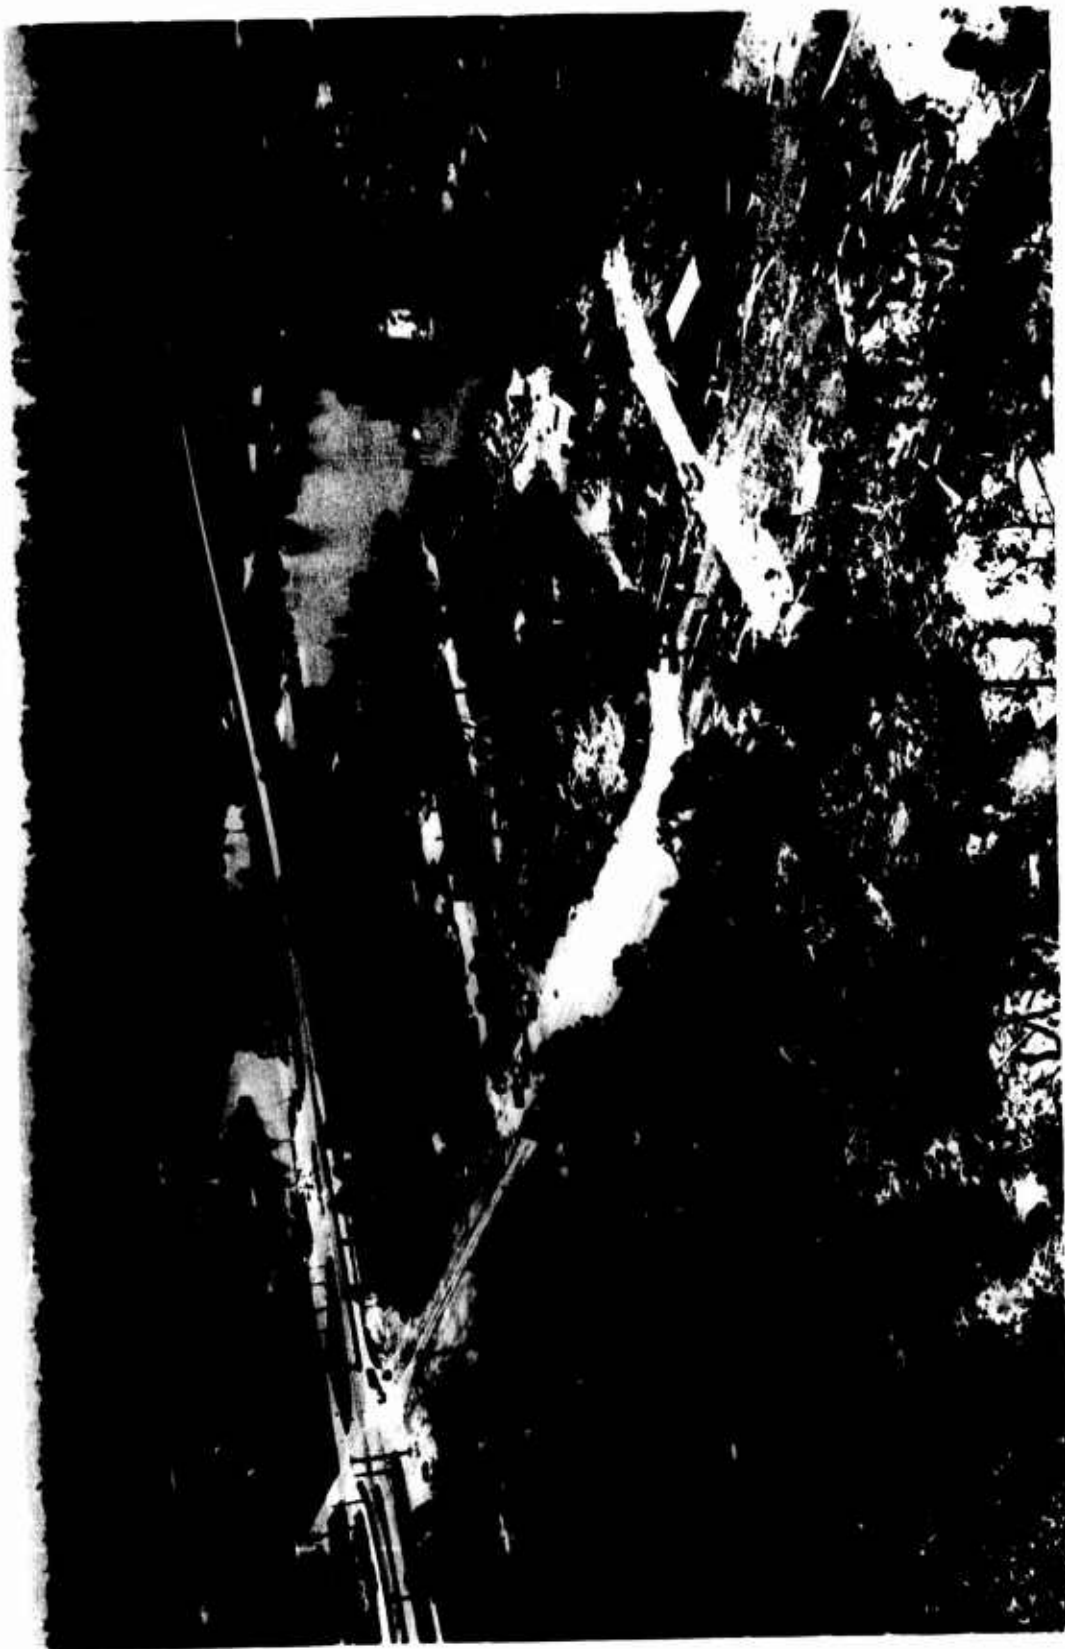
Figure 2.26 Henderson Point, on east shore of Saint Louis Bay, Mississippi.

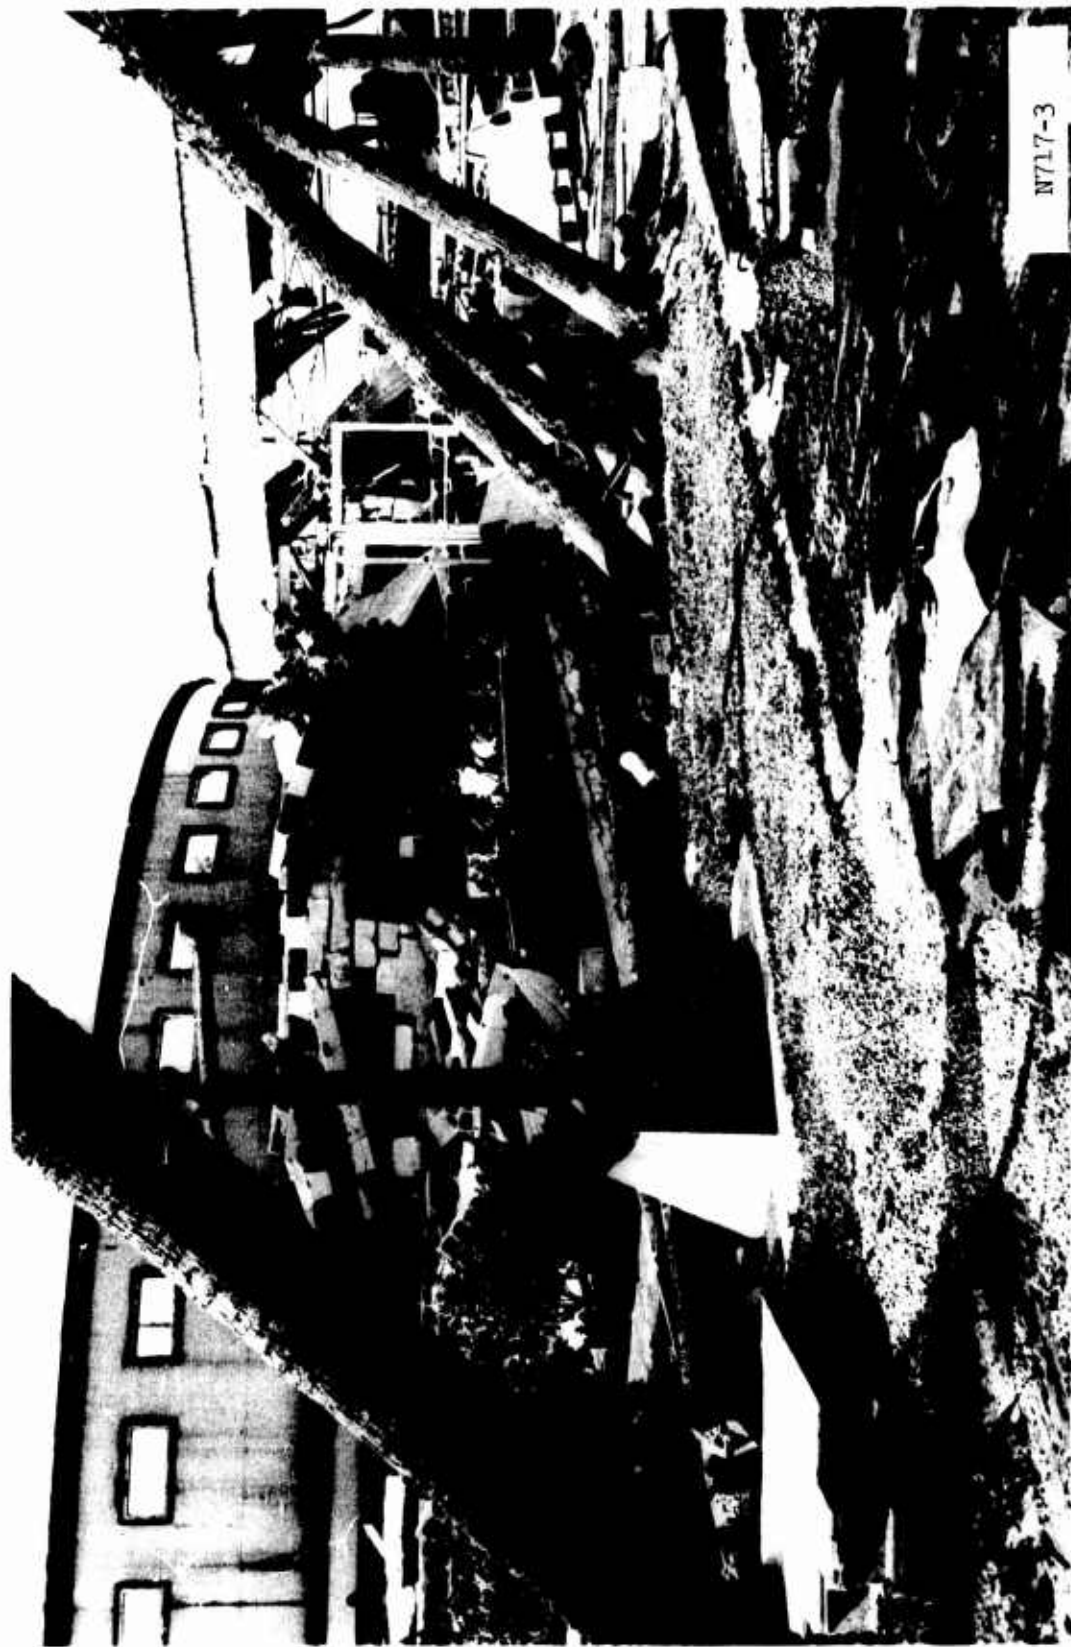
Marine Life consisted of a group of various structures (Figure 3.12). A large steel arch which this team was told was designed for 120-mph winds sheltered a display tank and a concrete seating area. A small (30 to 50 spaces) NFSS shelter was located under this seating area. A concrete floor and block wall structure surrounded the large display tank to the east of the arch.

Figure 3.12 Marine Life Aquarium.

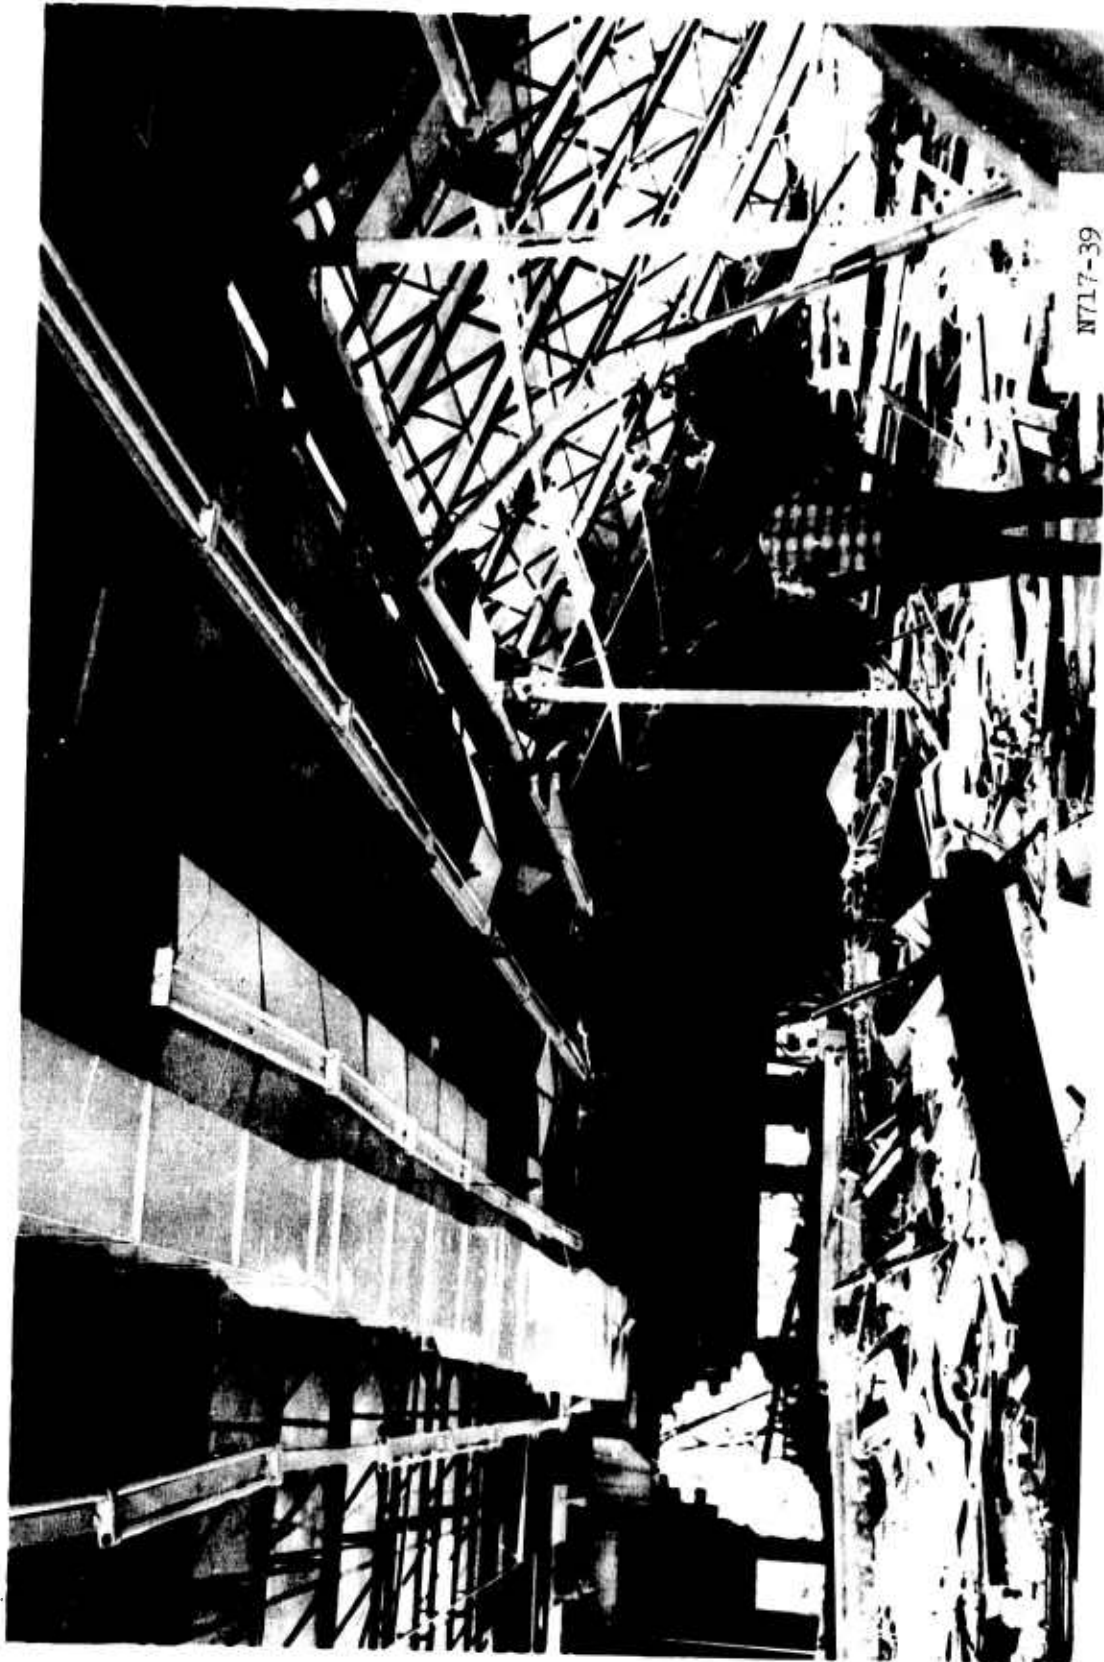
The two side bays of the A&P store collapsed, probably when the walls between this building and the adjoining stores were destroyed. One corner of the wooden truss hip roof at the front of the A&P was left cantilevered over the debris (Figure 3.43). The center bay, supported on steel beams at both ends, did not suffer extensive structural damage (Figure 3.44). The presence of lamps in the fixtures shows that the water did not reach the ceiling level.

Figure 3.44 Central bay of A&P, Long Beach.
