Special Report 150

CAMP CENTURY REVISITED A PICTORIAL VIEW-JUNE 1969

Austin Kovacs

July 1970

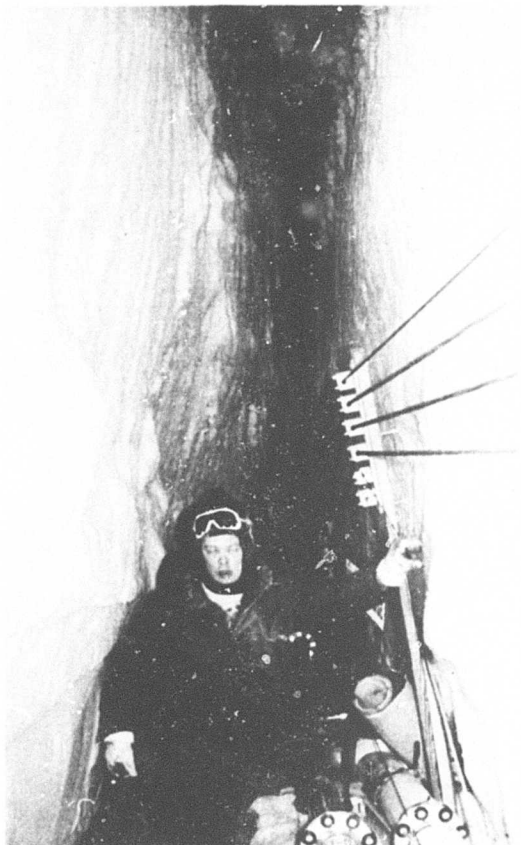
Figure 11. The glycol trench, once 9 ft wide, has undergone considerable deformation. Heat which once escaped from the glycol pipeline leading from the reactor to the glycol well and residual heat within the well increased the temperature of the surrounding snow. This in turn increased the deformation rate of the snow and accelerated trench closure.

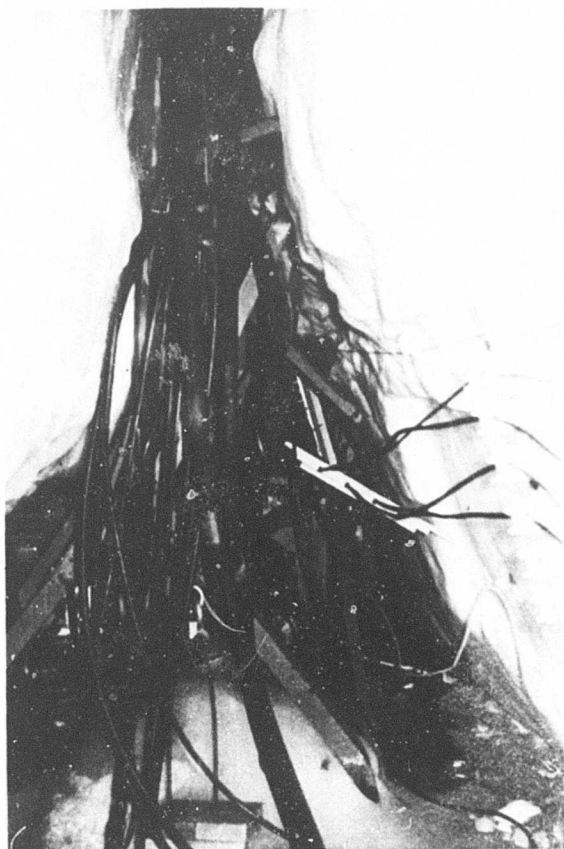
Figure 12. Snow deformation crushes the derrick over the glycol well.

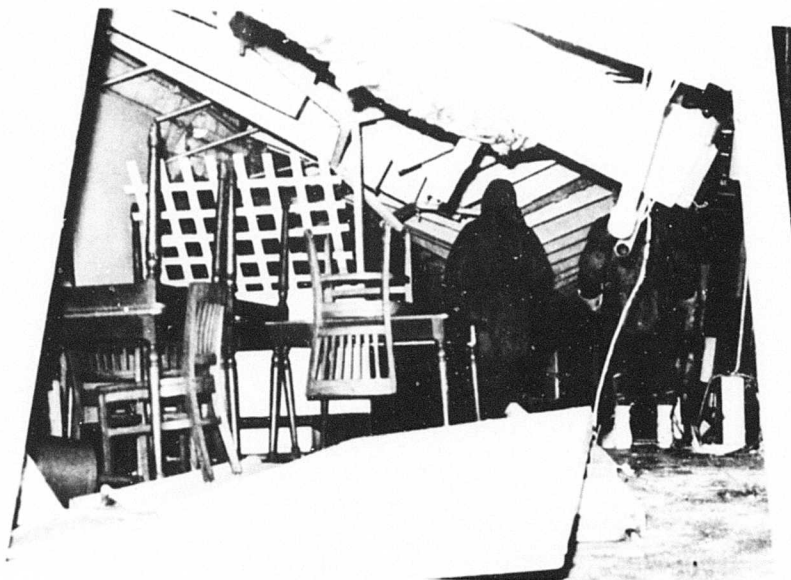
Figure 24. Ceiling joists pushed downward by snow encroachment upon mess hall roof.

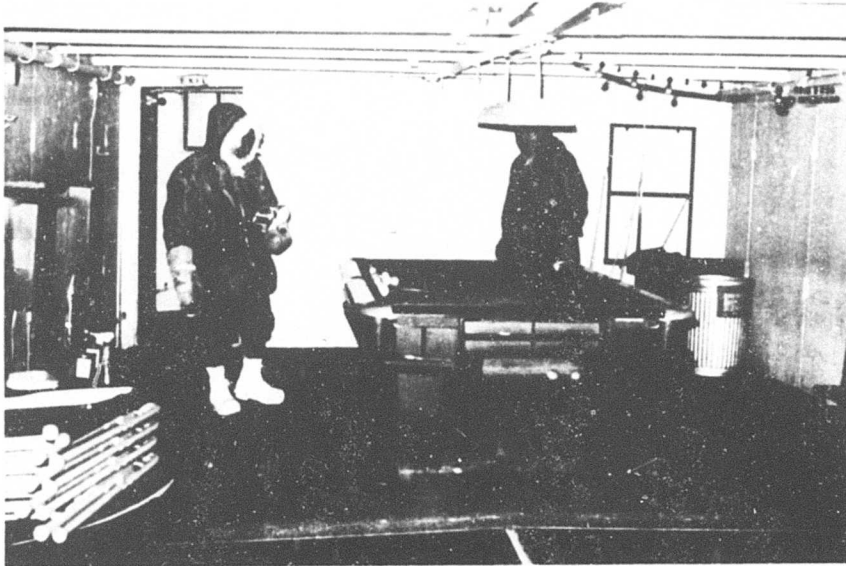
Figure 46. Floor buckling in EM club.

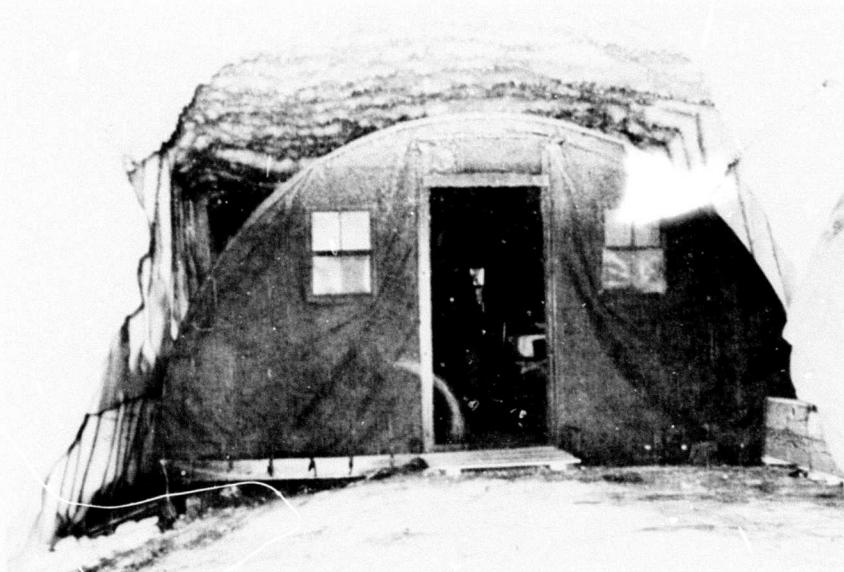
Figure 81. Jamesway at rear of Trench 20.

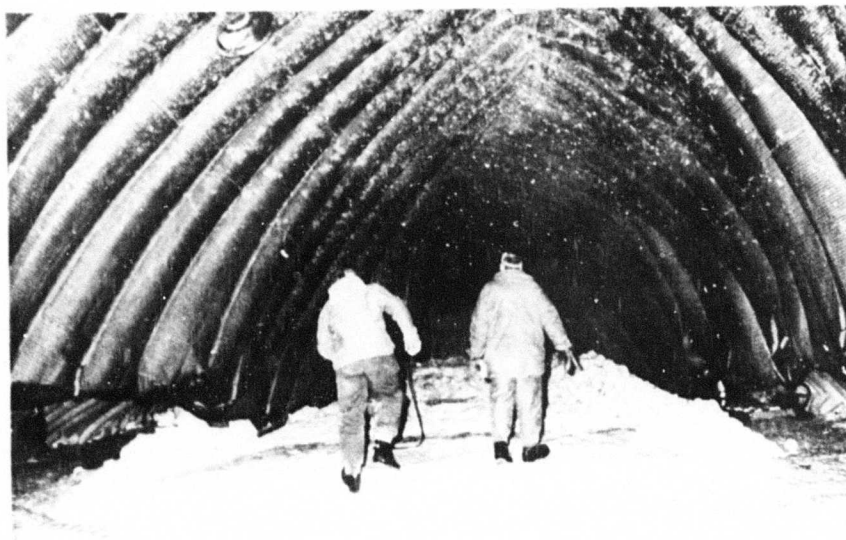
Figure 86. Arch deformation, Trench 21.

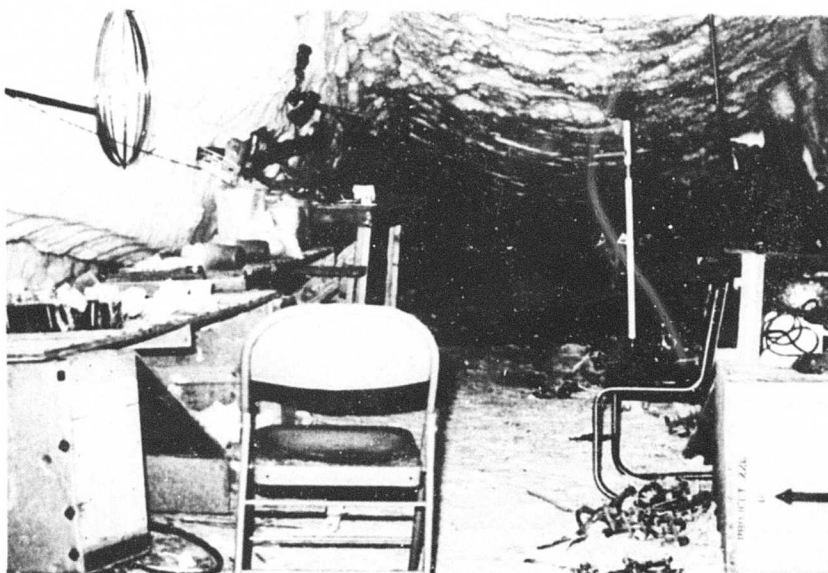
Figure 91. Roof sags most where the inclined drift and railroad trench intersect.
