AFRPL-TR-70-43

**LONG-TERM STORABILITY
OF
PROPELLANT TANKAGE AND COMPONENTS
INTERIM REPORT #1**

R. B. MEARS, 1st LIEUTENANT, USAF

INTERIM REPORT #1

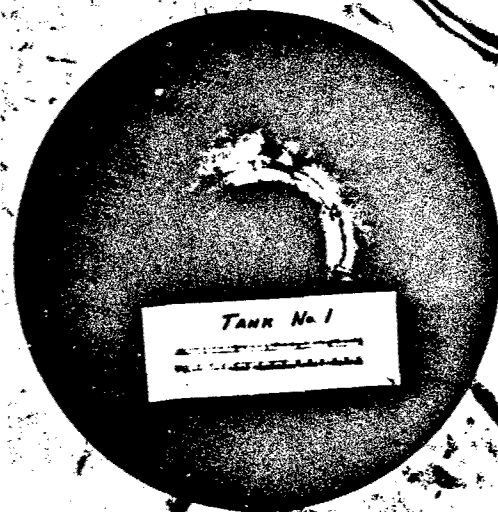
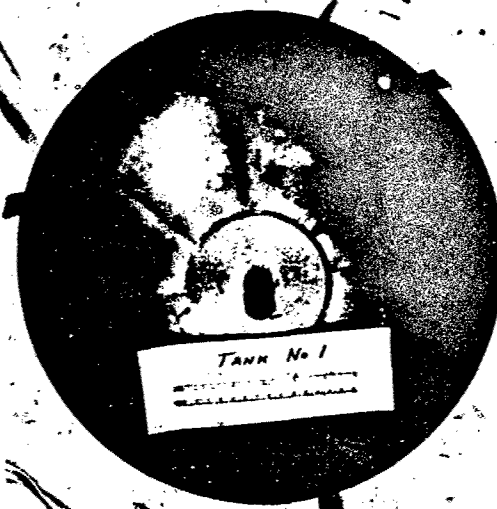
2. Leak Test - The tank was baked at $250^{\circ}F$ for one hour. It was then pressurized with 100% helium for 30 hours. The tank was then leak checked by the hand probe method, using a CEC helium mass spectrometer. One leak was found in the bottom of the tank. This leak had a magnitude of 8.4×10^{-6} atm. cc/sec. One leak having a magnitude of 1.6×10^{-9} was also found in the top of the tank, Figure 2.

Figure 2. Leak Areas of Tank No. 1
0.2X (Shown by Arrows)

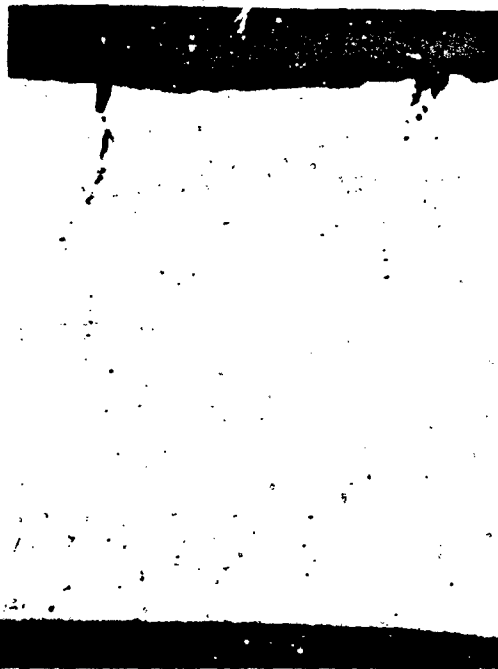
Figure 7. Stress-Corrosion Cracks and Alpha Case in Discolored Area, Unetched and Etched. (100X)

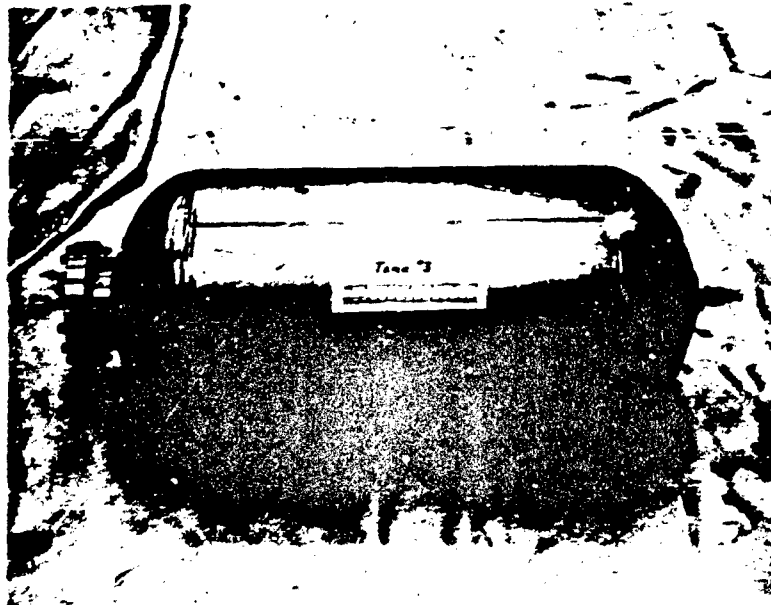
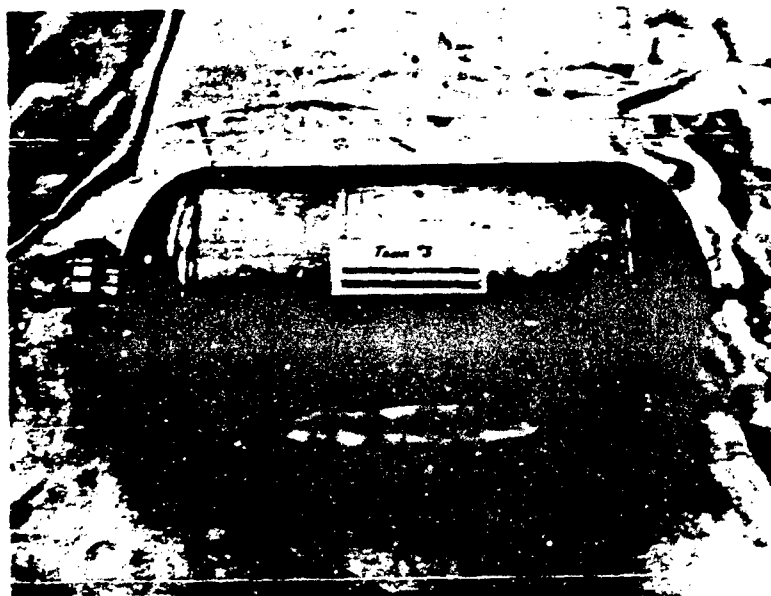
Figure 2. Side Views of Tank No. 3

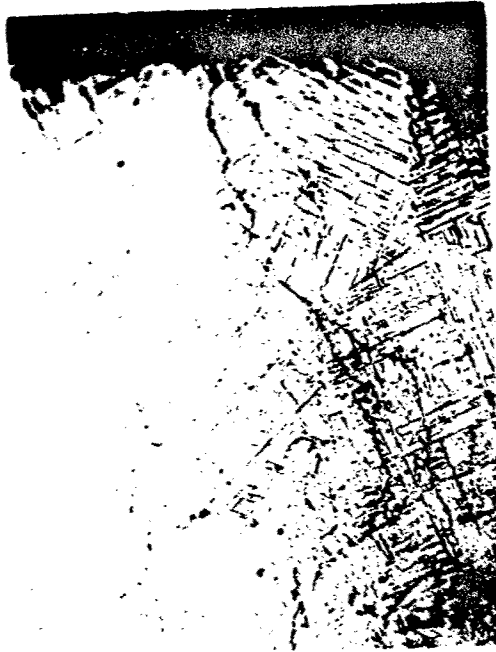
Figure 6. Photomicrograph Showing the Microstructure of the Ti-6Al-4V Titanium Alloy at a Stress Corrosion Crack (250X)

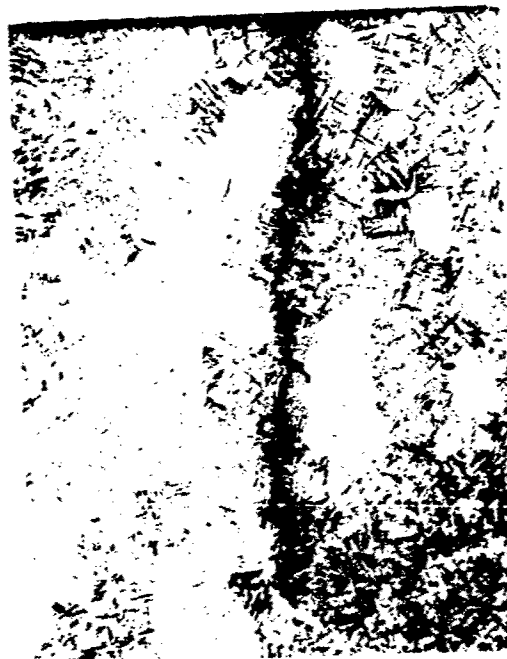
Figure 7. Photomicrograph Showing the Microstructure of the Ti-6Al-4V Titanium Alloy at a Stress Corrosion Crack (100X)

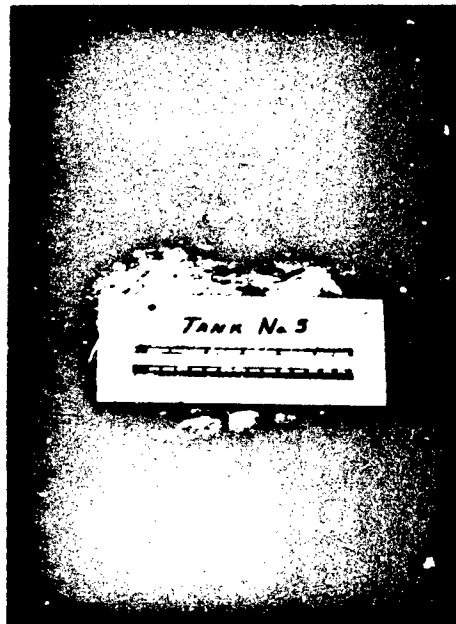
Figure 1. Crack in Outlet Flange of S/N 5 1/4X

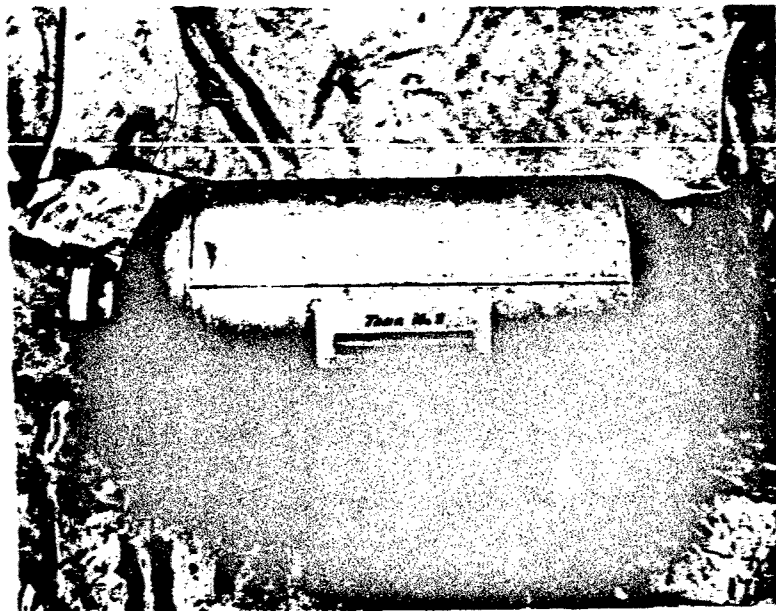
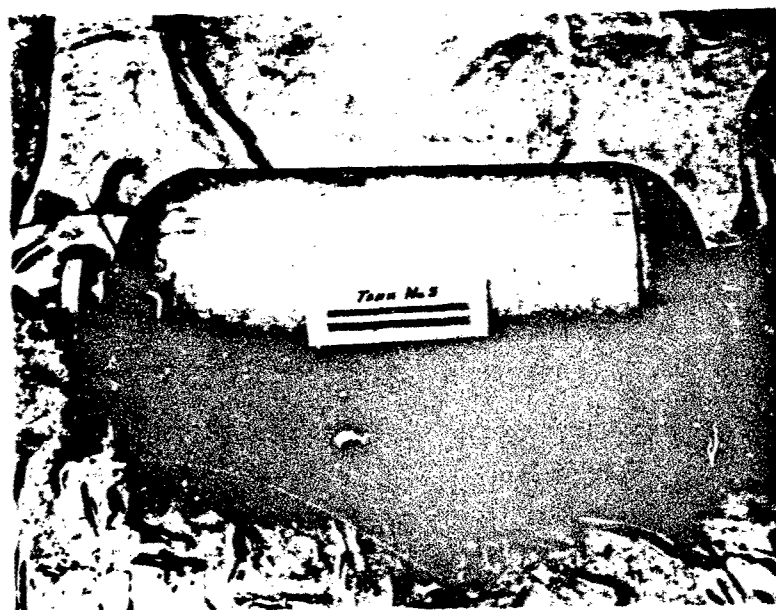
Figure 3. Sideviews of Small Tank S/N 5 1/8X
78

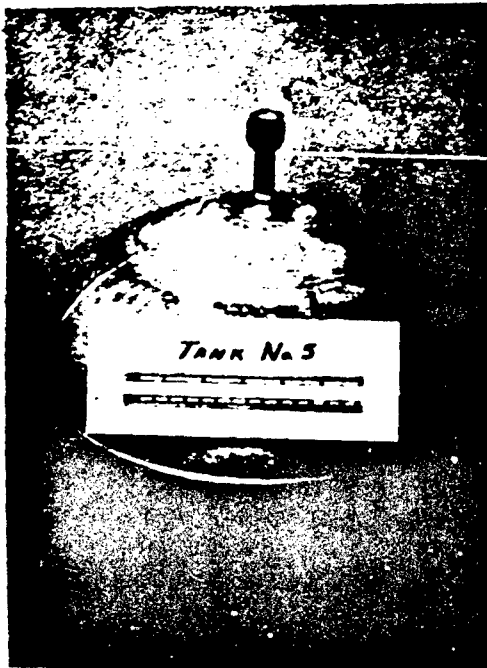
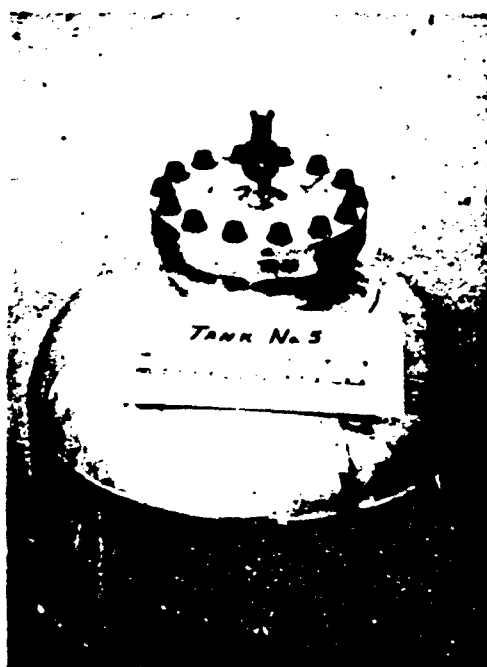
Figure 4. End Views of Small Tank S/N 5 1/4X

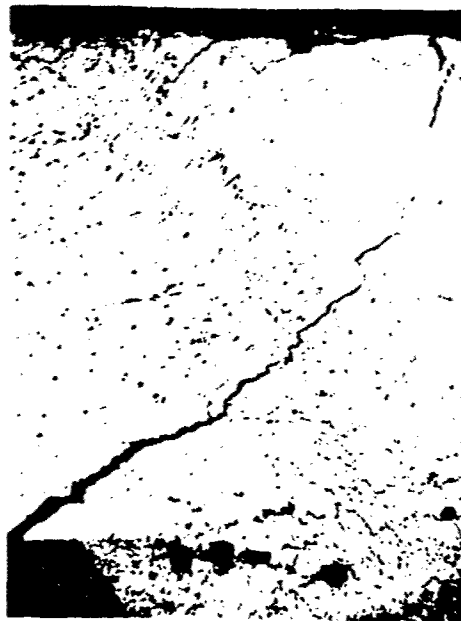
Figure 10. Microsection Through Hot-Short Crack in Figure 9. (50X)

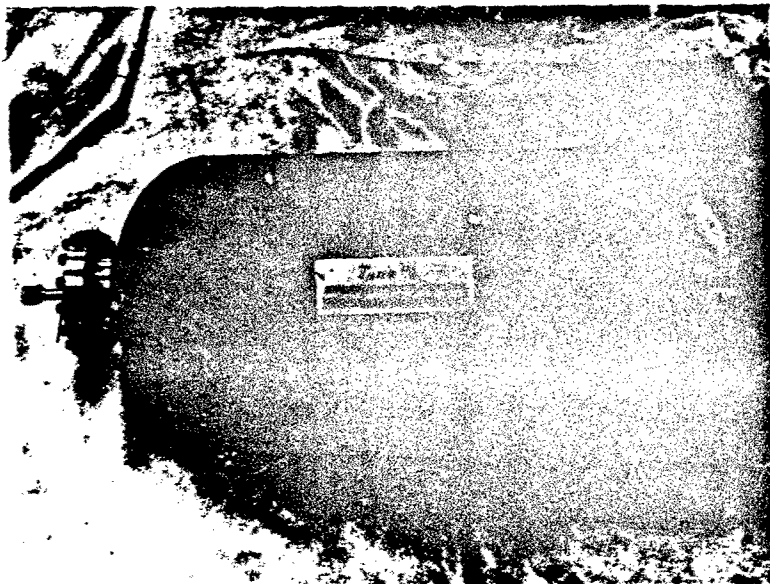
1. The tank failed because of corrosion through by nitric acid from the exterior surface of the tank.
2. The nitric acid apparently formed on the failed tank by condensation of water (85% relative humidity) and N_2O_4 from a nearby leaking N_2O_4 vessel.
3. One leak may have occurred through a hot-short crack in a dome weld.

Figure 1. Side views of Tank No. 6.

1. Test conditions should be regulated so that when other test specimens fail, the by-products of that failure should not be allowed to interfere with another test in progress.
2. Weld acceptance criteria used to initially accept this tank should be reviewed for future orders. The criteria should be strengthened in the area of acceptable radiographic defects.
3. Weld parameters must be adjusted on initial qualifications and certifications to assure that the production articles will be free from hot tearing.

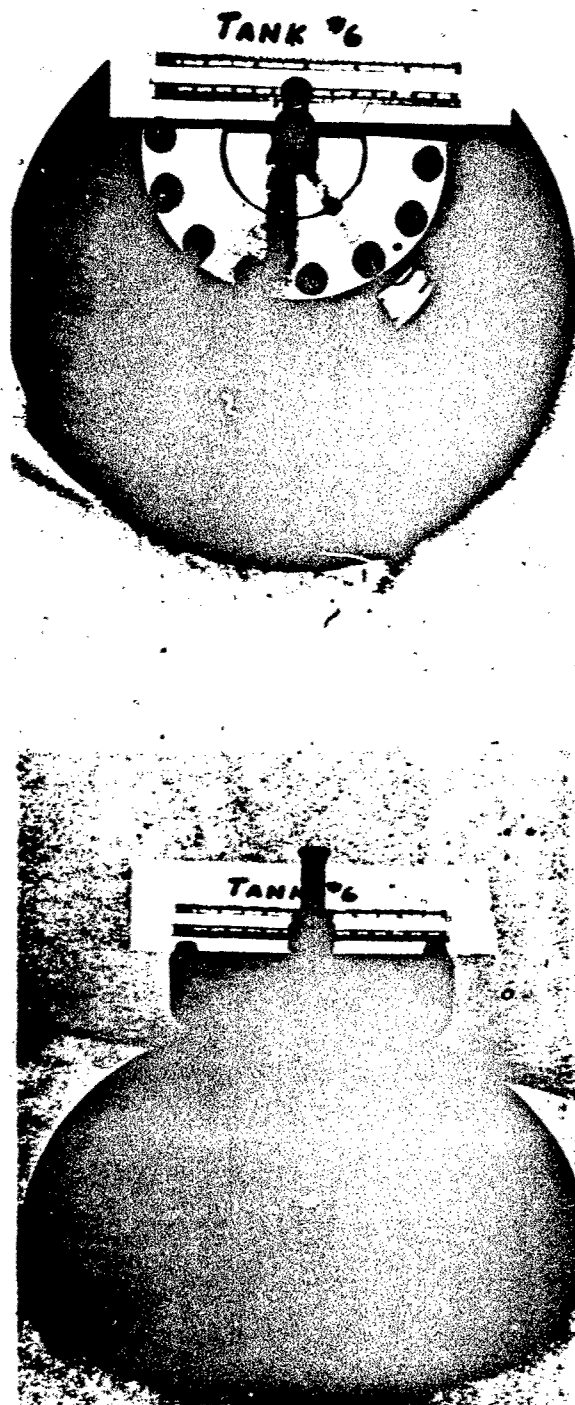
Figure 3. Flanged End of Tank No. 6.

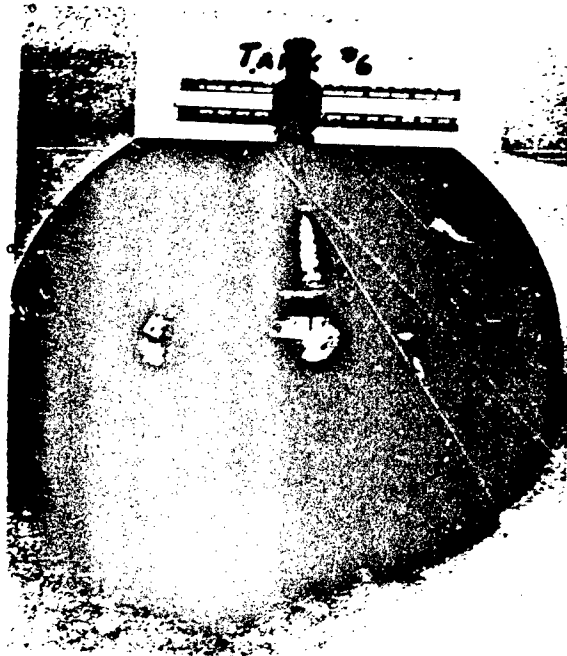
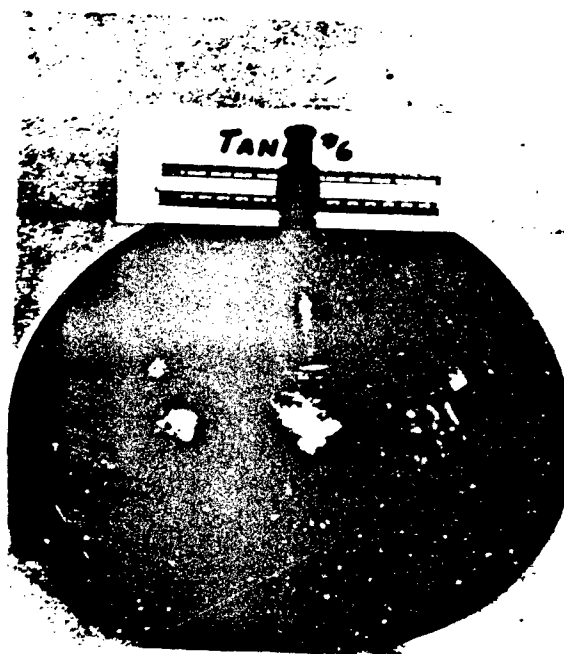
Figure 4. "Eenie" End of Tank No. 6.

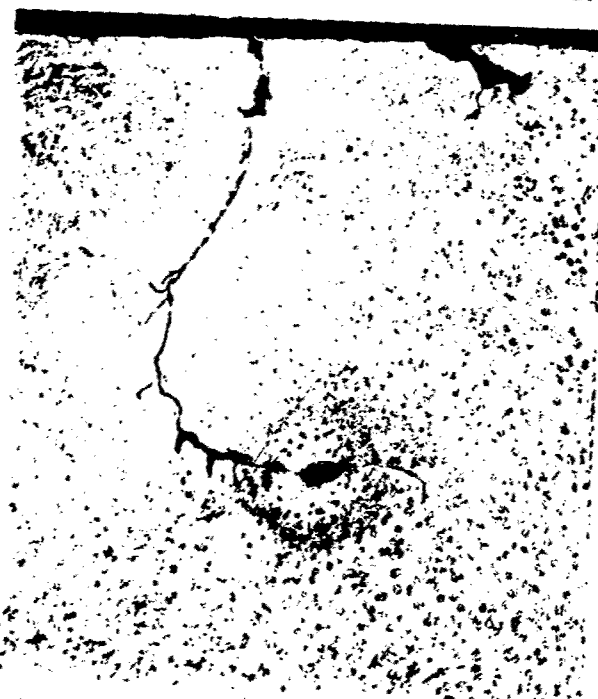
It was apparent from the microsections that all of the leaks except one were caused by external corrosion. One leak apparently occurred through a hot-short crack in a dome weld, Figure 6.

4. X-ray Examination - The dome welds from both ends of the tank were x-rayed. In addition to the corrosion pits, three hot-short cracks were visible in the weld x-rays.
5. Mechanical Tests - Tensile specimens were taken longitudinally from the barrel section of the tank. The following properties were obtained.

Figure 6. Photomicrograph of Hot-Short Crack
in Dome Weld Area of Tank No. 6.
75X

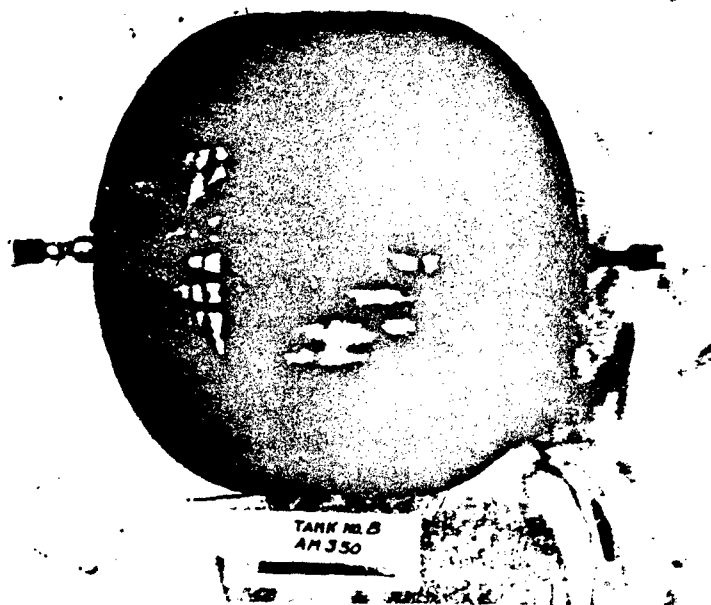
10. The cause of leakage of this tank apparently was that under 85% relative humidity and close proximity of this tank to a leaking N_2O_4 vessel, HNO_3 was condensed on the top of the tank. The HNO_3 then drained down the sides of the tank and concentrated on the bottom. Corrosion occurred generally over the outer surfaces of the tank and heavy pitting occurred on the bottom of the tank with two pits penetrating the wall thickness of the tank. Actually, HNO_3 is the suspected oxidizing acid that caused corrosion in this case since there was no fluorides or chlorides present in the corrosion residue.

Figure 1. Sideview of Tank Serial No. 8. Representative Photomacrographs Showing General Corrosion. Top of Tank Is To The Left of The Photograph. Approximately 1/4X magnification.

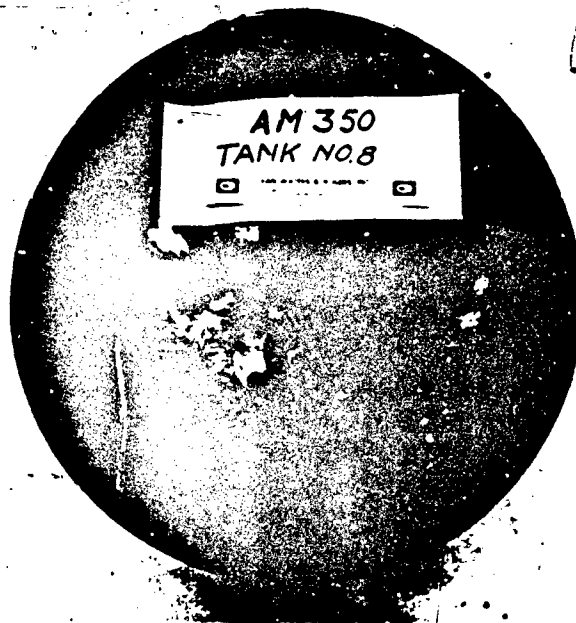
1. Small tank serial number 8 failed as a result of a corrosion through by nitric acid from the exterior surface of the tank.
2. The nitric acid apparently formed on the failed tank by condensation of water (85% relative humidity) and N_2O_4 from a nearby leaking N_2O_4 vessel.

Figure 3. A Photomicrograph Showing The Two Leak Areas in Bottom of Tank Serial No. 8. Approximately 1/4X Magnification.

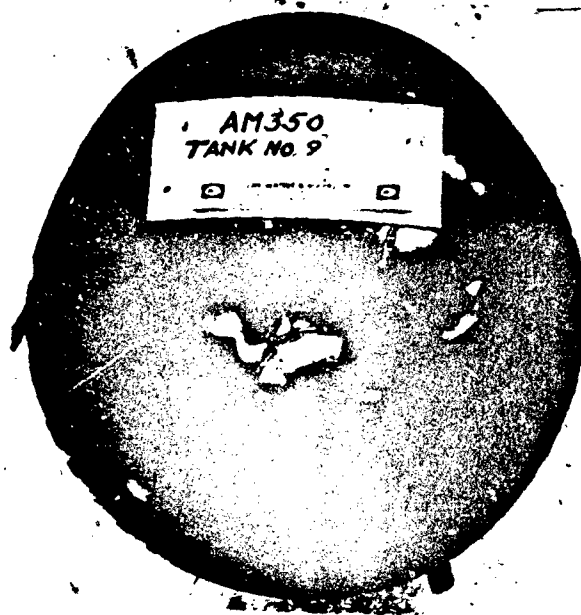
10. The 85% relative humidity and close proximity of this tank to a leaking N_2O_4 vessel, resulted in condensation of HNO_3 on the top of the tank, and caused tank S/N 9 to leak. The HNO_3 then drained down the sides of the tank and concentrated on the bottom. Corrosion occurred generally over the outer surfaces of the tank and heavy pitting occurred on the bottom of the tank with two pits penetrating the wall thickness of the tank. Actually, HNO_3 is the suspected oxidizing acid that caused corrosion in this case since there were no fluorides or significant amounts of chlorides present in the corrosion residue.

Figure 1. Top View of Tank No. 9.

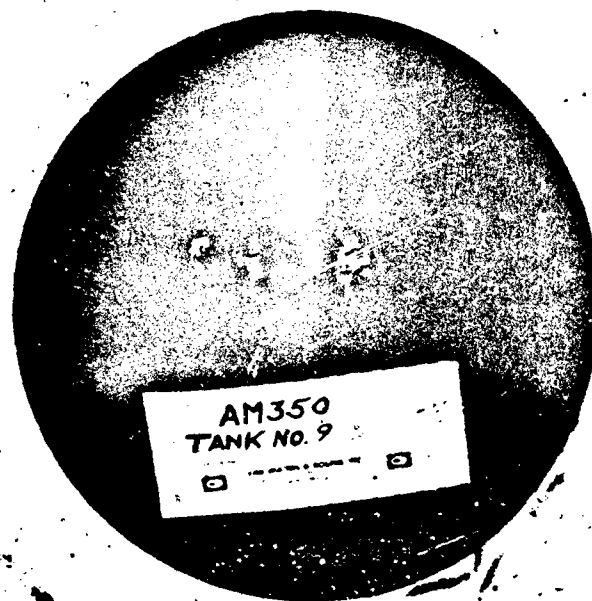
Figure 2. Bottom View of Tank No. 9.
Circled areas are leaks.

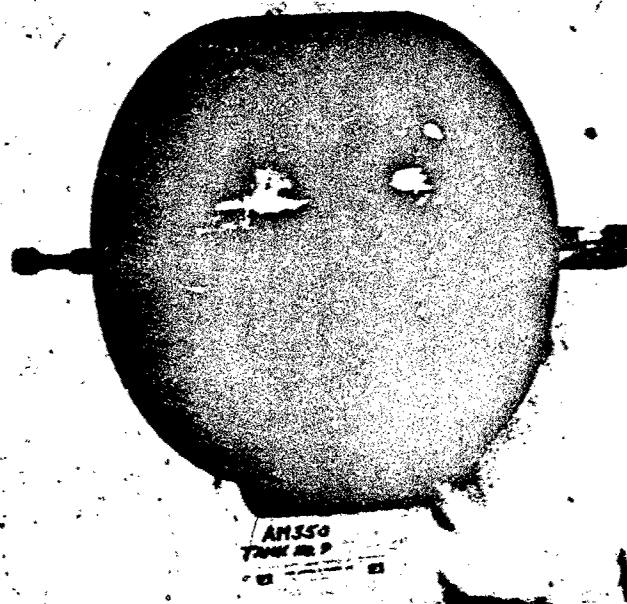
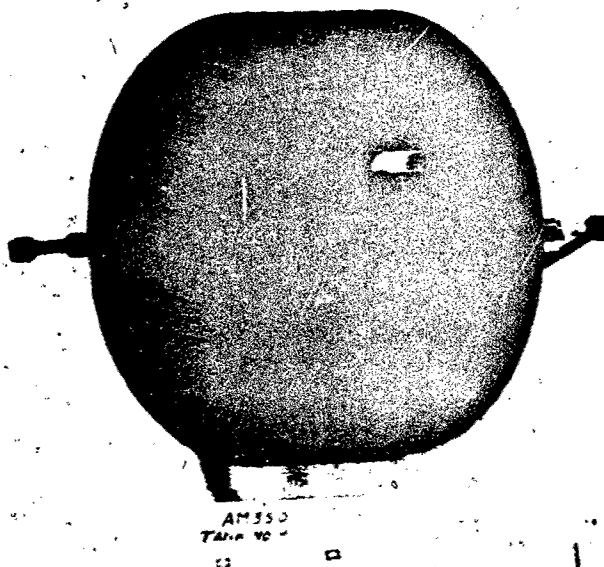
Figure 3. Side Views of Tank No. 9.

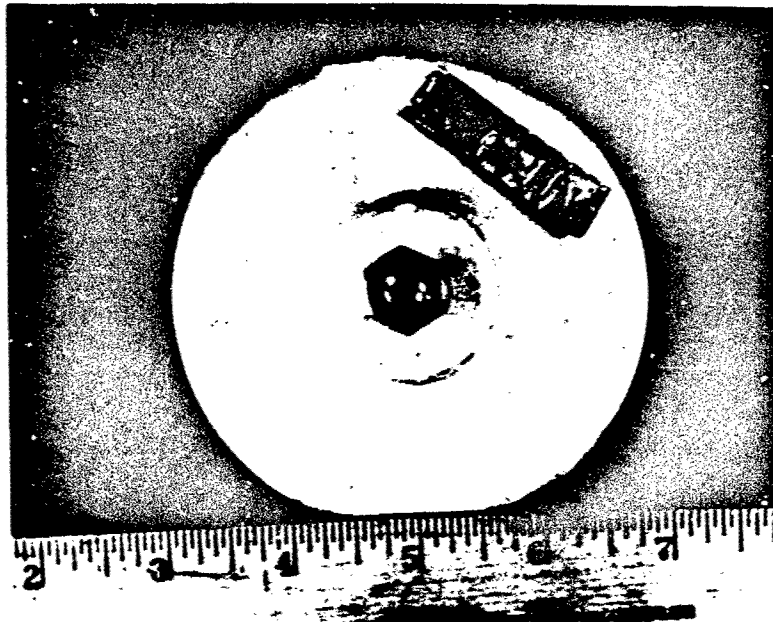
Figure 5. Photomacrograph showing an overall view of the bottom of small tank no. 11 0.75X

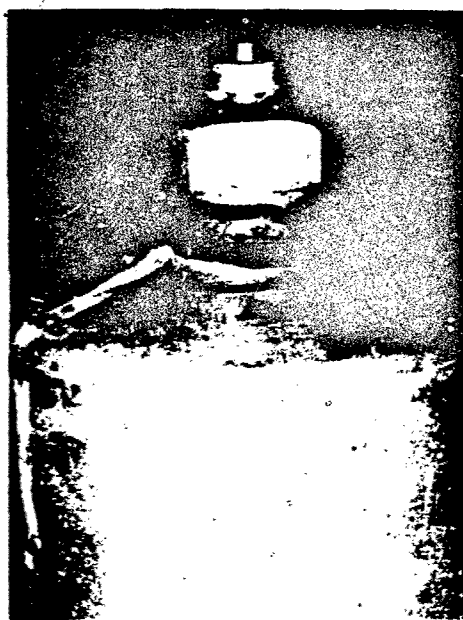
Figure 9. Photomacrograph showing the single leak area in the weld of the bottom boss-to-end segment of small tank no. 11. 1X

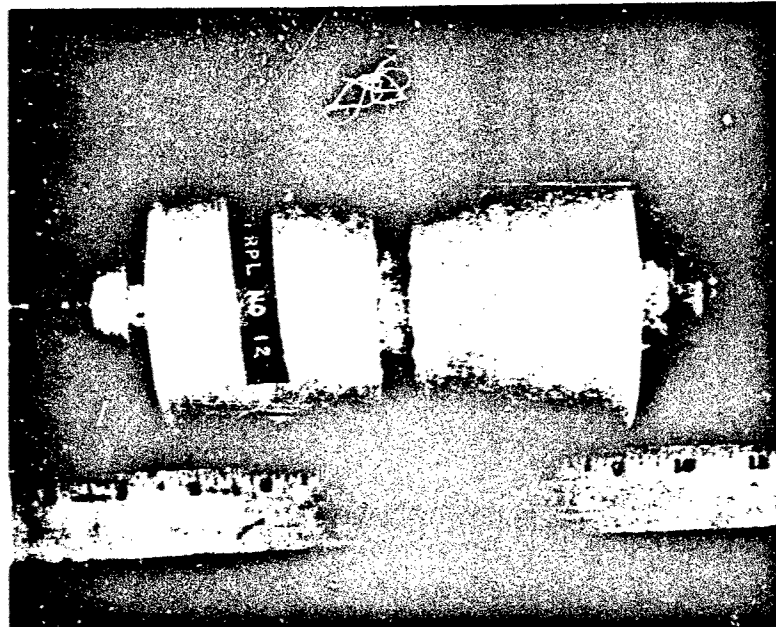
1. Macroexamination - The tank was lightly etched over its entire surface, Figures 1, 2, and 3. The tank was severely corroded in the area of the fitting welds, Figures 4, 5, and 7. The weld cross-over areas in the main tank body were not severely attacked, but the start area of the girth weld was cracked, see Figure 6. Significant acid etching was observed on the bottom fitting weld as shown in Figure 7. Figure 8 shows cracking as a result of intergranular corrosion in the stop area of the top fitting weld.

Figure 3. Photomacrograph showing overall sideview of small tank no. 12. Top of tank is shown to the right. 0 6X

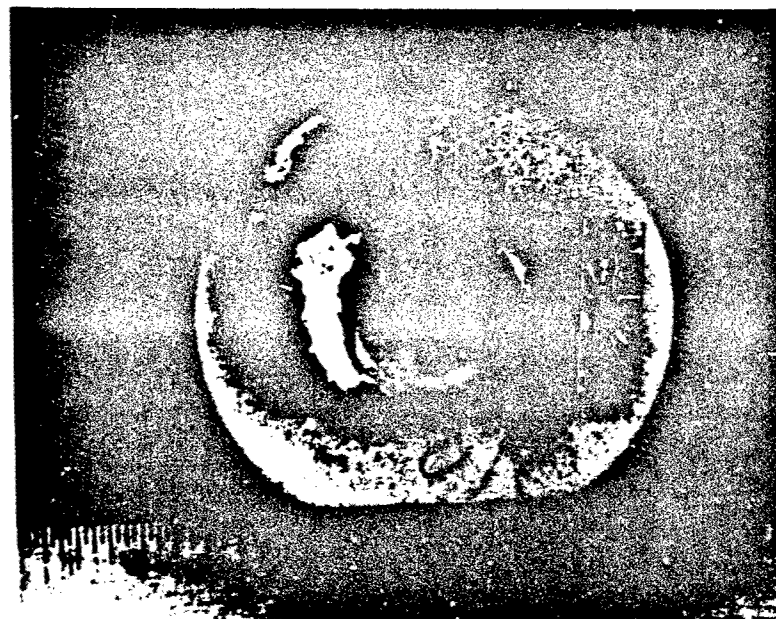
Figure 4. Photomacrograph showing and overall view of the top end of small tank no. 12. 0.75X

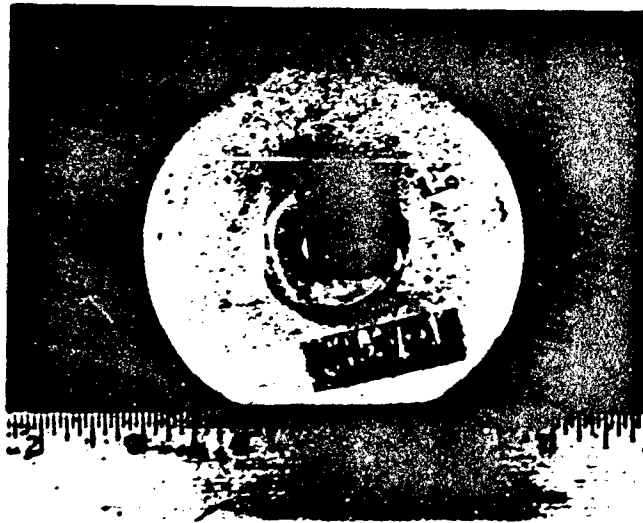
Figure 5. Photomacrographs showing an overall view of the bottom of small tank no. 12. 0.75X

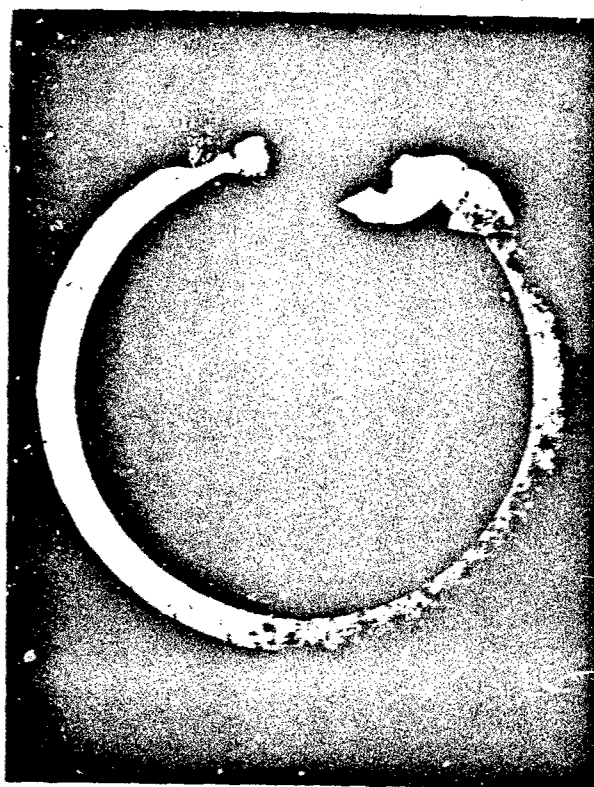
B. Close-out weld: The close-out weld was oriented such that it faced downward onto the top of the tank. (Fig. 7). Corrosion of the close-out weld was localized. In figs. 10, 11, & 15 a "plug" of weld material appears missing. Two tongue-like protrusions can be seen directed toward the inside of the tube. The weld material could have been locally corroded away after a leak had developed in the weld region. The origin of this hypothetical leak is unknown. However, it is felt that the most probable cause was by pitting corrosion at a crack or crevice in the weld area of the interior surface of the tube. (Fig. 12)

Figure II. Cross-section of tube at
close-out weld (Etched) 6X
