PEPORT DOCUMENTATION PAGE	READ INSTRUCTIONS
	3. RECIPIENT'S CATALOG NUMBER
TITLE (and Sublitio) Gruber Wagon Works, Blue Marsh Lake, Berks Count	5. TYPE OF REPORT & PERIOD COVERED
Pa. : Historic Structures report	Final

6. PERFORMING ORG. REPORT NUMBER
7. AUTHOR(+)	8. CONTRACT OR GRANT NUMBER(*)
De Siltes, Robert R.A. Parrott, Charles A.	DACW61-78-C-0038 men
John) Milner Associates West Chester, Pa.	10. PROGRAM ELEMENT, PROJECT, TASK AREA & WORK UNIT NUMBERS

1. CONTROLLING OFFICE NAME AND ADDRESS	12. REPORT DATE
U.S. Army Engineer District, Philadelphia	28 April, 1978
Custon House, 2nd & Chestnut Sts. Philadelphia. Pennsylvania 19106	13. NUMBER OF PAGES

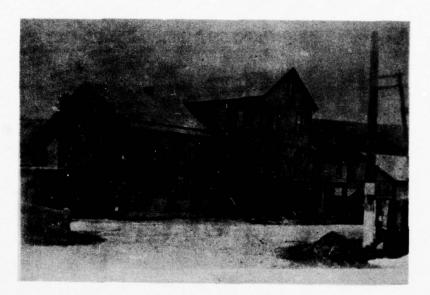
A) c. 1920 Wagon Works

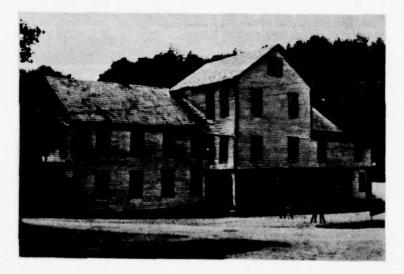
B) 1973 Wagon Works

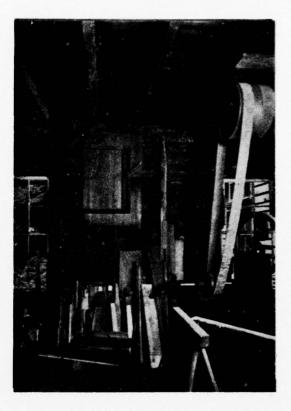
A) 1974 Detail of Balloon Framing, Room 102A

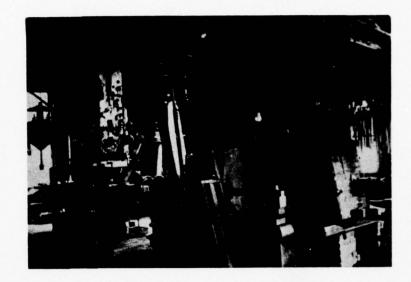
A) 1973 Blacksmith & Machine Shops
