ESL-TR-80-45

## FLUSH AM-2 MAT PATCH FOR RAPID RUNWAY REPAIR

JAMES L. GREENE

SEPTEMBER 1980

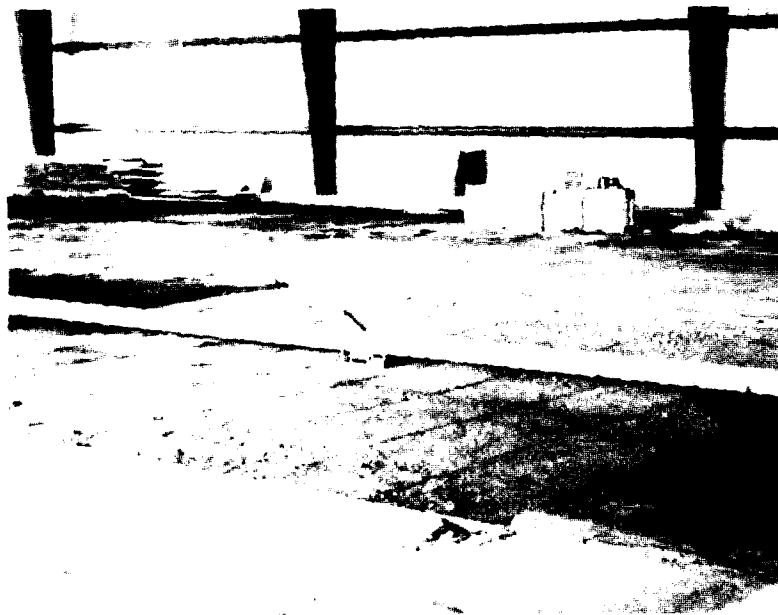
Figure 77. Test 3 (Side Panel)-Base Course  
After Testing
