DOT/FAA/CT-94/56

Transportation Development Centre Montreal, Quebec, Canada Characterization of Corrosion and Development of a Breadboard Model of a D Sight Aircraft Inspection System: Phase I

August 1994

Final Report

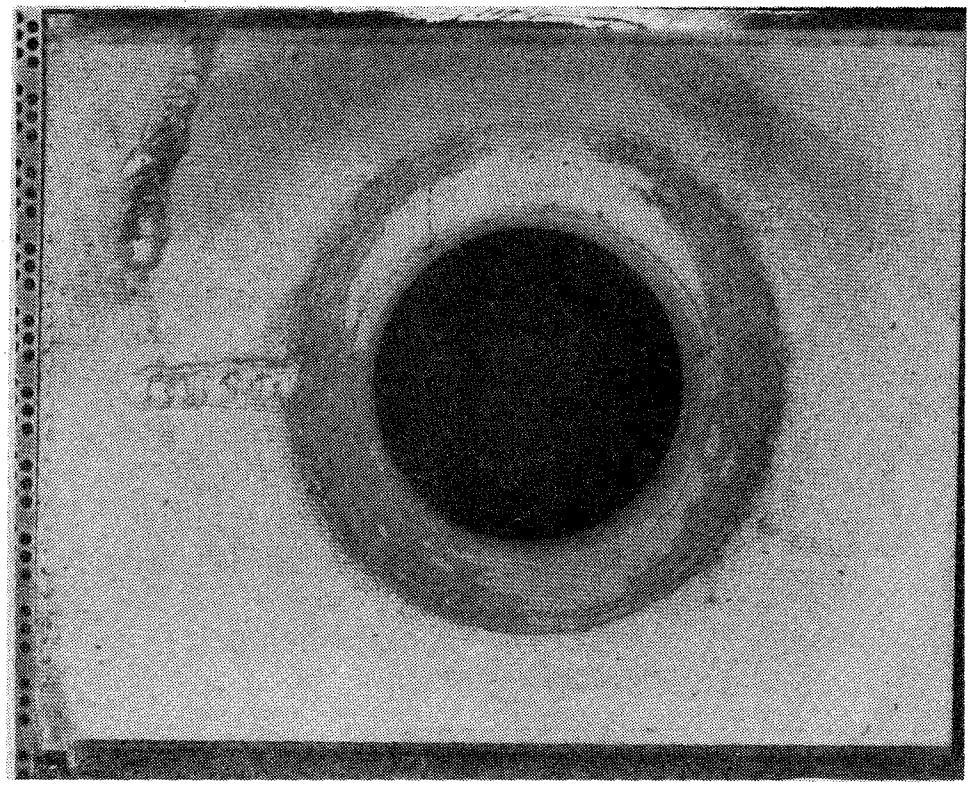
COUNTERSINK SURFACE 50X

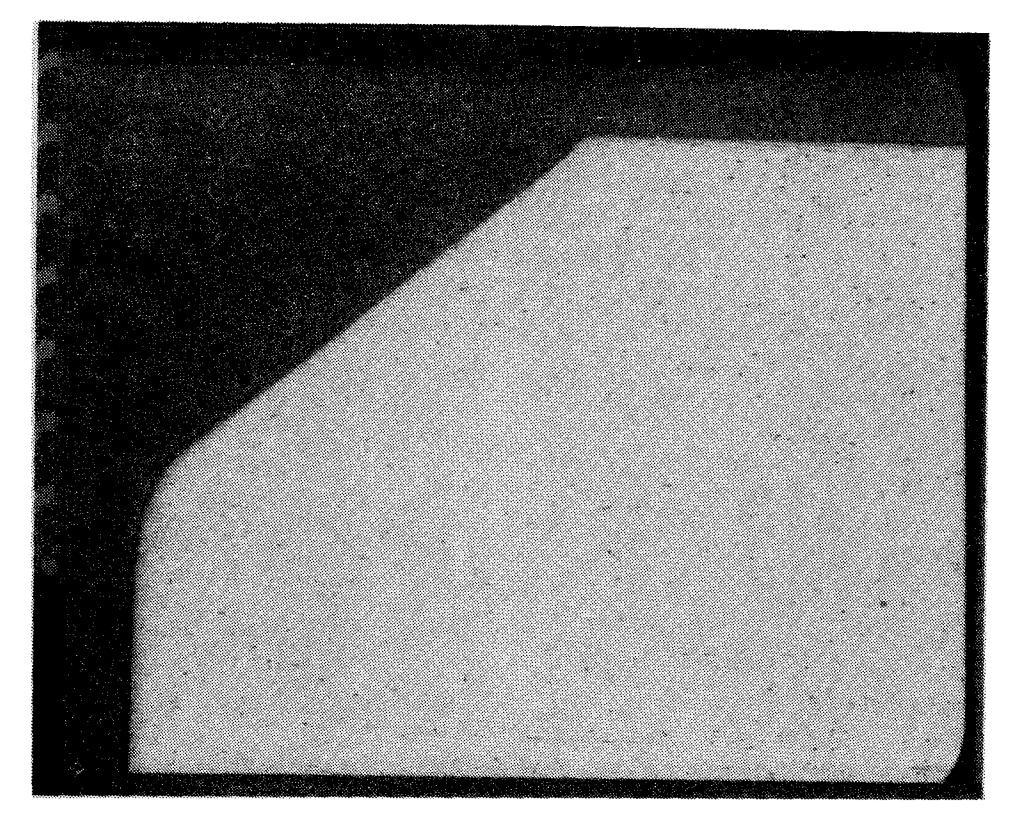
GOOD COUNTERSINK CROSS SECTION 50X

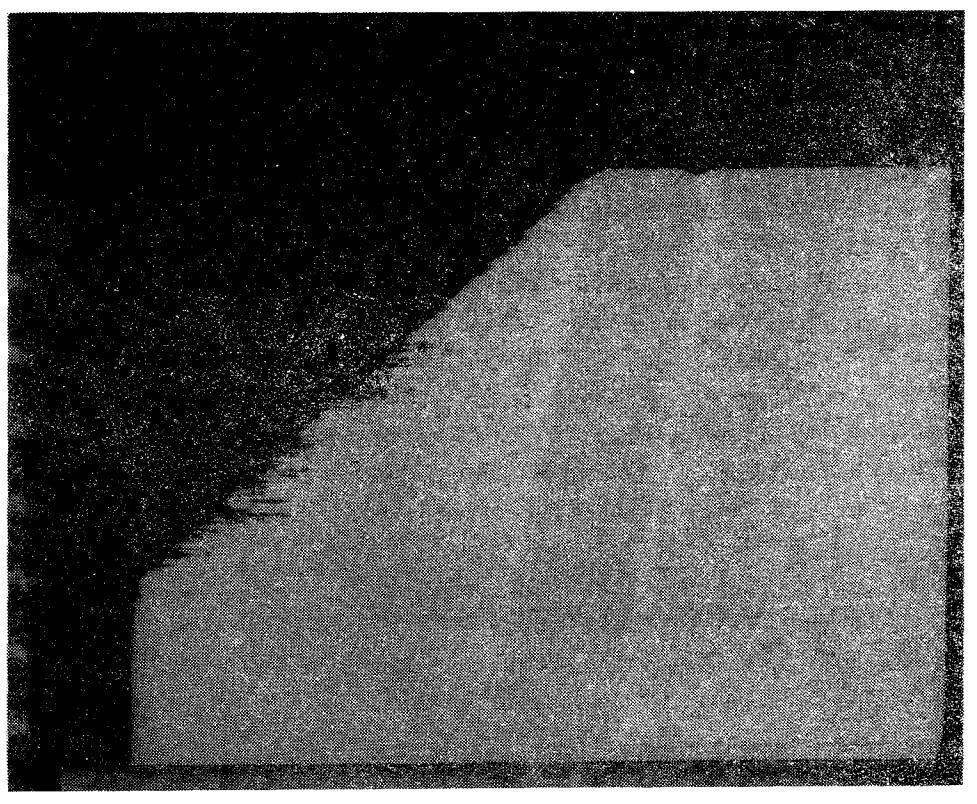
CROSS SECTION WITH PITTING 50X

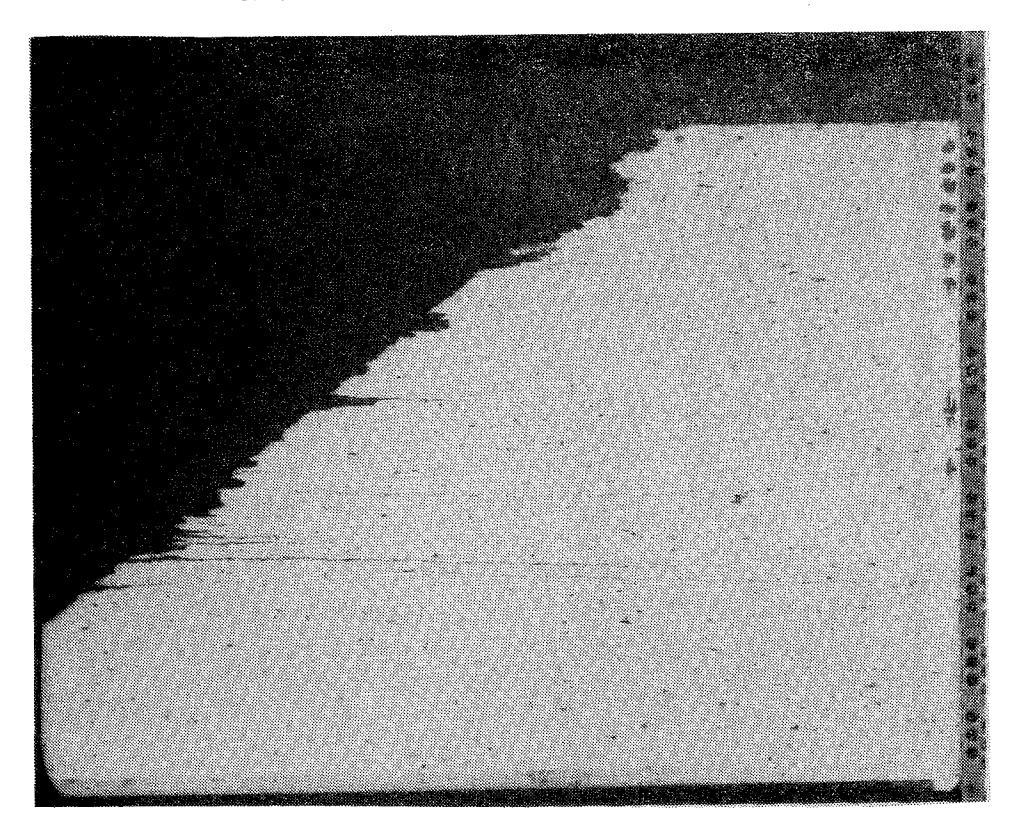
CROSS SECTION SHOWING PITTING AND EXFOLIATION 50X

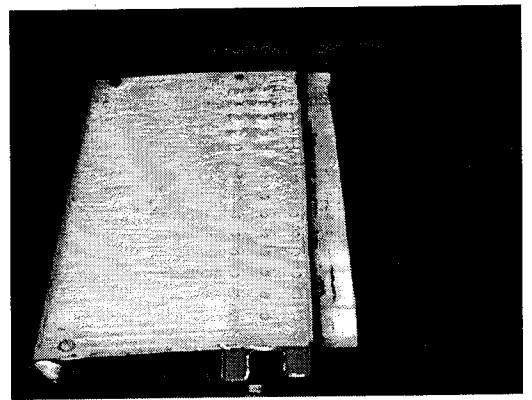
Test images such as Figure 1 clearly indicated the need for more magnification. But this has the undesirable side effect of reducing the inspected surface area. To counteract this, it was decided early in the testing phase that it would be more efficient to mount the camera on its side. Thus the longest dimension of the camera's CCD imager would view the maximum surface length possible, making the most efficient use of the available imaging area. With this modification a 50 mm focal length lens produced an optimum image size and was used for all subsequent tests.

Figure 1: Sample 4743R1 imaged via the DAIS 500 configuration

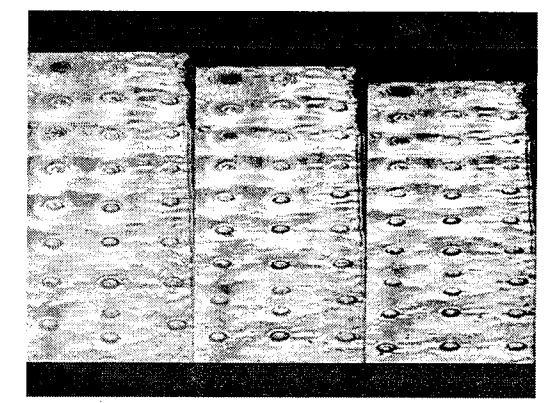
Figure 5: Imaging corroded rivets at 32, 27 and 22.5 deg. grazing angle

Figure 5 illustrates three views of the rivets taken with the 1.4 in. reflector lamp below the lens and the camera grazing angle set to 32 deg., 27 deg. and 22.5 deg. Using a camera grazing angle of 22.5 deg. Figure 6 shows four views of the two worst rivet rows with the retroreflective screen located 6 in., 12 in., 18 in. and 24 in. from the centre of the surface. With the screen to surface distance set to 18 in. the effect of lamp size was tested next. In Figure 7 two images of the same surface region are shown with the lamp 1.4 in. diameter reflector lamp located above and below the lens. The views in Figure 8 are similar except that the lamp now has a 2 in. diameter reflector.

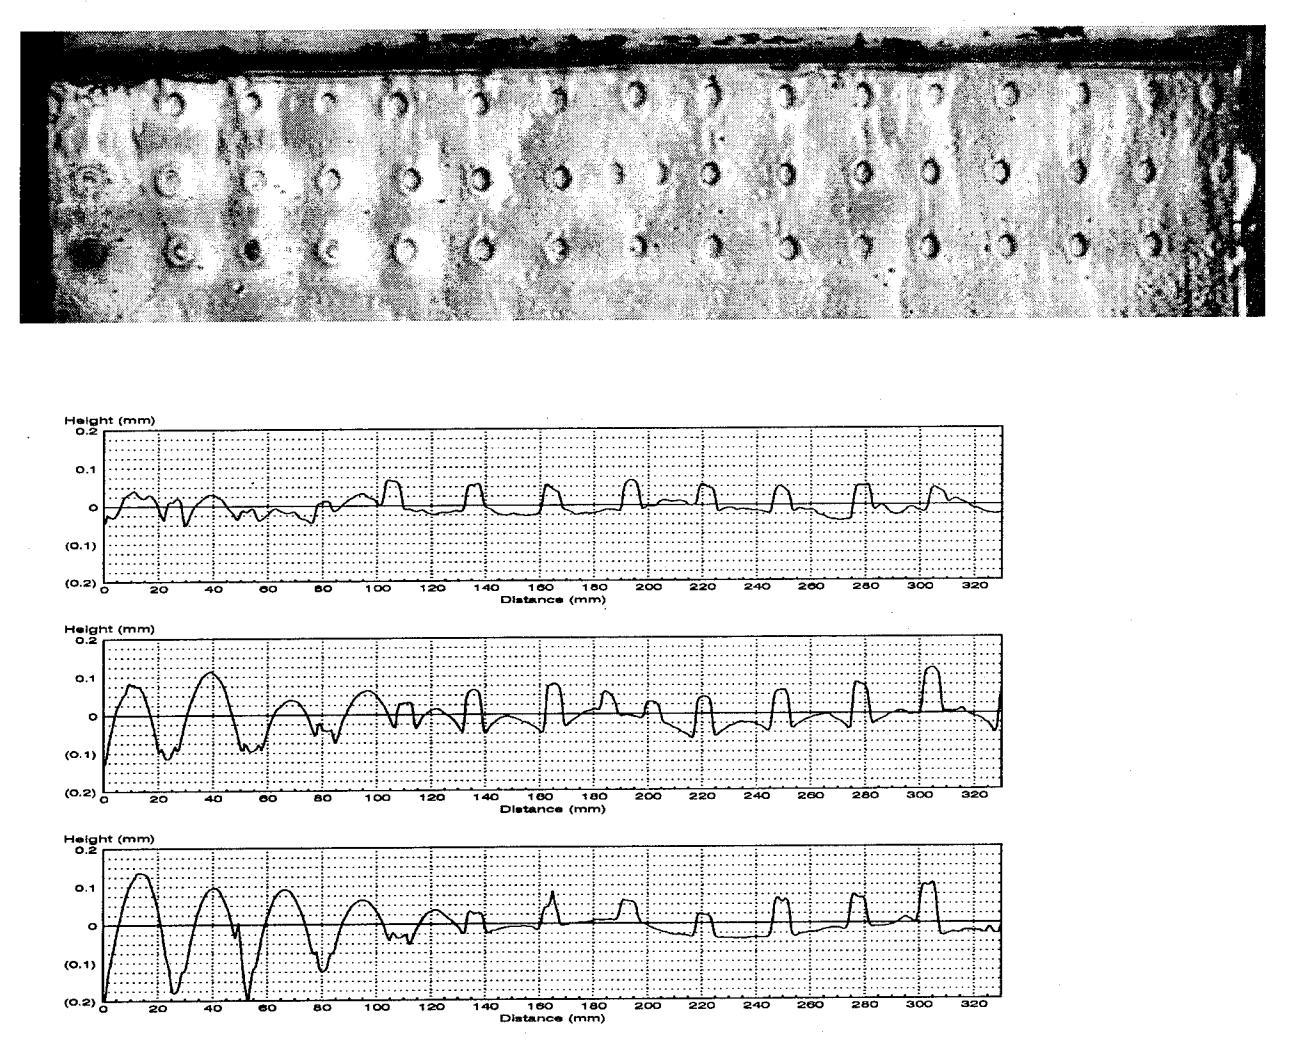
Finally, Figure 13 shows a line-scan image of the sample. Below this, arranged in the same order top to bottom, are dimensional profiles of the three rows of rivets.

Figure 13: Profiles of the three rivet rows in order from top to bottom

The profiles in Figure 13 begin just after the first rivet at the left of each row. The perception of the rivet heads "sinking" into the the hills between them is a side effect of subtracting the third order curve. Generally there is a good visual correlation between the height of the bulge between rivets and its DAIS signature. Unfortunately, the largest bulges between the first and second rivets in rows 2 and 3 (0.3 mm and 0.2 mm high respectively) do not have distinct signatures. It is surmised that this is due to their proximity to the sample's edge.

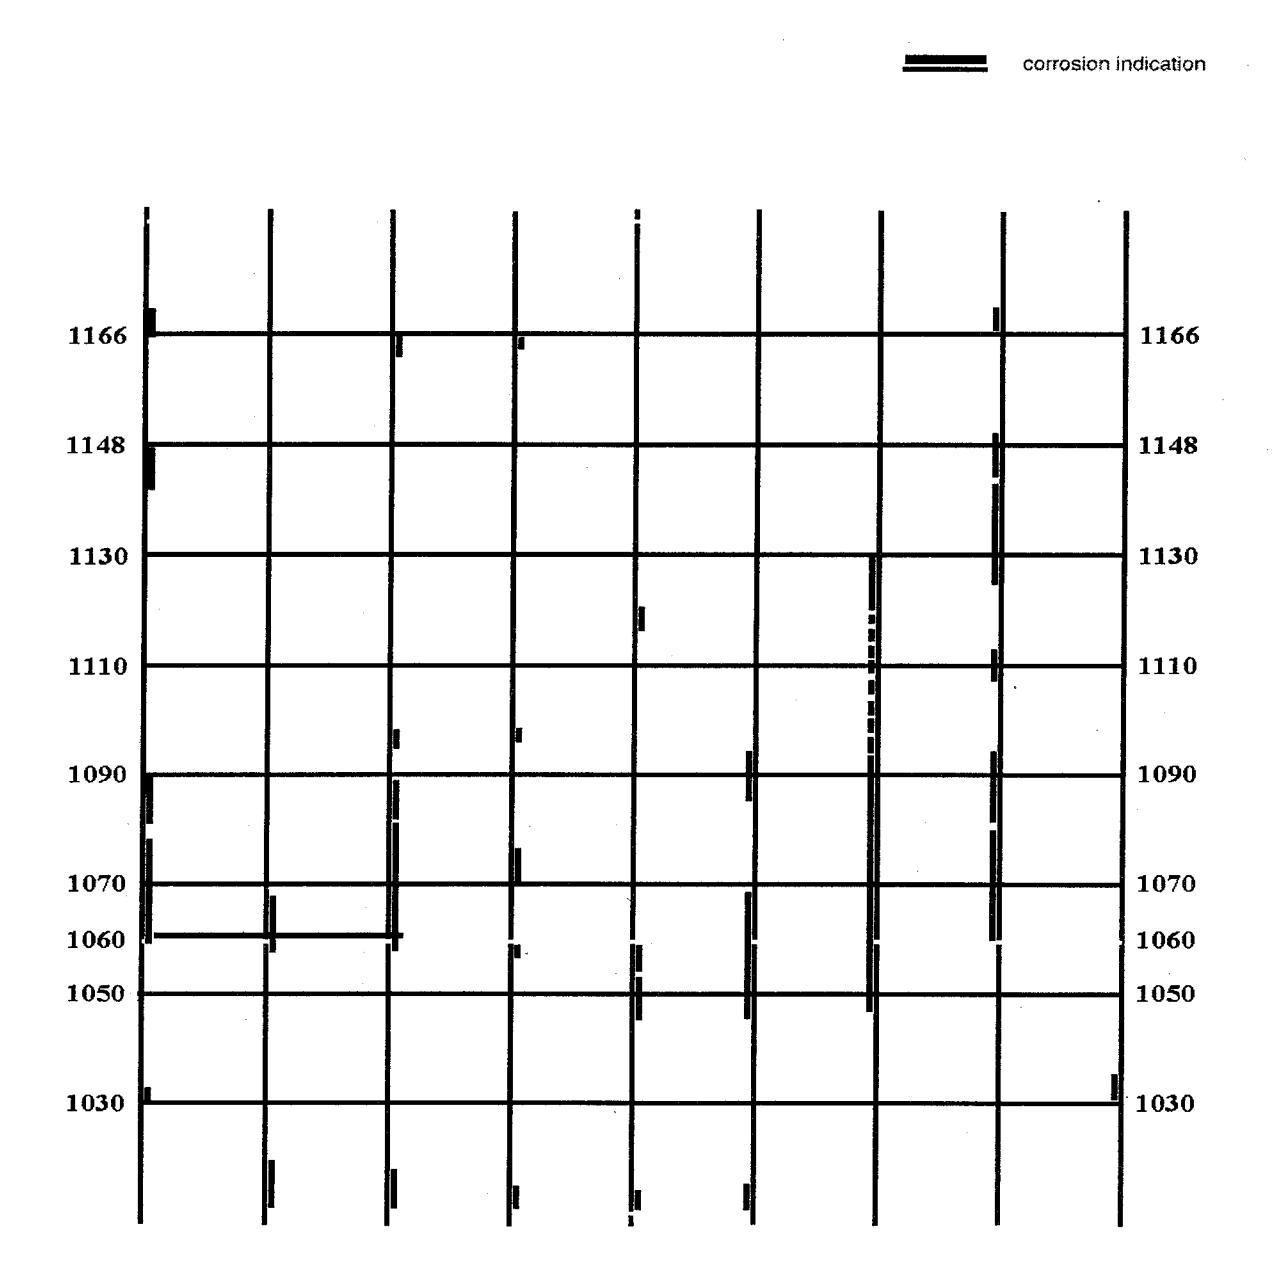
Figure 1: Results of D SIGHT inspection of DC-9-32 for corrosion

Preliminary analysis of the results did not reveal any areas of significant corrosion. Several sections along inspected stringers appear to contain a low level of corrosion. The strongest indication of corrosion was from the short section of stringer 18R. This observation was reinforced after the discussion with Air Canada personnel which revealed that:

Excessive application of sealant is one cause other than corrosion for pillowing detected by D SIGHT.

The areas inspected and suspected to contain corrosion are shown on Figure 1. It would be desirable to verify D SIGHT findings with low frequency eddy current techniques. A negative result from the eddy current test would confirm that the corrosion level is low, however the area should be monitored more frequently in the future. Depending on the availability of funding a specimen of stringer 18 lap splice could be subjected to accelerated corrosion testing thus allowing us to 'calibrate' the on-aircraft finding.

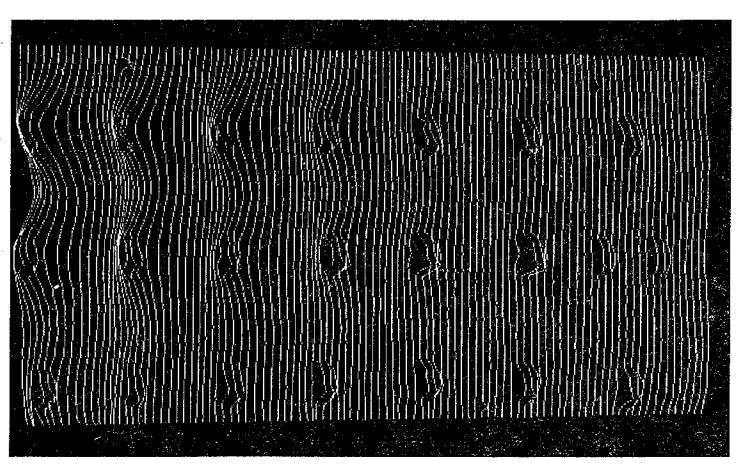
Figure 2: Surface profile of horizontal lap splice

The use of the amount of pillowing or surface height deflection as an indicator of corrosion presence and level is supported by surface traces of corroded and non-corroded areas on actual specimens. Figure 2 shows a two dimensional physical profile of a horizontal lap splice from a B-727. The figure clearly indicates that the surface pillowing or bulging between the rivets on the left side increases to a much higher degree than on the right side or along the bottom row of rivets. Eddy current scans between

the rivet rows indicate that the percent material loss in the areas of increased surface height reaches 25 percent in the top row and up to 15 percent in the second row. Such evidence supports the notion that the physical deformation of the upper surface has a direct relationship

to the presence and level of corrosion found below the surface. A D SIGHT image of this specimen is shown and discussed in chapter 6.

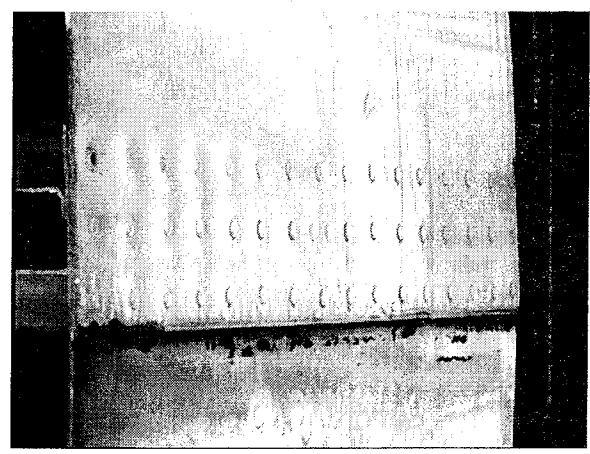
Figure 4: Painted lap splice without highlighting

Giving all surfaces a consistent yet temporary reflective finish is best accomplished through highlighting. This is a process whereby a thin liquid film is evenly applied to fill in the surface's microscopic roughness making it reflective without introducing a second liquid surface that may mask the underlying surface variations. For example, Figure 4 shows a DAIS captured view of a section of horizontal lap splice cut from a decommissioned aircraft. From the seam upwards the surface has a white, low gloss paint finish while below the seam the surface is bare aluminum. Although a slight amount of surface deformation is detected around the rivets on the left hand side, the image signatures are very low contrast and ill defined. Overall, the reflectivity of this surface is poor and uneven. Figure 5 illustrates the effect of highlighting this surface. All surface variations, including the "pillowing" around the left most rivets can now be seen clearly as bright white areas.

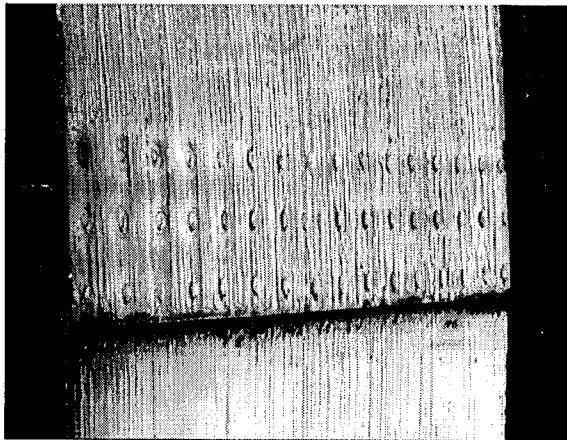
Figure 12:Highlighter streaks across the
sensor's view

Figure 13. The fluid in both illustrations has been applied with a paper towel to produce streaks far more severe than those produced by the sponge applicator. When the streaks travel across the sensor's field of view, as in Figure 12, they produce a distinct pattern of background noise which can disguise legitimate surface variations. When similar streaks are oriented to run along the sensor's view, as in Figure 13, they are much less objectionable.

Having cleaned the surface of interest allow it to stand briefly. Add about 3 ml. more fluid to the applicator sponge and give the surface an additional light coat. This final step is to produce an evenly distributed, ripple free film. Using light pressure, draw the applicator sponge smoothly over the surface using parallel strokes, much as if one were painting the surface. Although the sponge applicator tends to leave few streaks, every attempt should be made so that the finishing highlighting strokes are in a direction parallel to the field of view of the DAIS sensor. For example, since a DAIS sensor images along a lap splice, highlighting streaks should be made parallel to the splice. The effect of highlighting streaks is illustrated in Figure 12 and

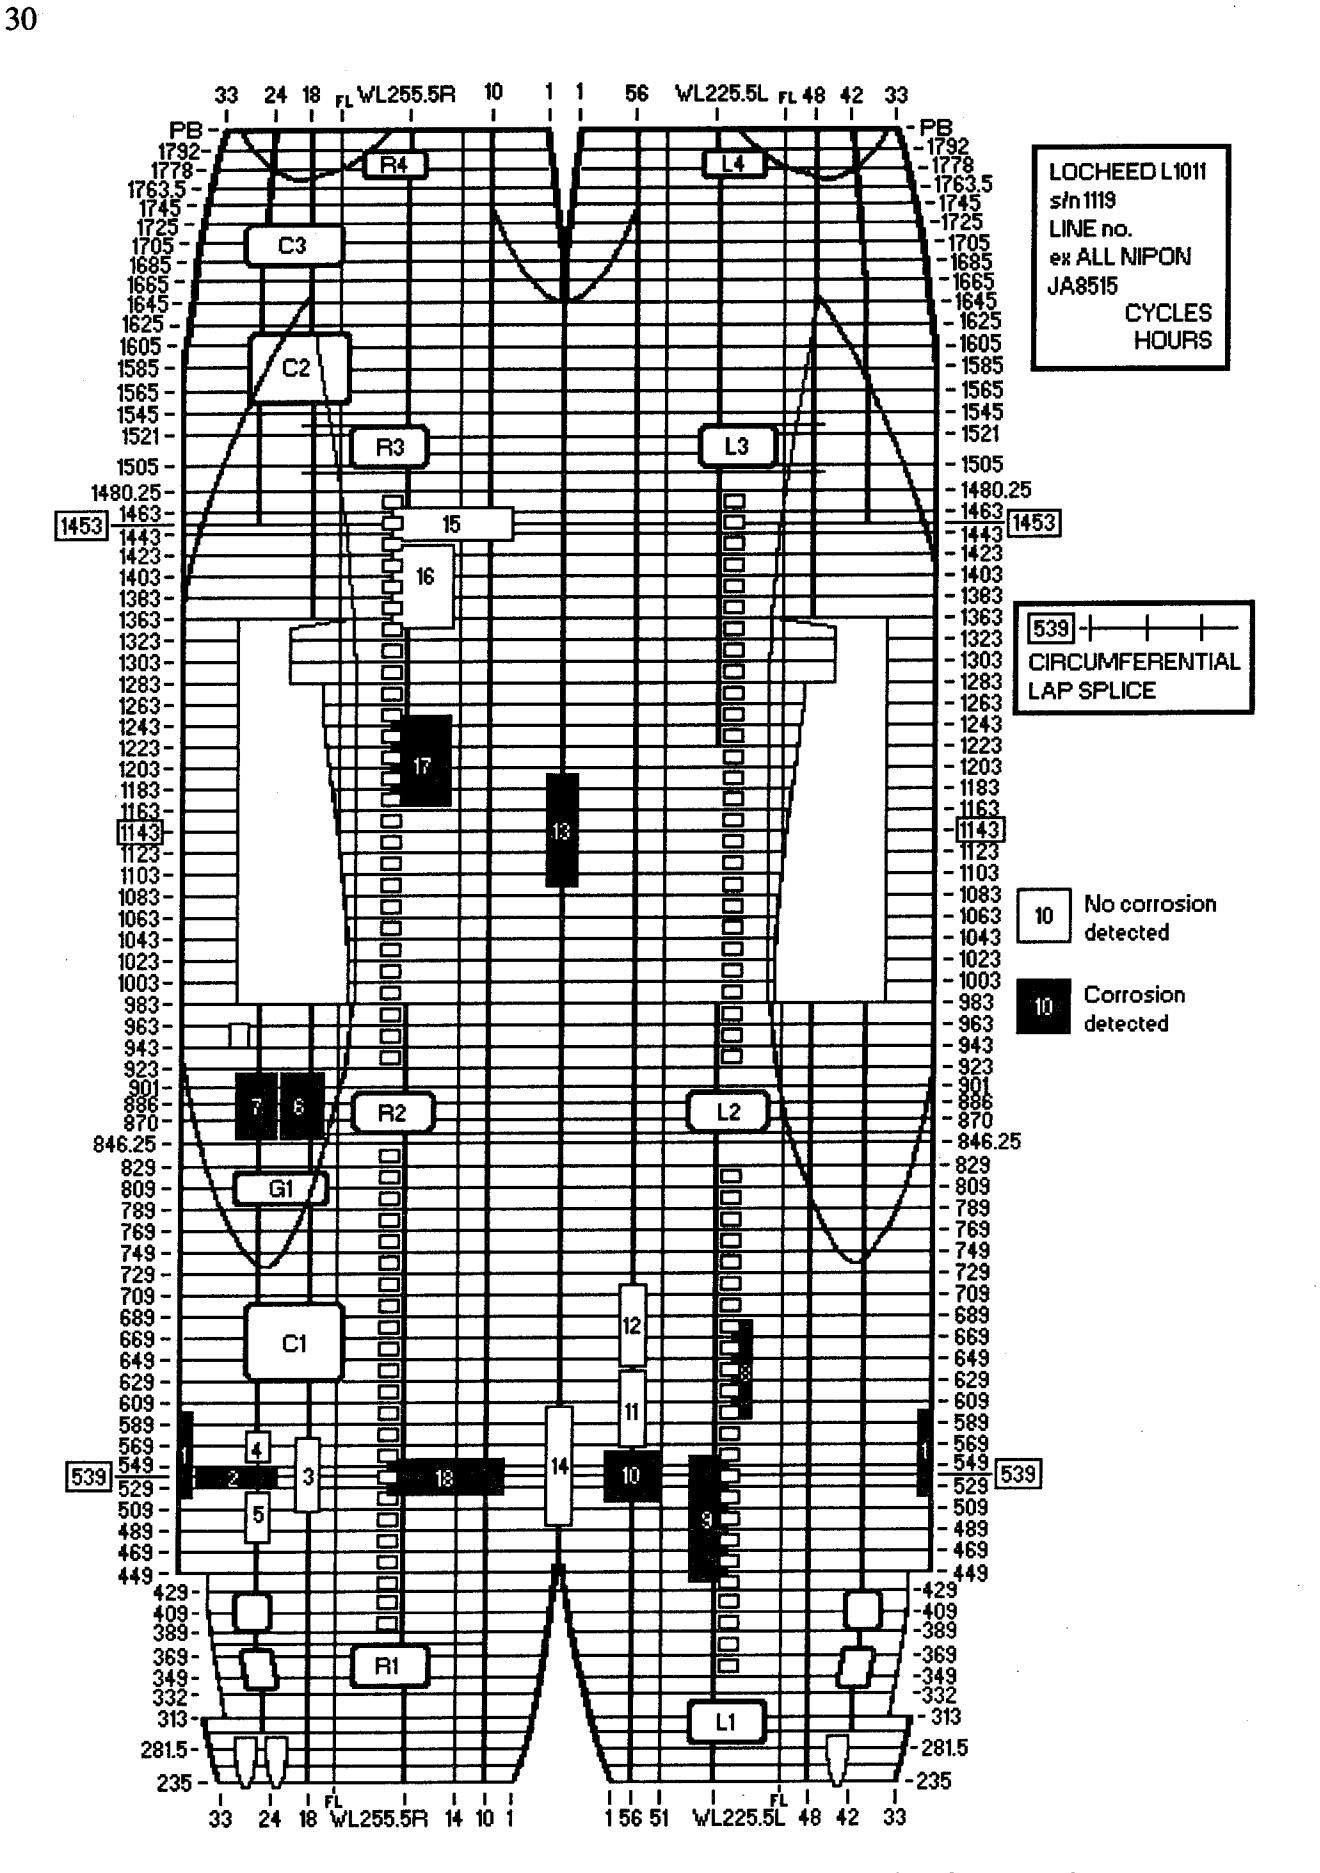
B727-N4747 SPECIMEN 4 IMAGE 1 - showing no corrosion Figure 5.1 Typical DAIS 250C D Sight images.

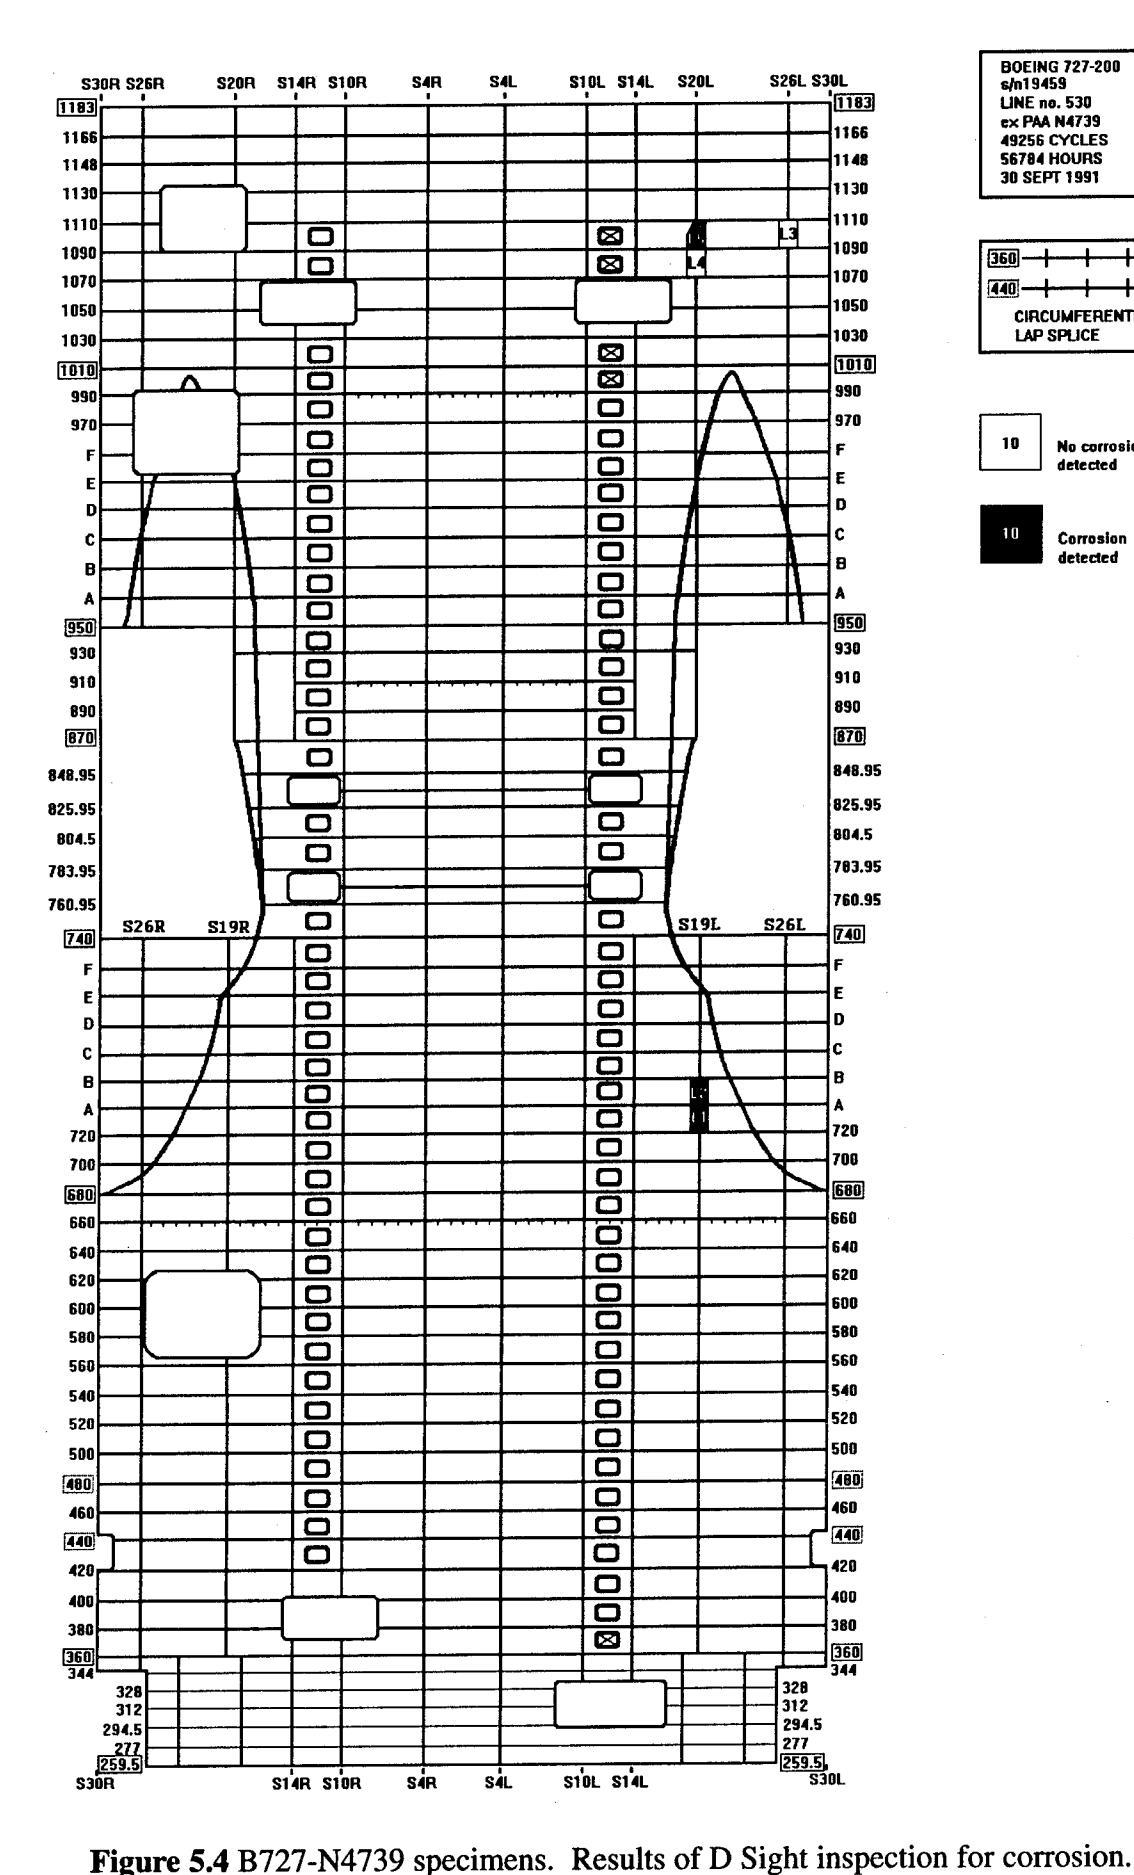
LINE no. 530 ex PAA N4739 49256 CYCLES 56784 HOURS 30 SEPT 1991 440 CIRCUMFERENTIAL LAP SPLICE 10 No corrosion detected 10 Corrosion

detected

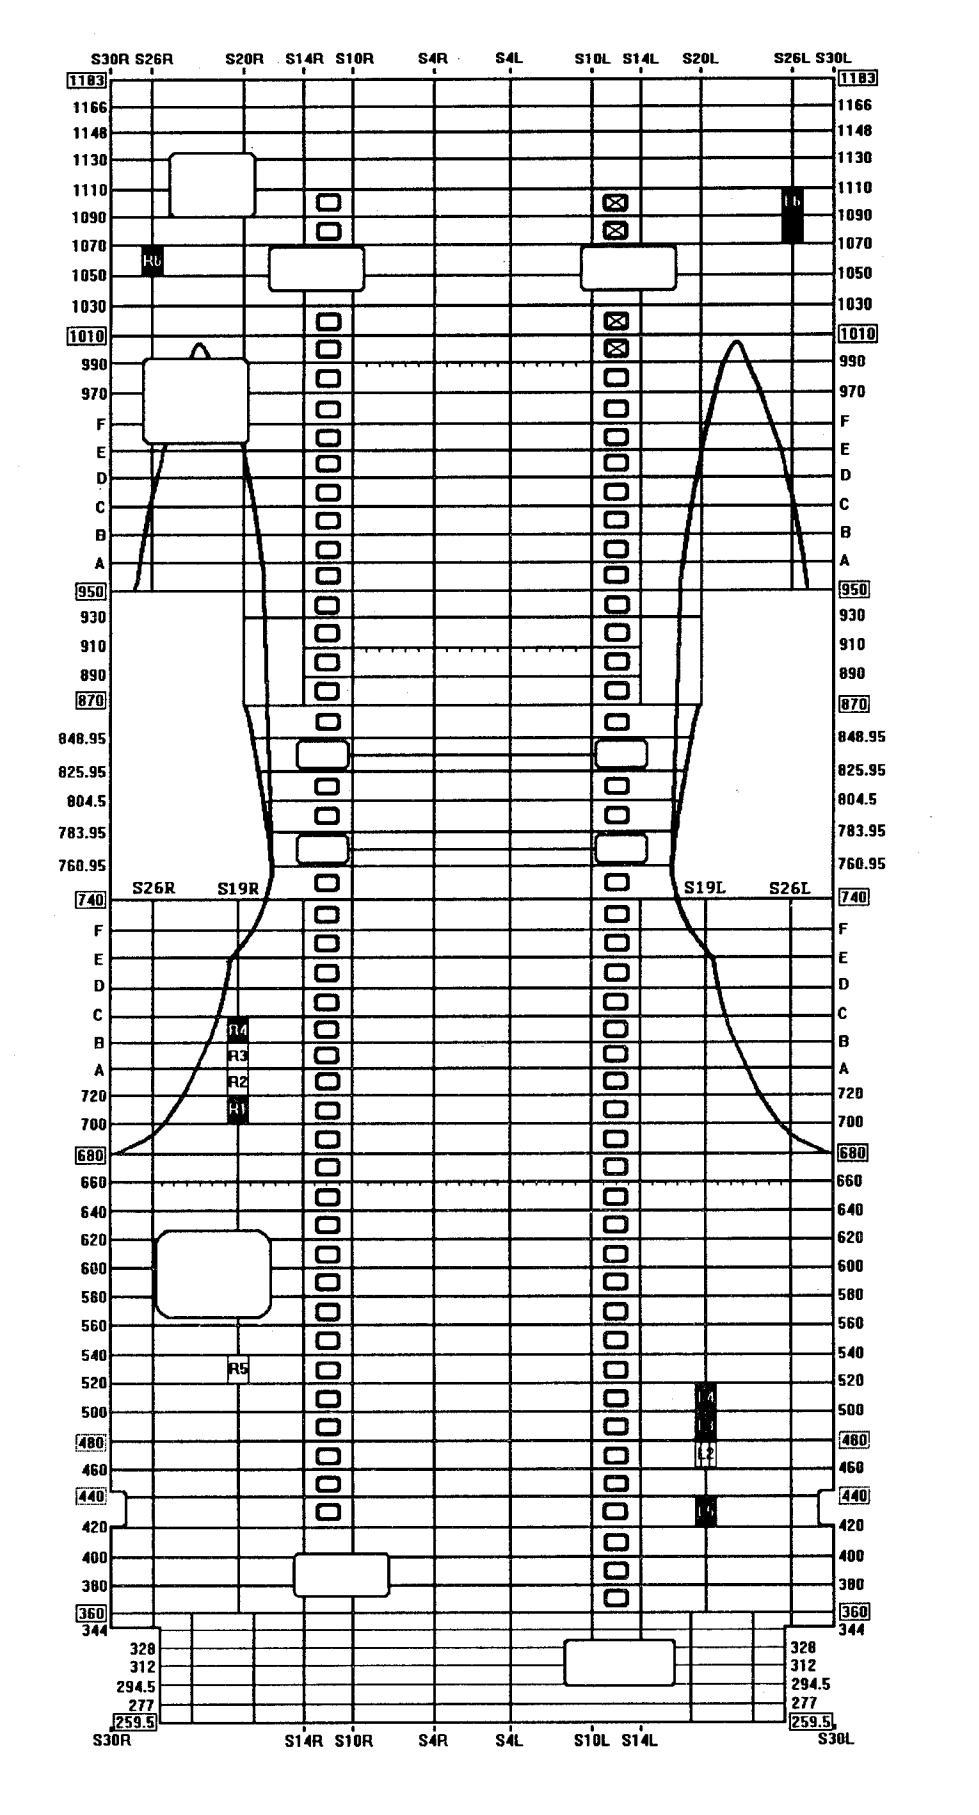
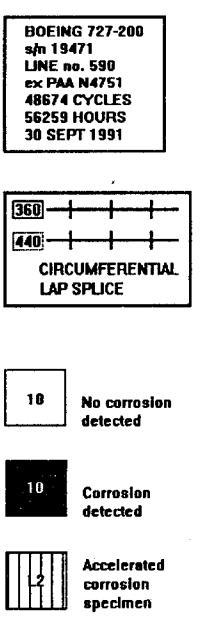
Figure 5.8 B727-N4751 specimens. Results of D Sight inspection for corrosion.

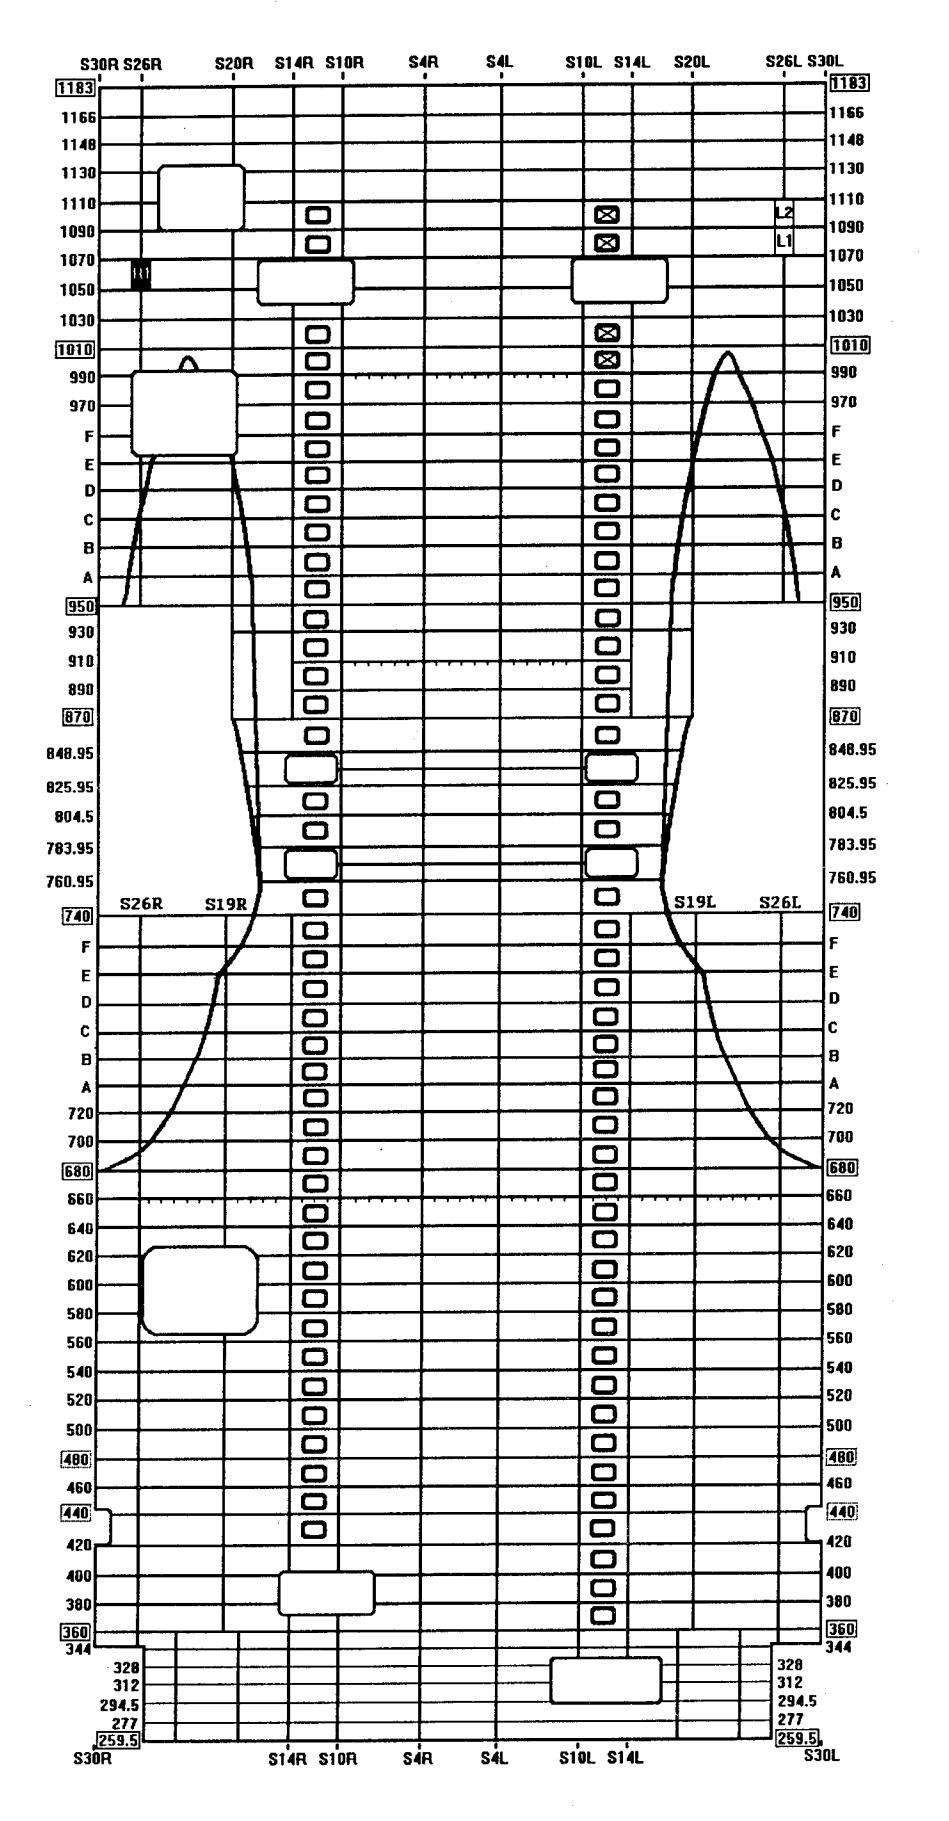
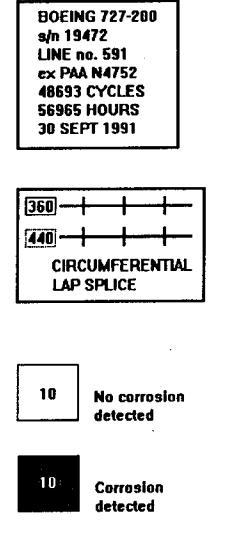
Specimen Number	Image Number	D Sight Image Comment and (construction of the joint)
L1		
L2		
R1		middle row slight pillowing

Figure 5.9 B727-N4752 specimens. Results of D Sight inspection for corrosion.

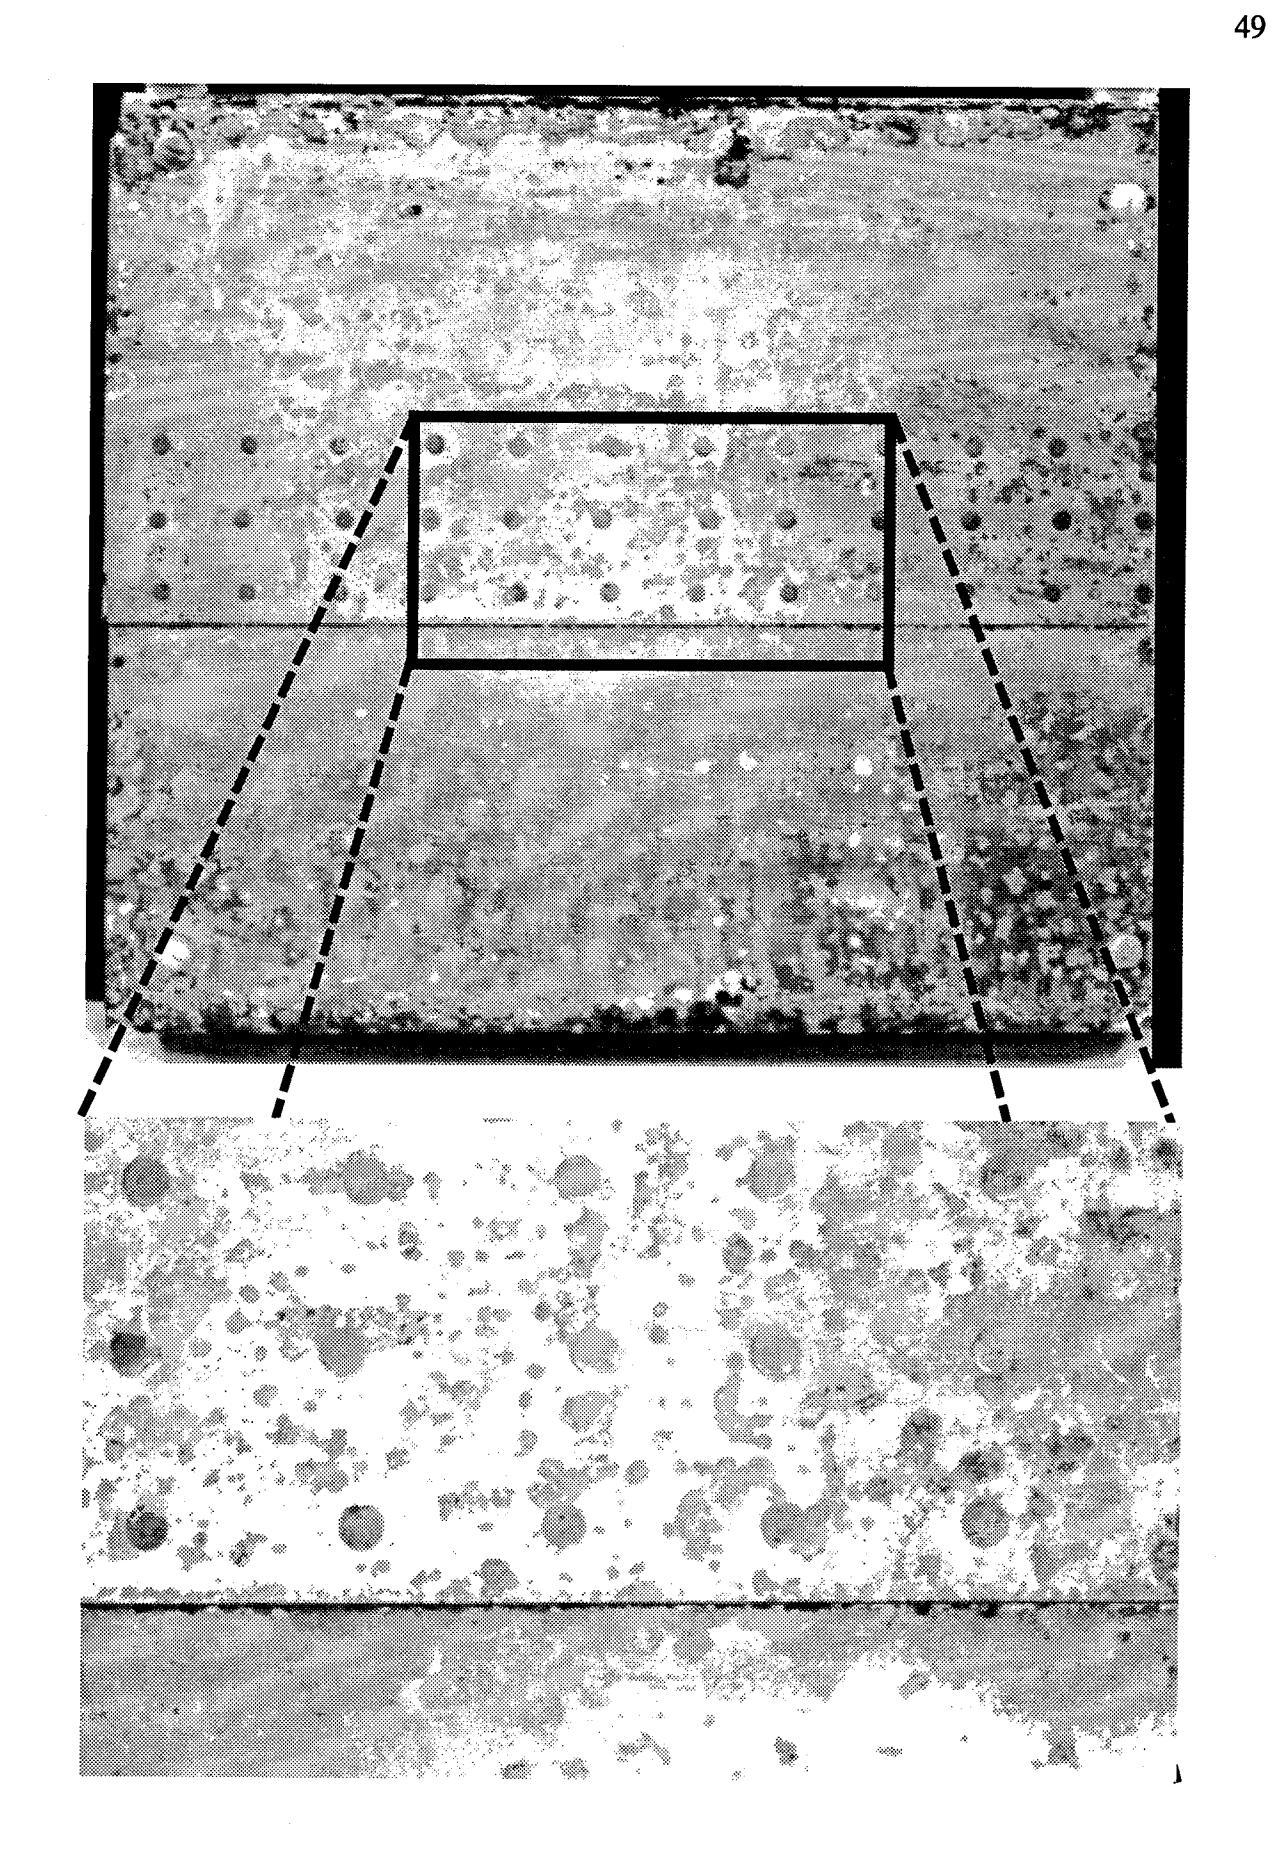
Figure 6.1 B727 specimen 43L6 ambient exterior view and close up.

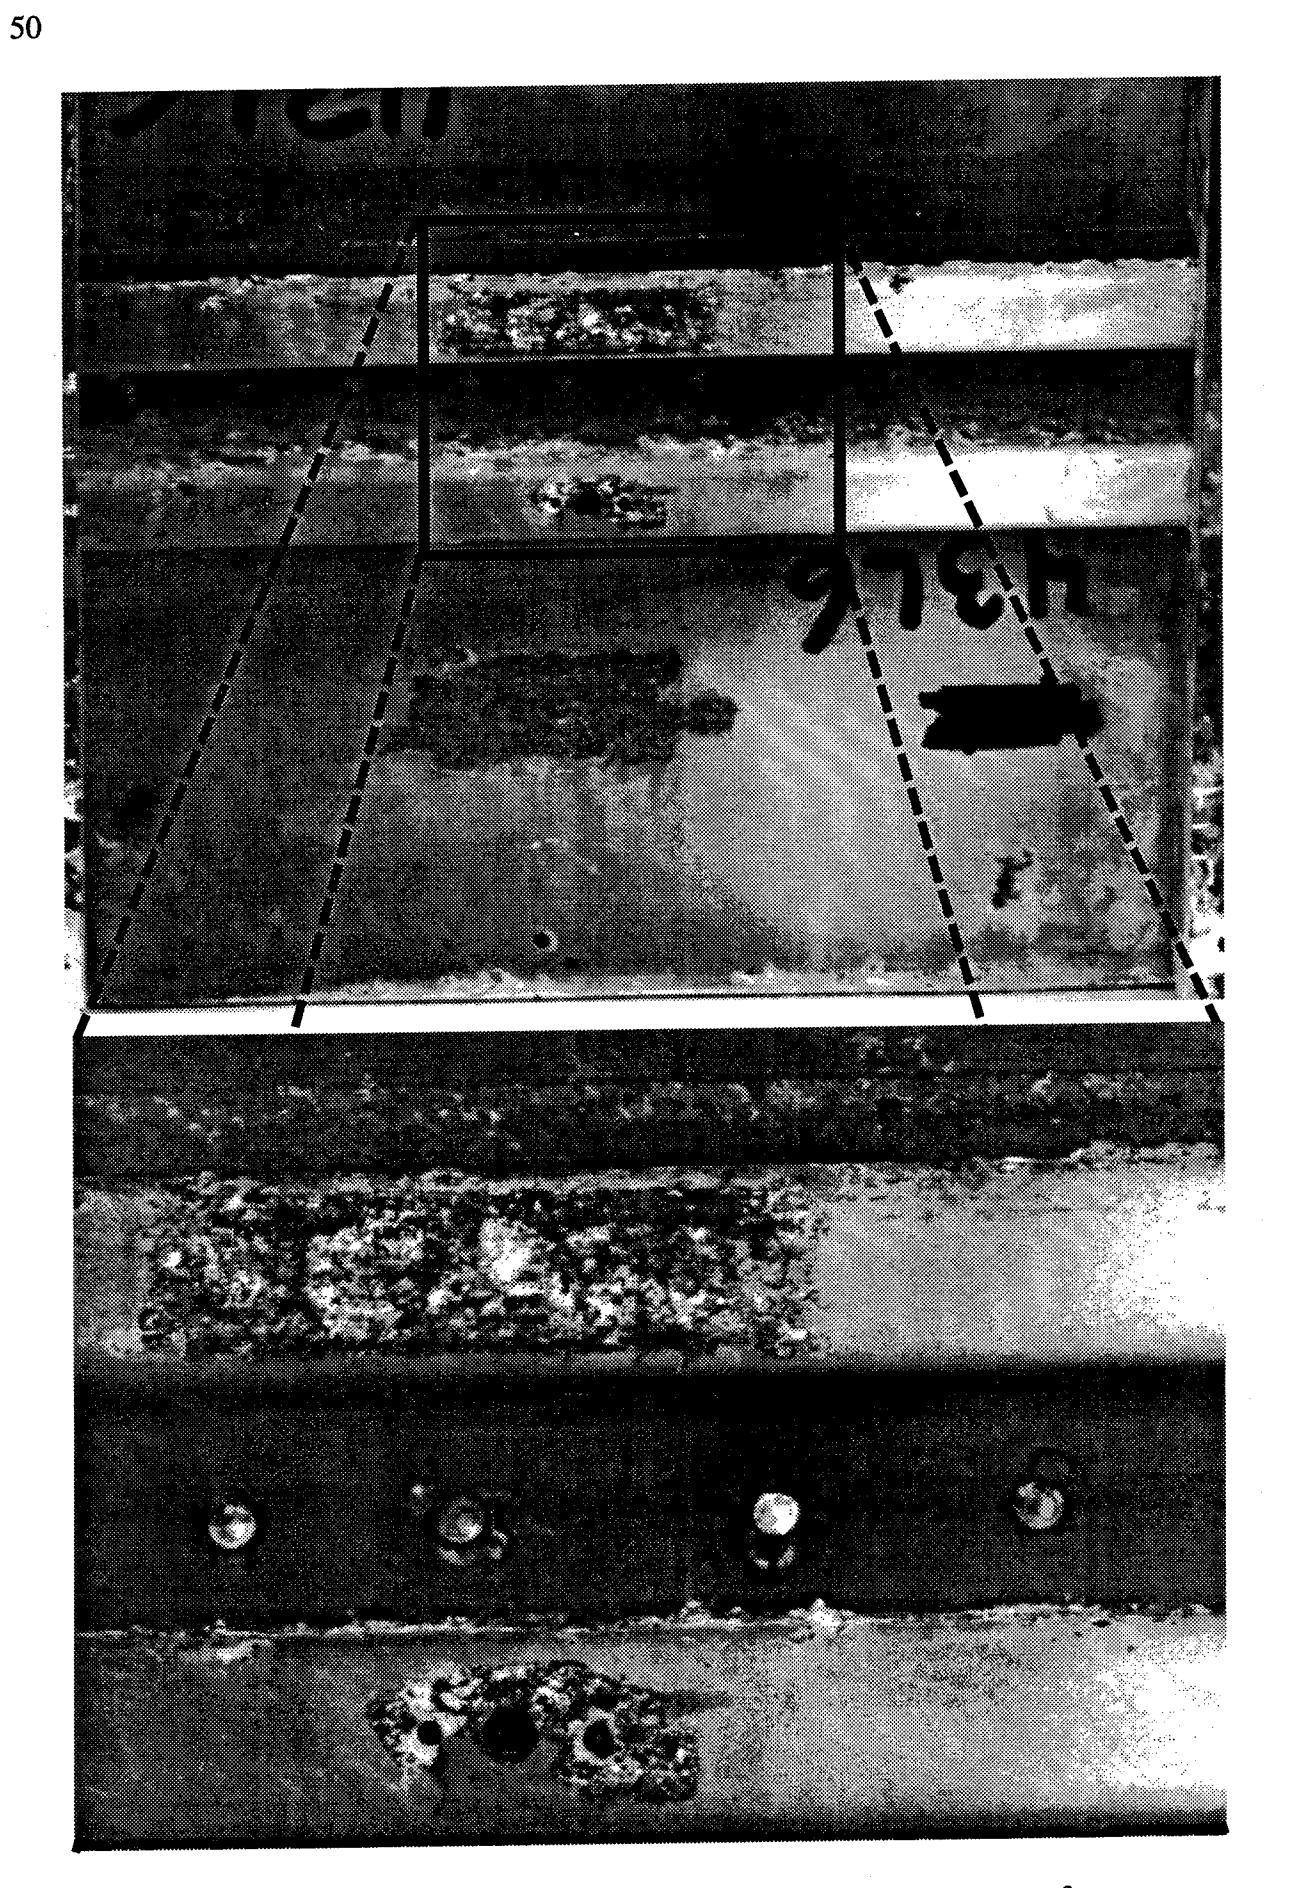
Figure 6.2 B727 specimen 43L6 ambient view and close up - rear surface.
