DOT/FAA/CT-94/56

Transportation Development Centre Montreal, Quebec, Canada Characterization of Corrosion and Development of a Breadboard Model of a D Sight Aircraft Inspection System: Phase I

August 1994

Final Report

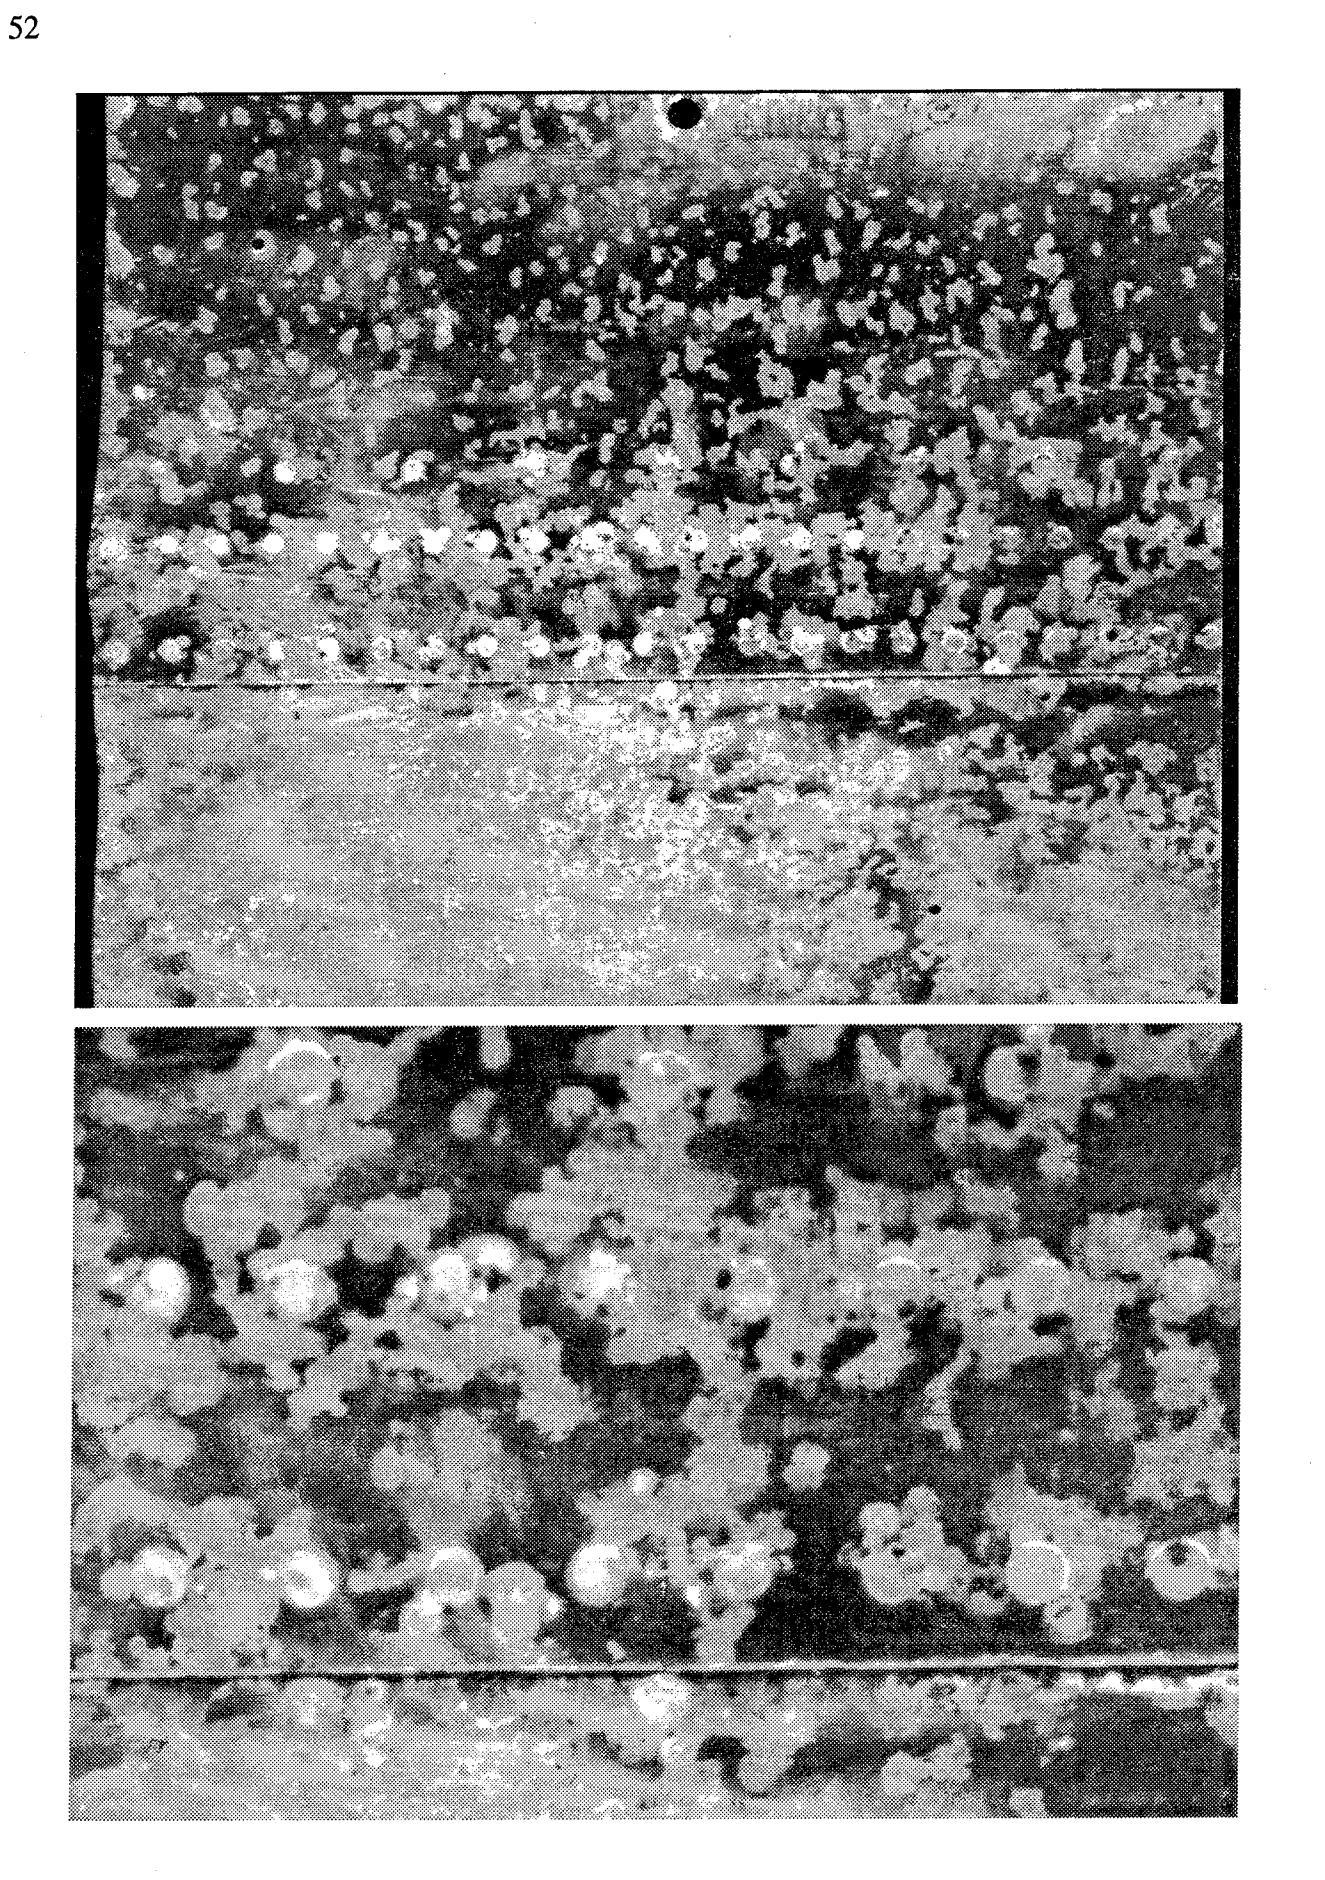
Figure 6.4 DC-9 Specimen 21A exterior surface and close up view.

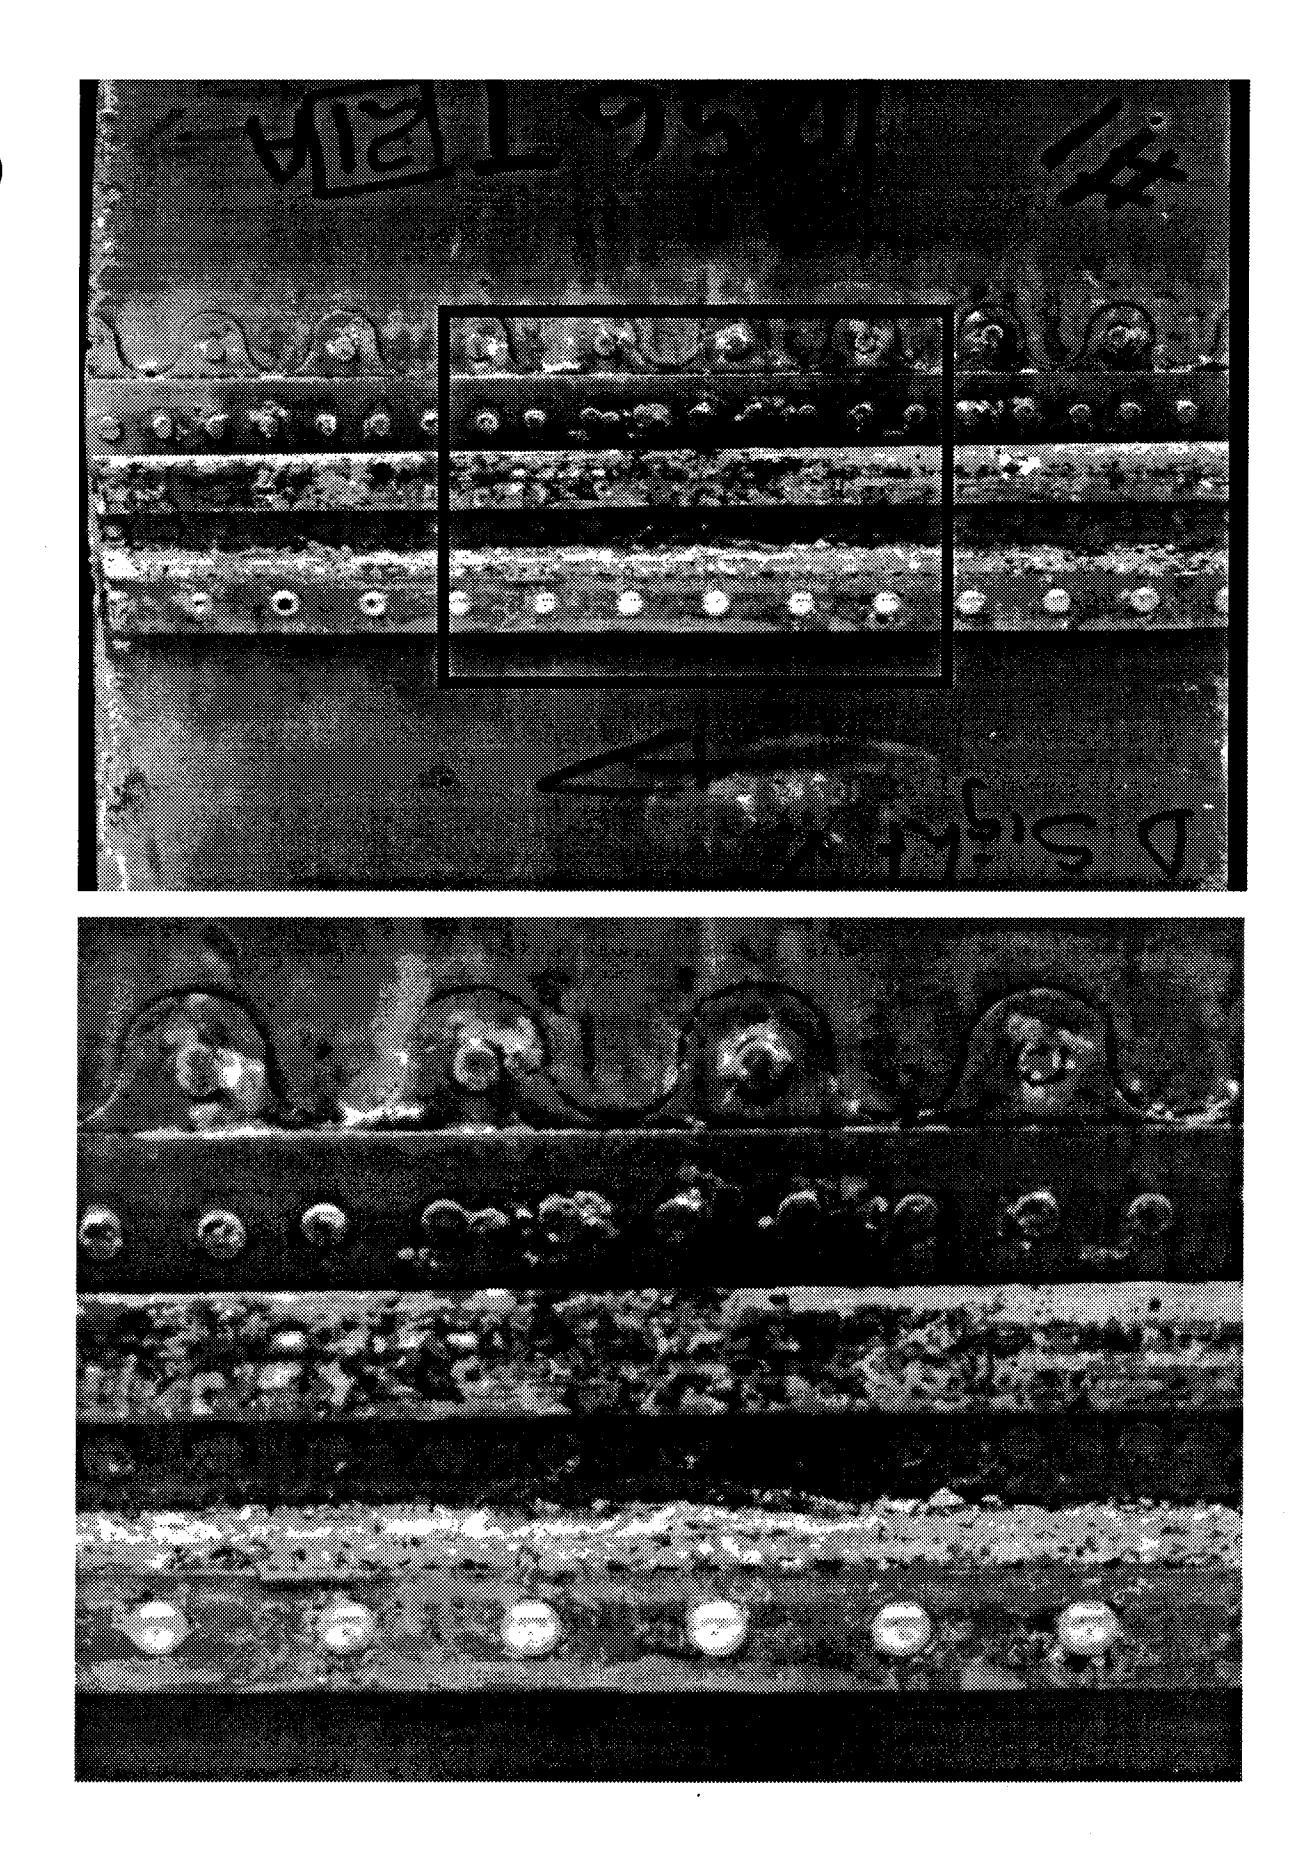
Figure 6.5 DC-9 Specimen 21A inner surface and close up view.

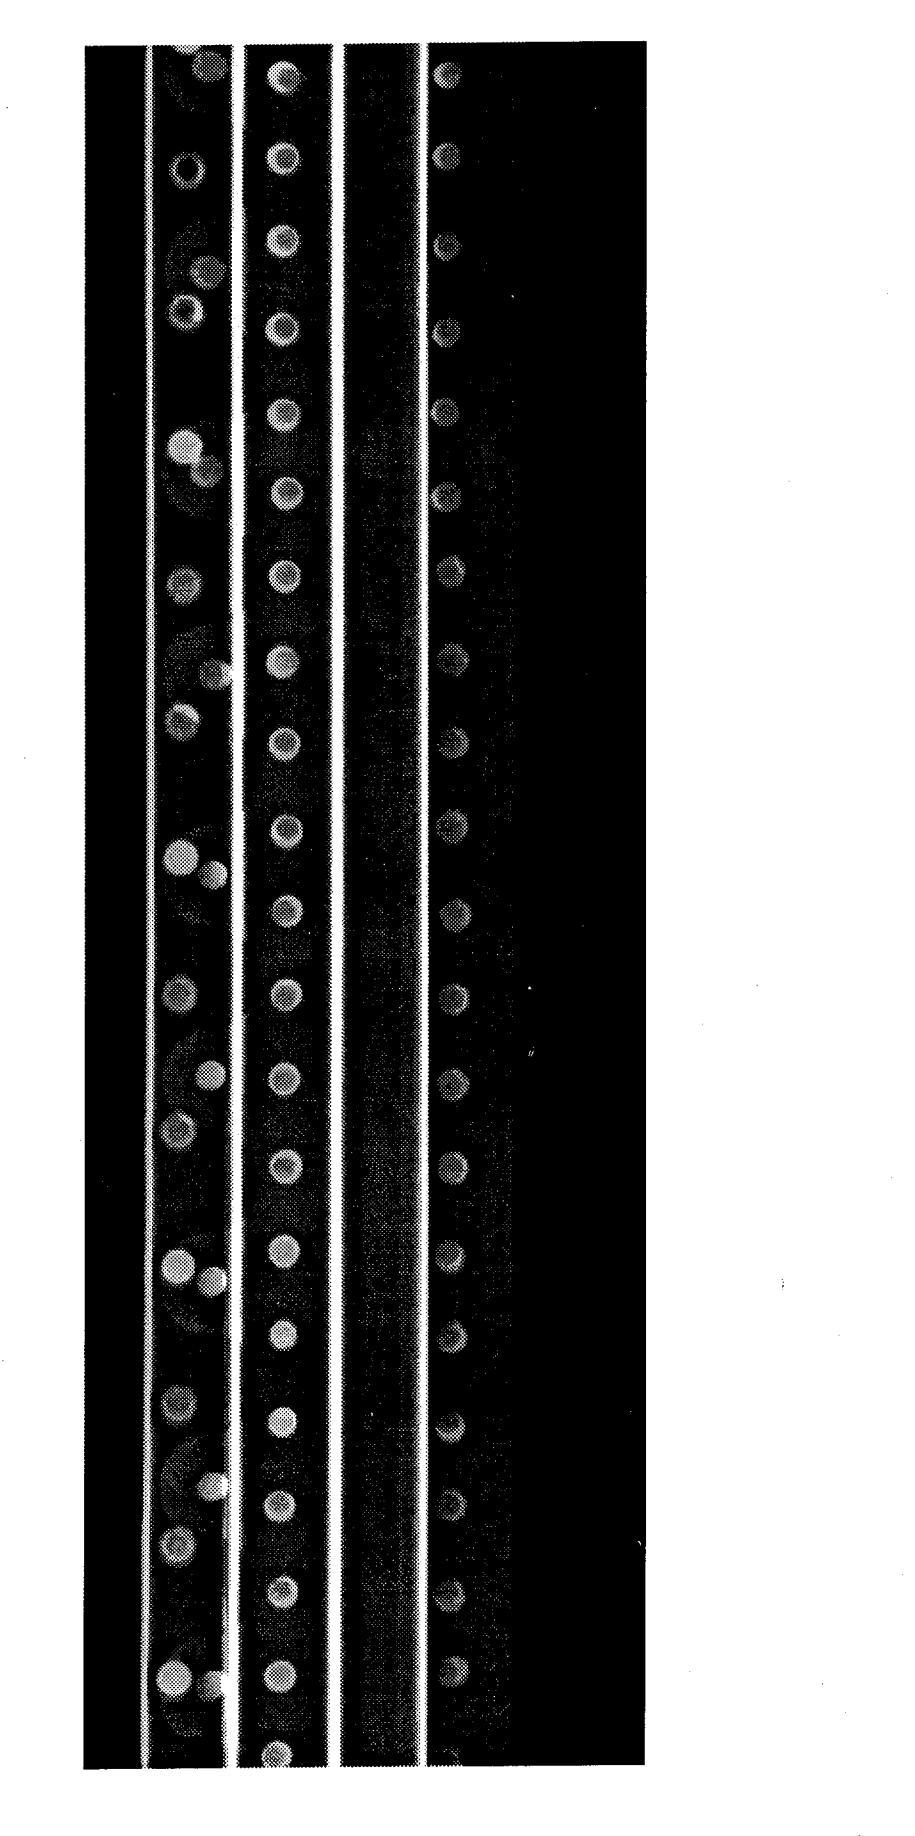
The results of the radiography inspection are illustrated in Figs.6.1 to 6.6. The ambient view photographs of the exterior and interior surfaces of the two lap joint specimens DC-9 Specimen 21A and Boeing 727 Specimen 43L6, taken after exposure to salt spray for a total of 1104 hours, are shown in Figs.6.1, 6.2 and Figs.6.4, 6.5 respectively, along with close-up views of the most heavily corroded sections. Figs. 6.3 and 6.6 are x-ray images of the DC-9-21A and B727-43L6 specimens respectively recorded at the end of the test. Significant amounts of corrosion are obvious in the ambient views of the interior and exterior surfaces of both specimens. Virtually no corrosion is identified in the x-ray of the DC-9 specimen (Fig.6.3). The x-ray of the Boeing 727 specimen (Fig.6.6) however, exhibits several dark areas which are indicative of corrosion within the lap joint.

Figure 6.6 DC-9 Specimen 21A radiograph - 1104 hours exposure to accelerated corrosion.

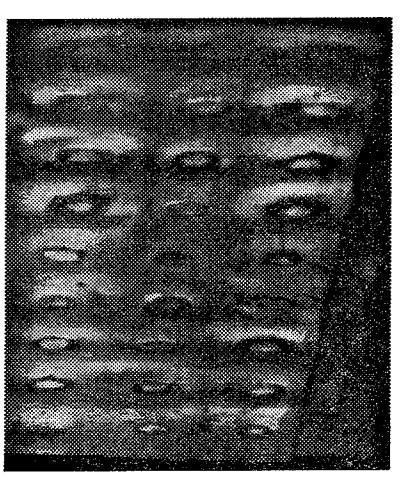
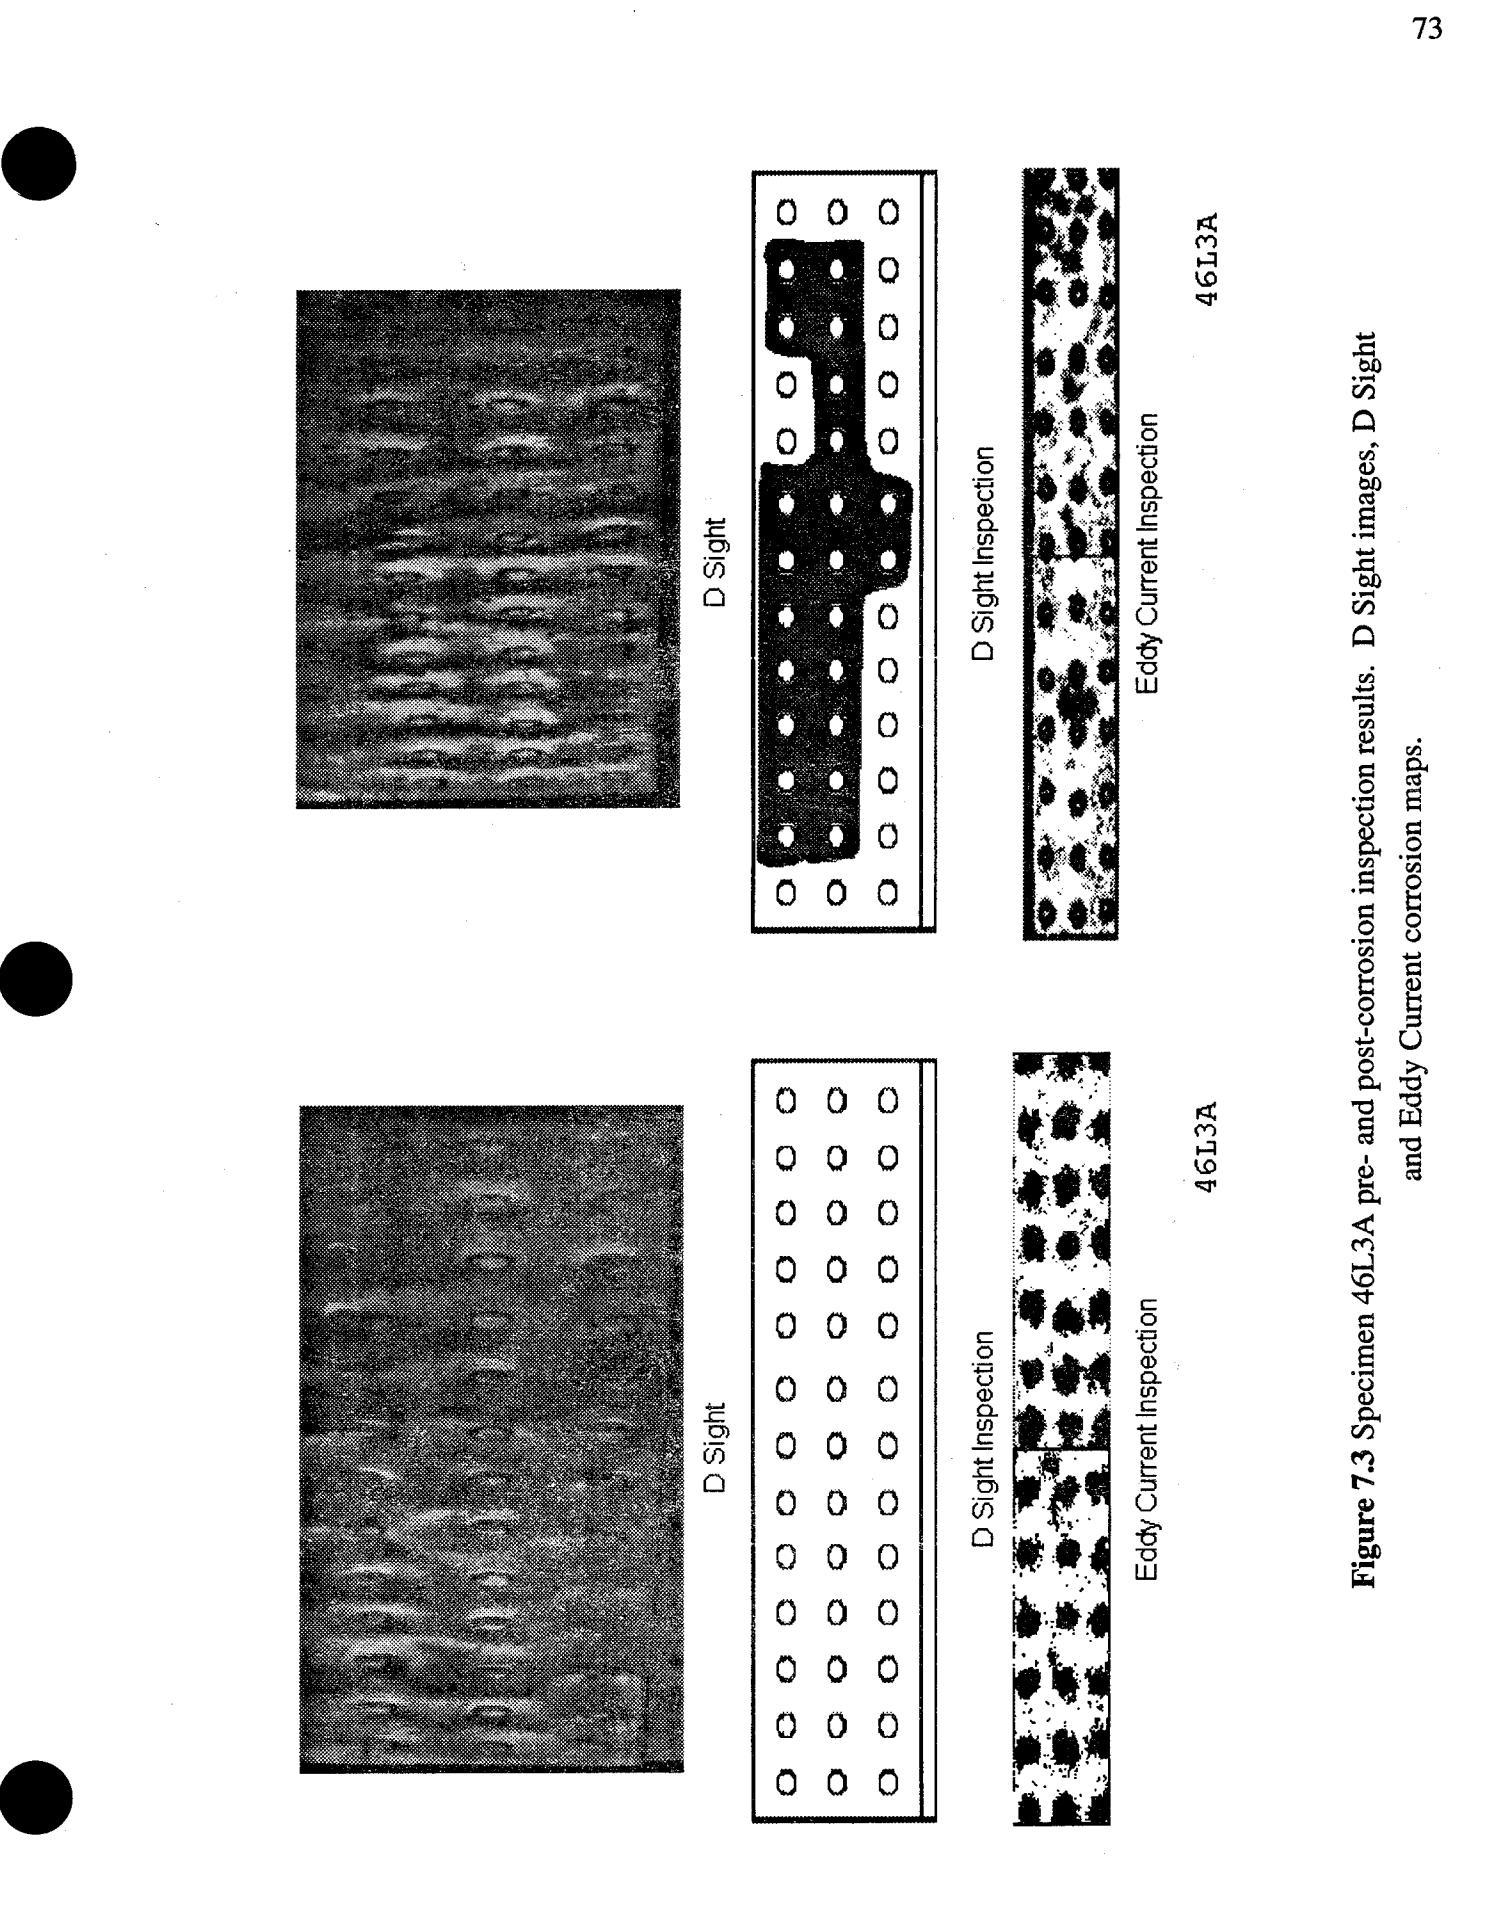
Figure 7.4 Specimen 46L3C pre- and post-corrosion inspection results. D Sight images, D Sight

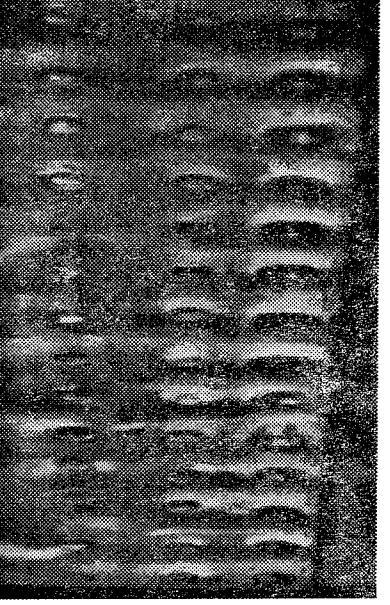
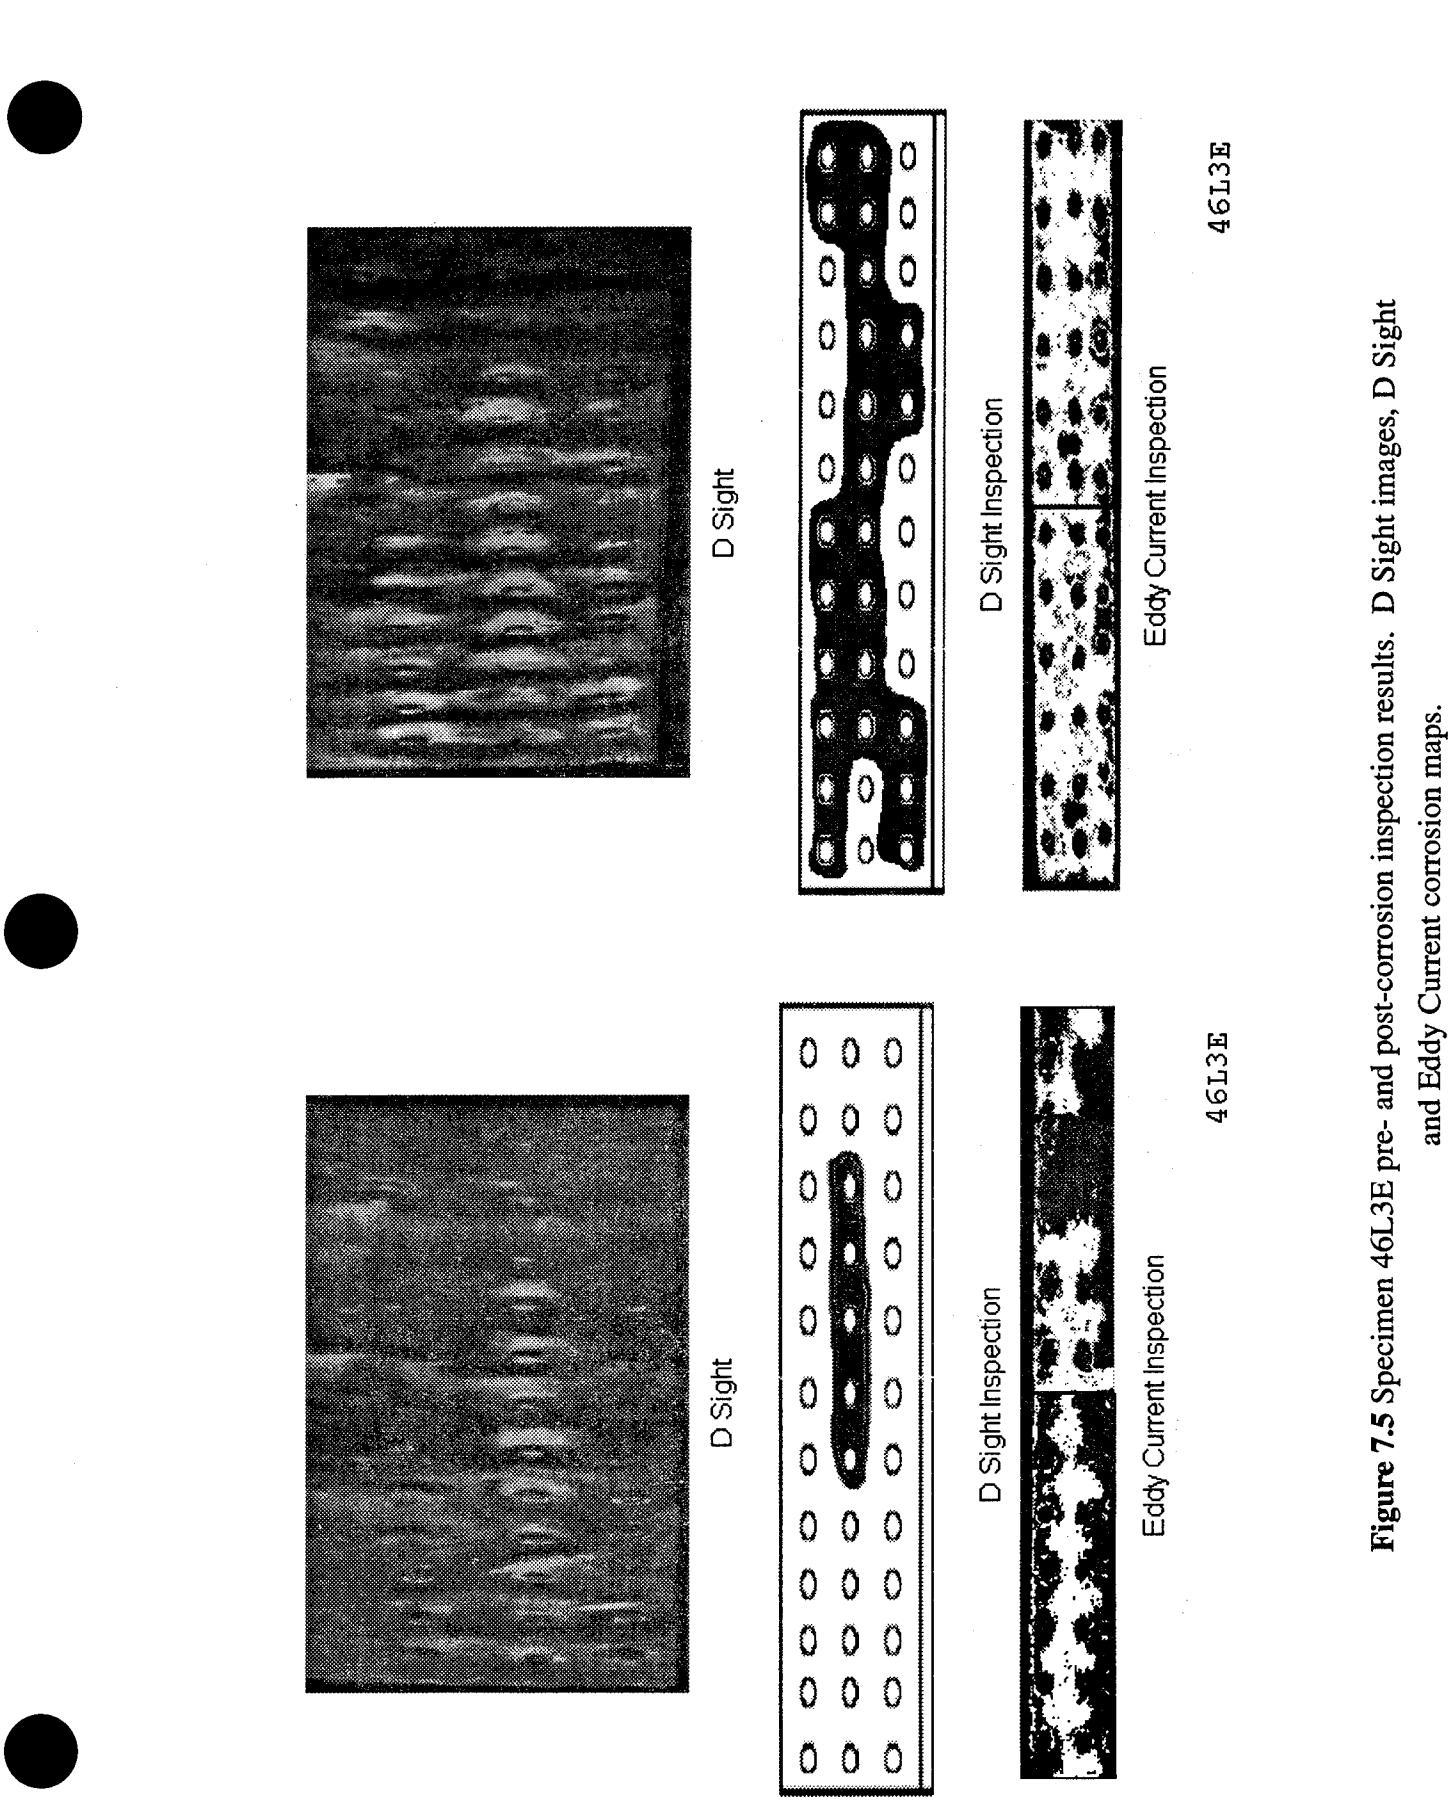
Figure 7.6 Specimen 46L4A pre- and post-corrosion inspection results. D Sight images, D Sight

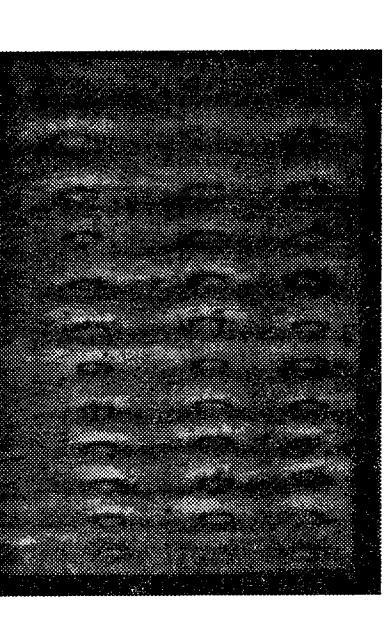
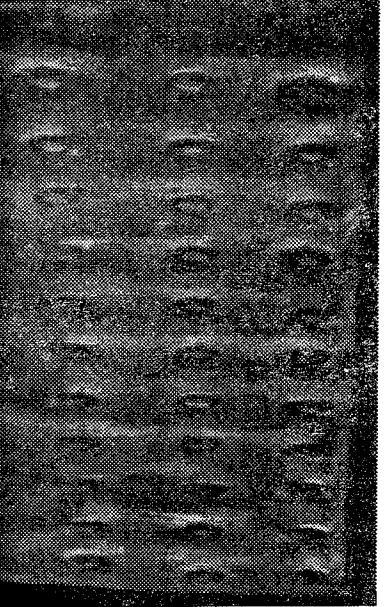
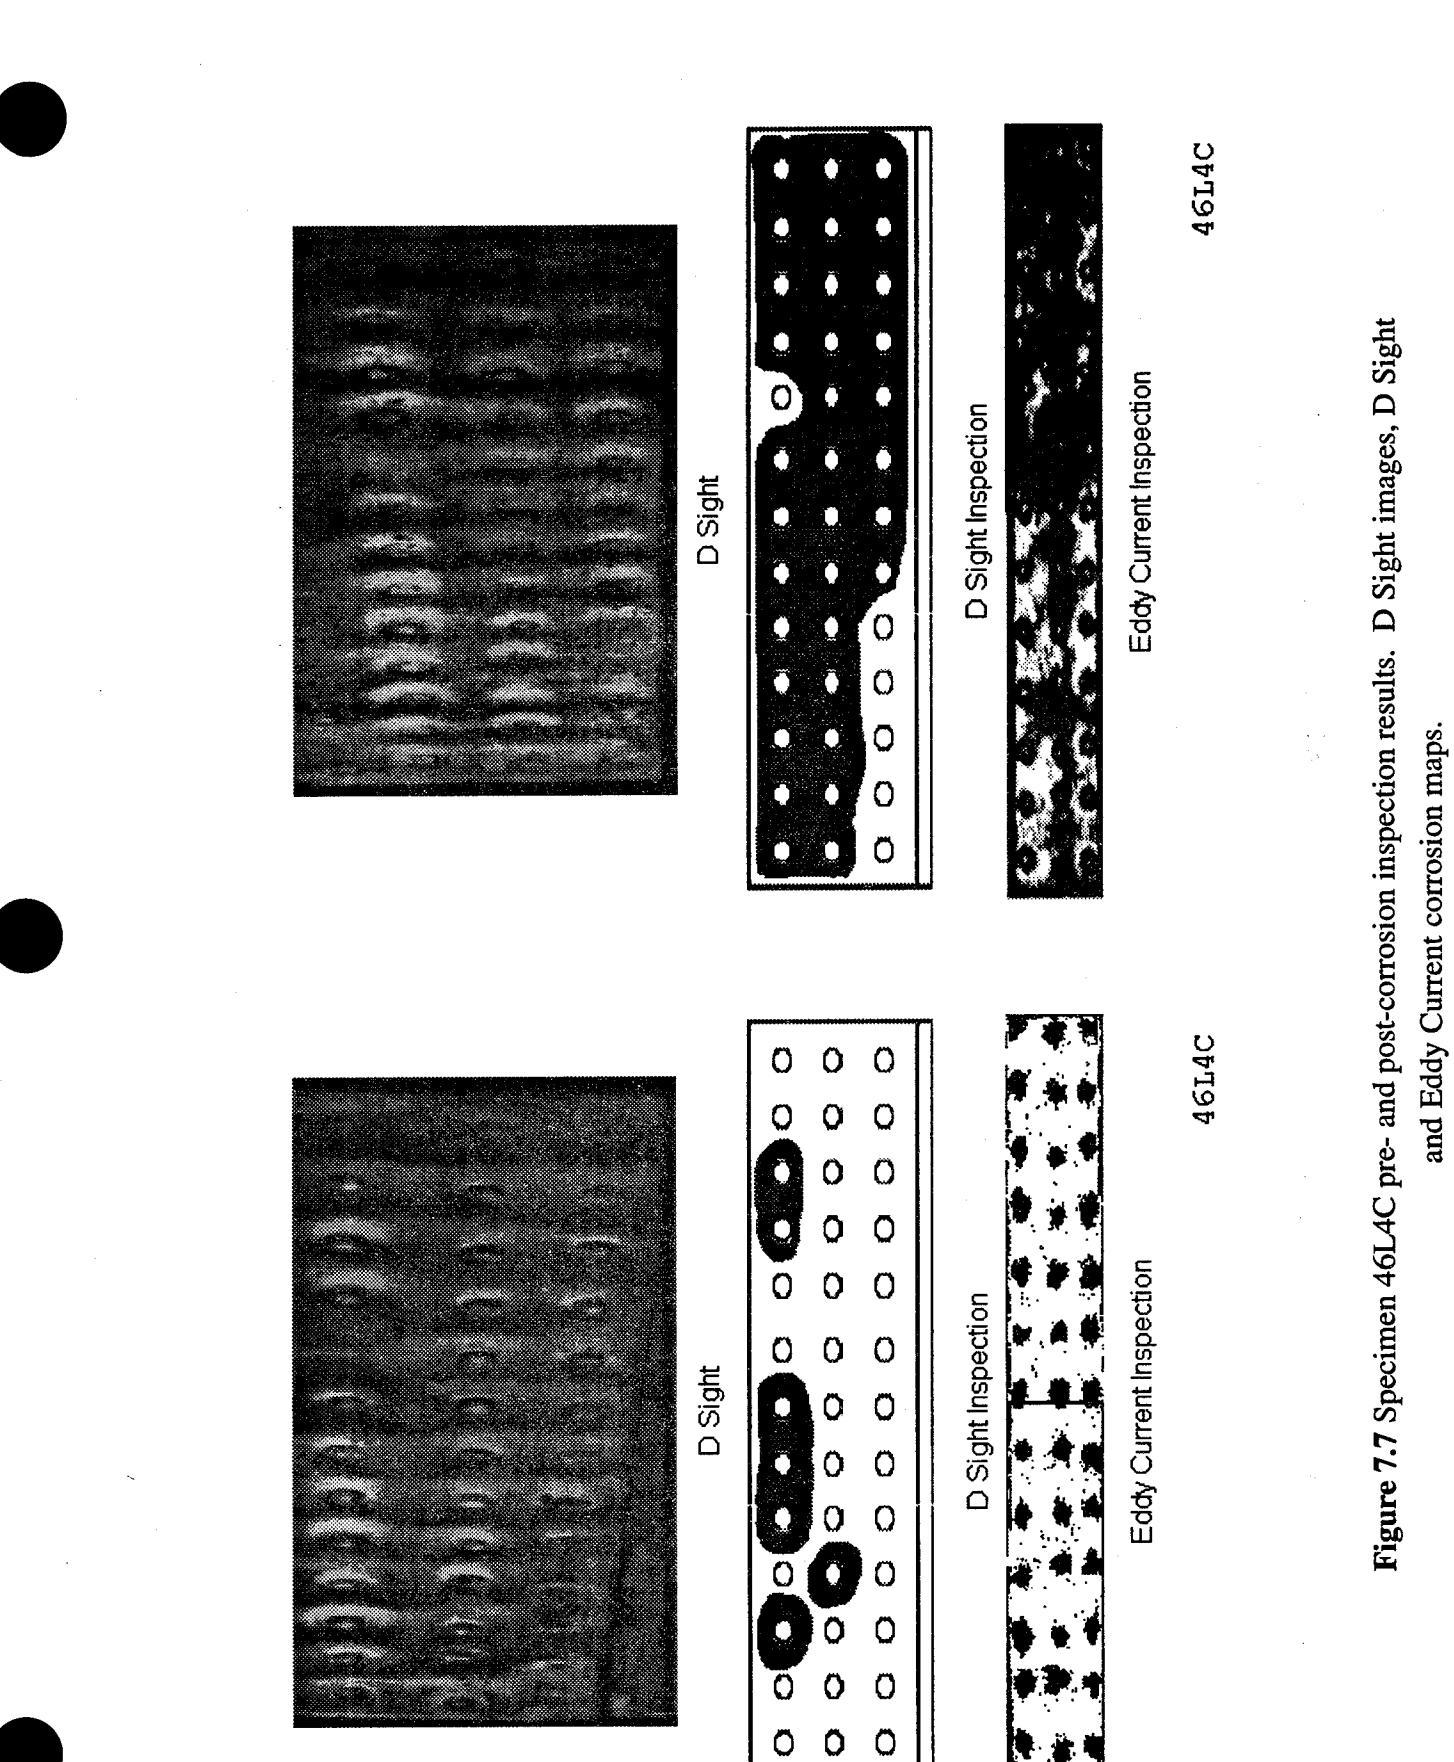
Figure 7.8 Specimen 51L2 pre- and post-corrosion inspection results. D Sight images, D Sight and

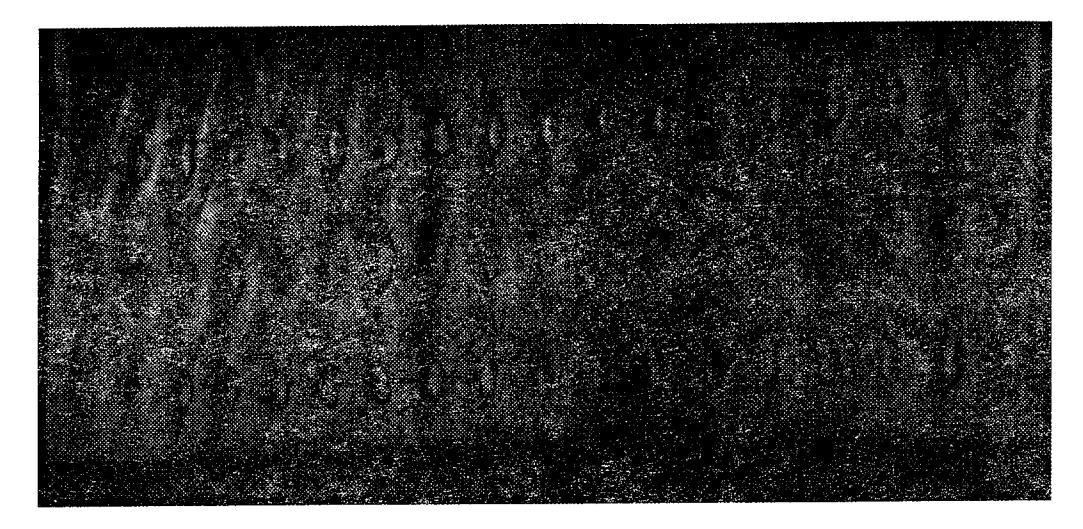
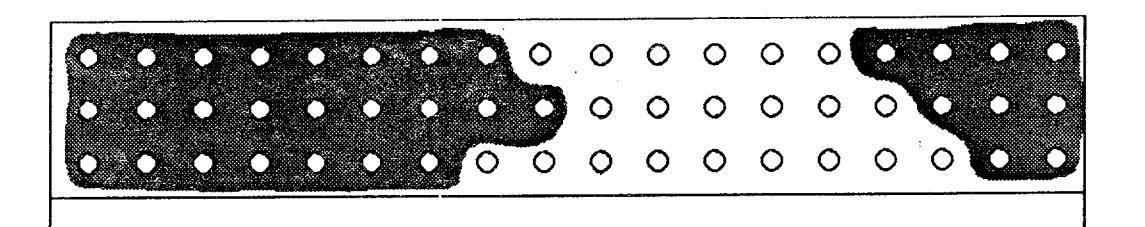
Only two specimens were subjected to tear down subsequent to D Sight inspections and these are shown in Figures 7.10 and 7.11. In both specimens the correlation is excellent.

Figure 7.10 Specimen 51L1 D Sight and teardown maps of corrosion.

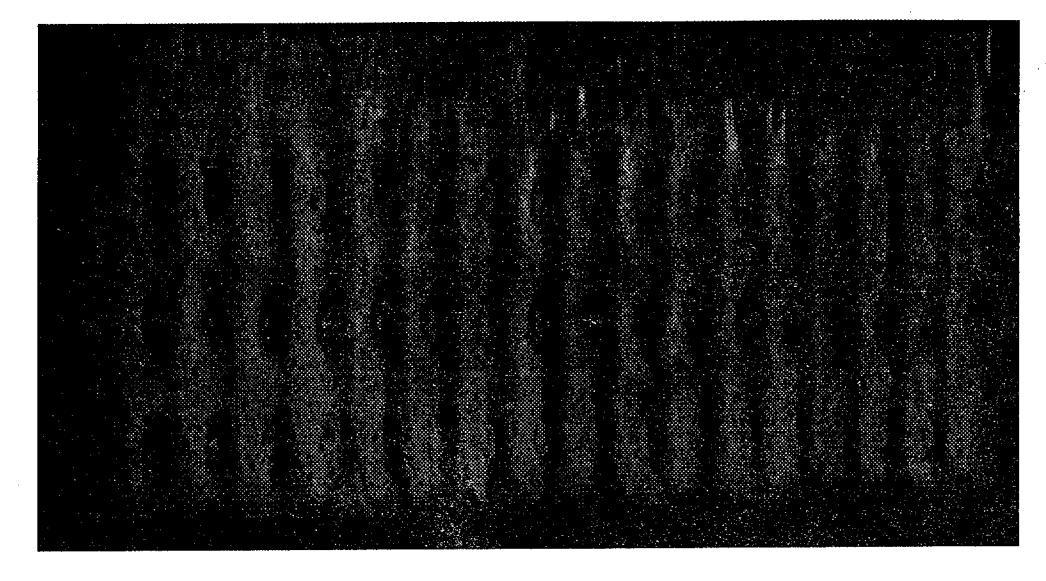
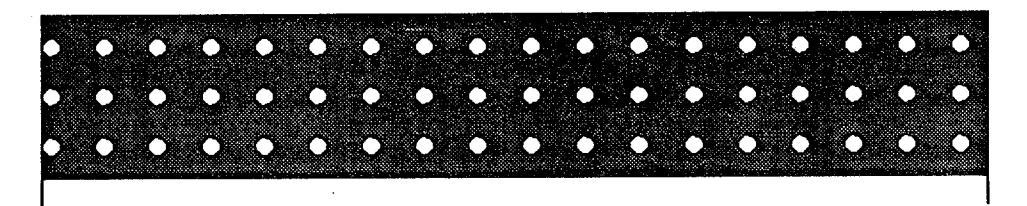
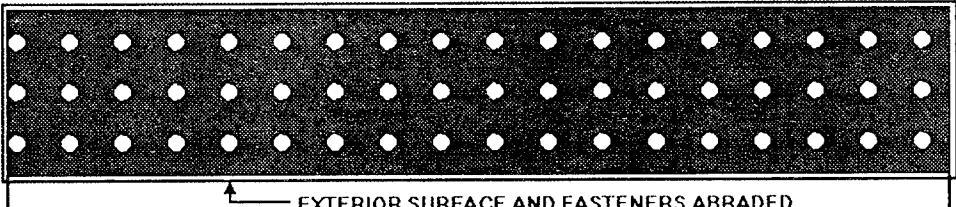
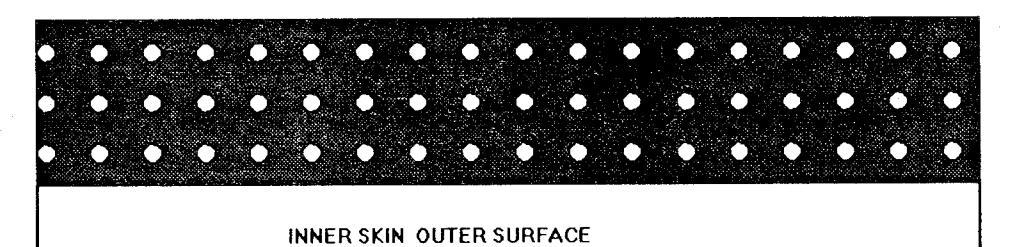
**TEARDOWN INSPECTION OF SPECIMEN B727 51L6**

Figure 7.11 Specimen 51L6 D Sight and teardown maps of corrosion.
