**DOT/FAA/AR-96/119**

# **Vertical Drop Test of a Beechcraft 1900C Airliner**

Robert McGuire and Dr. Tong Vu

Final Report

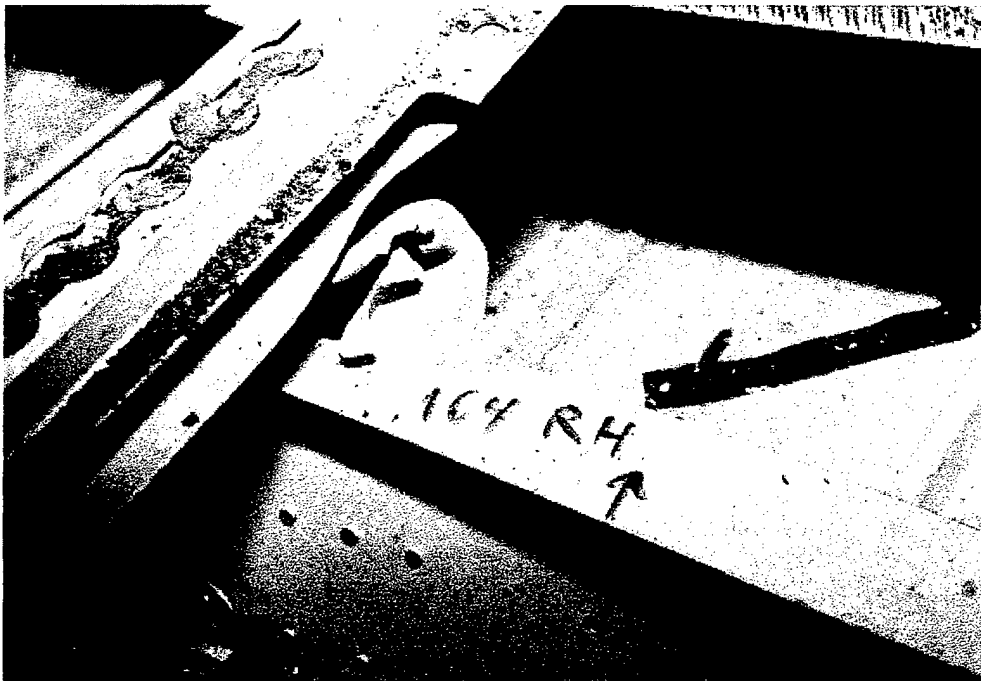
FIGURE 19. UNDERFLOOR BUCKLING R/H SIDE, AFTER IMPACT

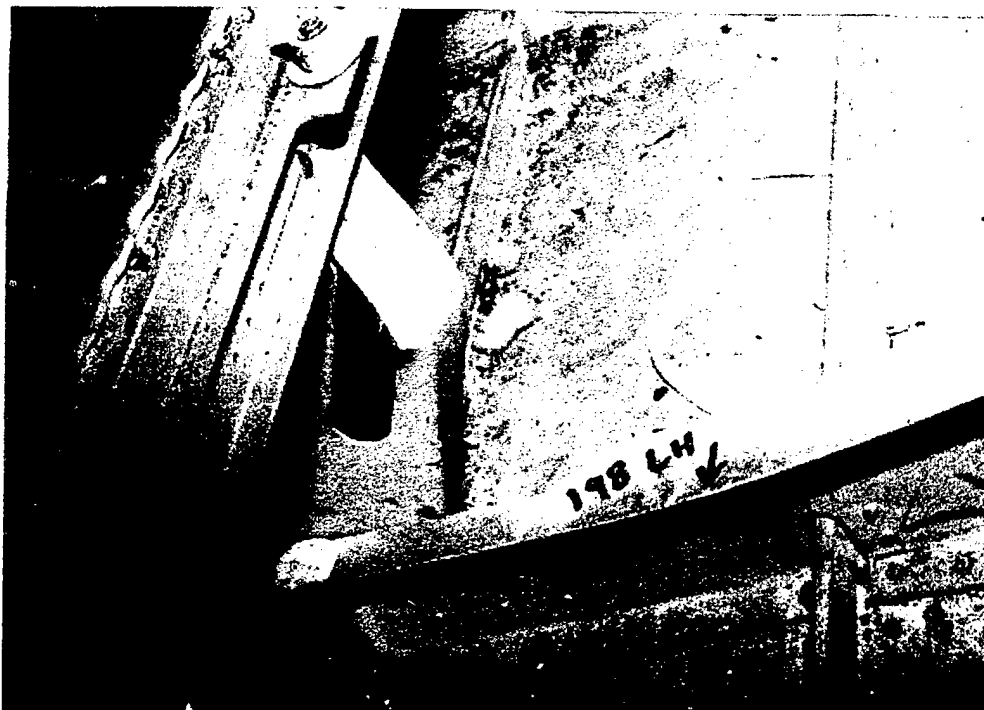
FIGURE 20. UNDERFLOOR BUCKLING L/H SIDE, AFTER IMPACT

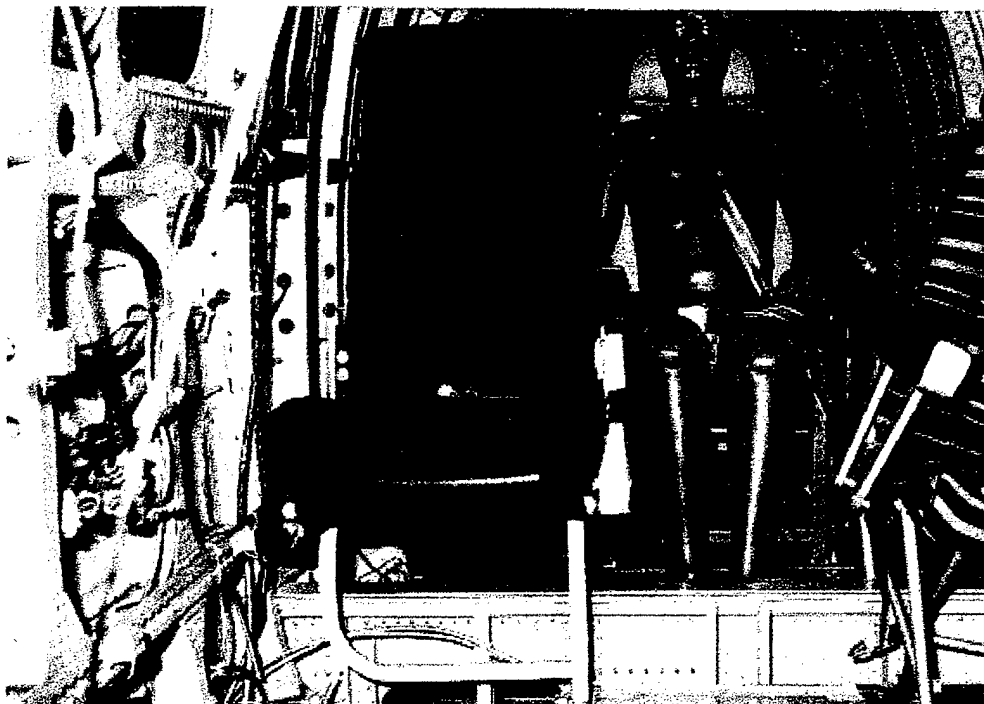
FIGURE 26. PTC SEAT, AFTER IMPACT

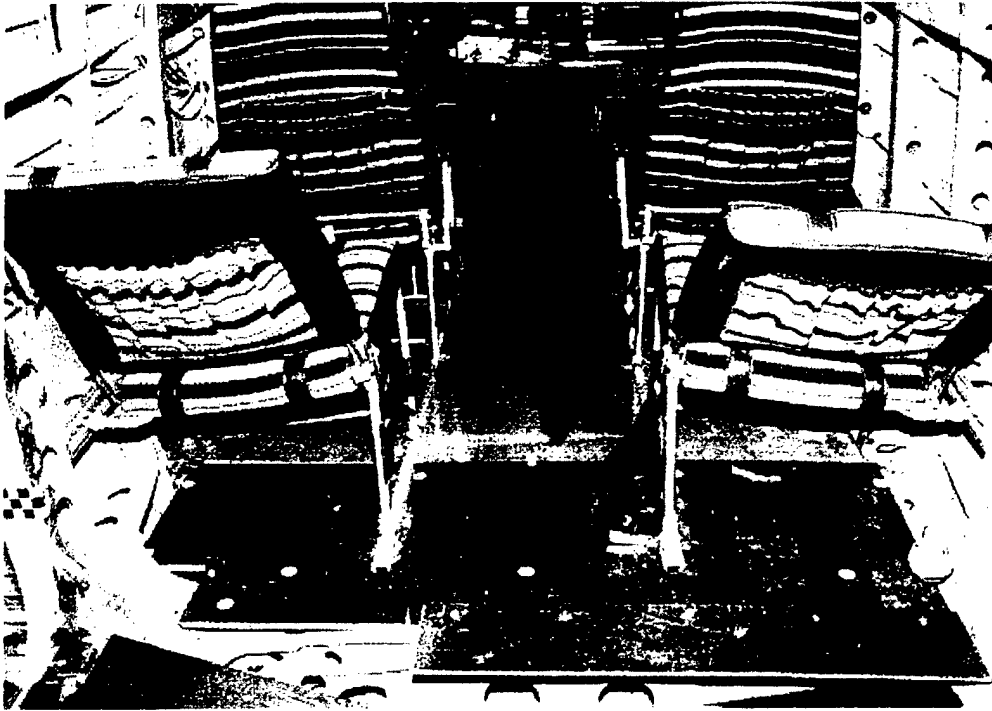
FIGURE 32. STANDARD BEEHCRAFT SEATS (BROWN), AFTER IMPACT

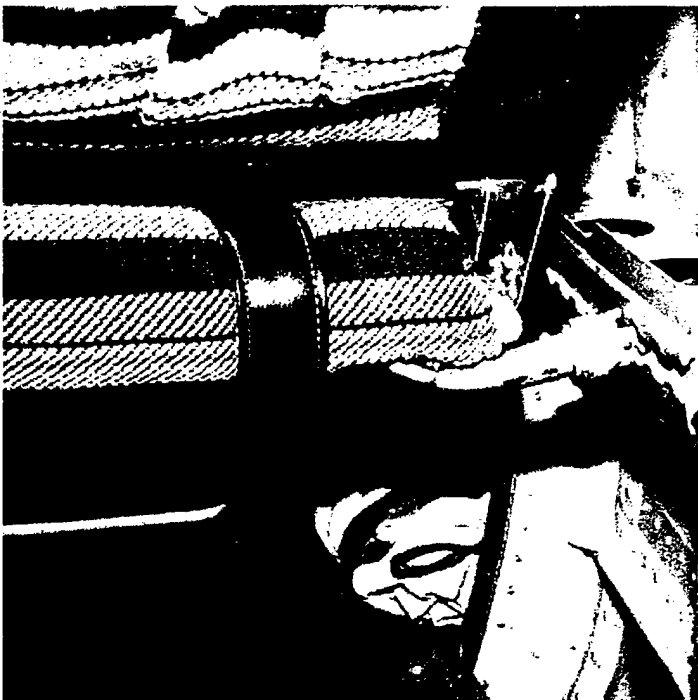
FIGURE 33. STANDARD BEEHCRAFT SEAT (BROWN), AFTER IMPACT
