ESL-TR-91-13  
VOL II

**EXPEDIENT REPAIR OF STRUCTURAL  
FACILITIES (ERSF) - VOLUME II: ERSF  
SYSTEM REQUIREMENTS AND USERS  
GUIDE**

**JULY 1991**

**FINAL REPORT**

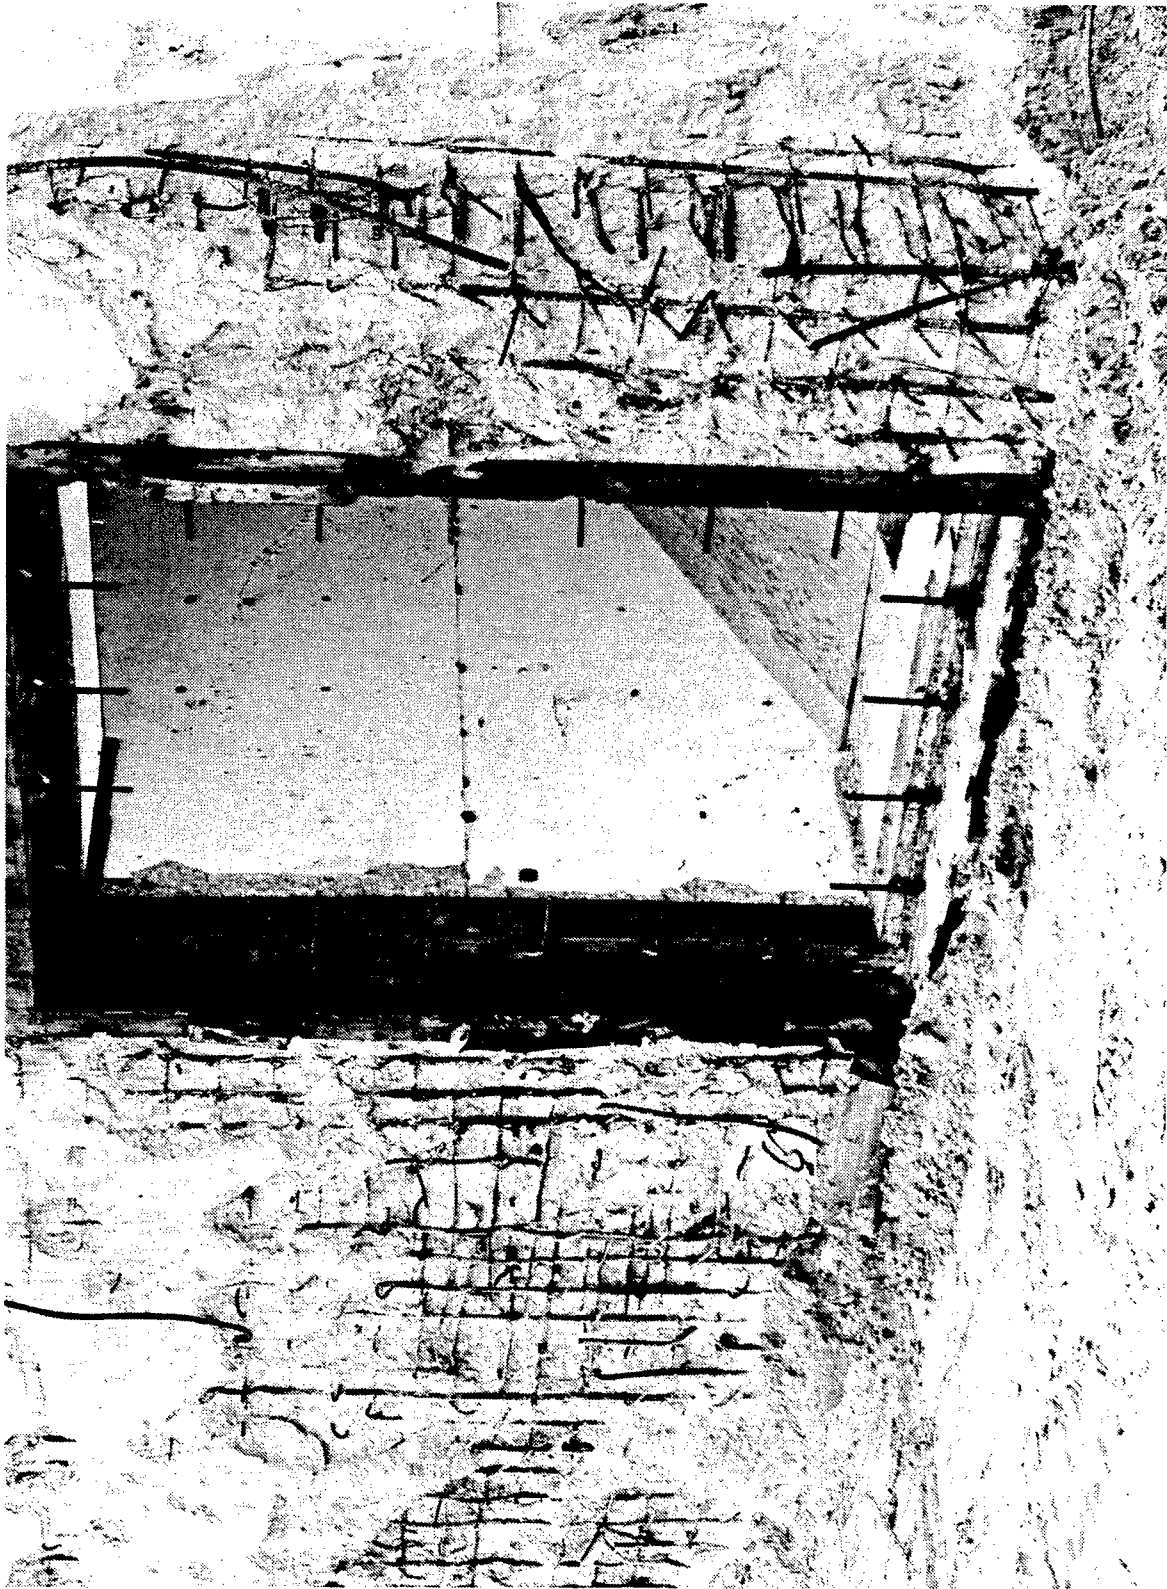
To simulate a non-load-bearing wall replacement, a door opening in the NATO structure was used. This door opening, which is shown in Figure 57, is located in the eastern wall of the structure. Prior to the repair, Number 4 rebar stubs were welded along the top, bottom, and sides of the door frame at 1-foot intervals, as shown in Figure 58. The rebar was butt-welded and fillet-welded on both sides for 4 inches. The rebar stubs protruded 6 inches beyond the edge of the door frame. After placing the rebar, a plywood backing was installed in the door opening, as shown in Figures 59 and 60.

Figure 57. Door Opening in NATO Structure Used for the Wall Replacement Field Demonstration.

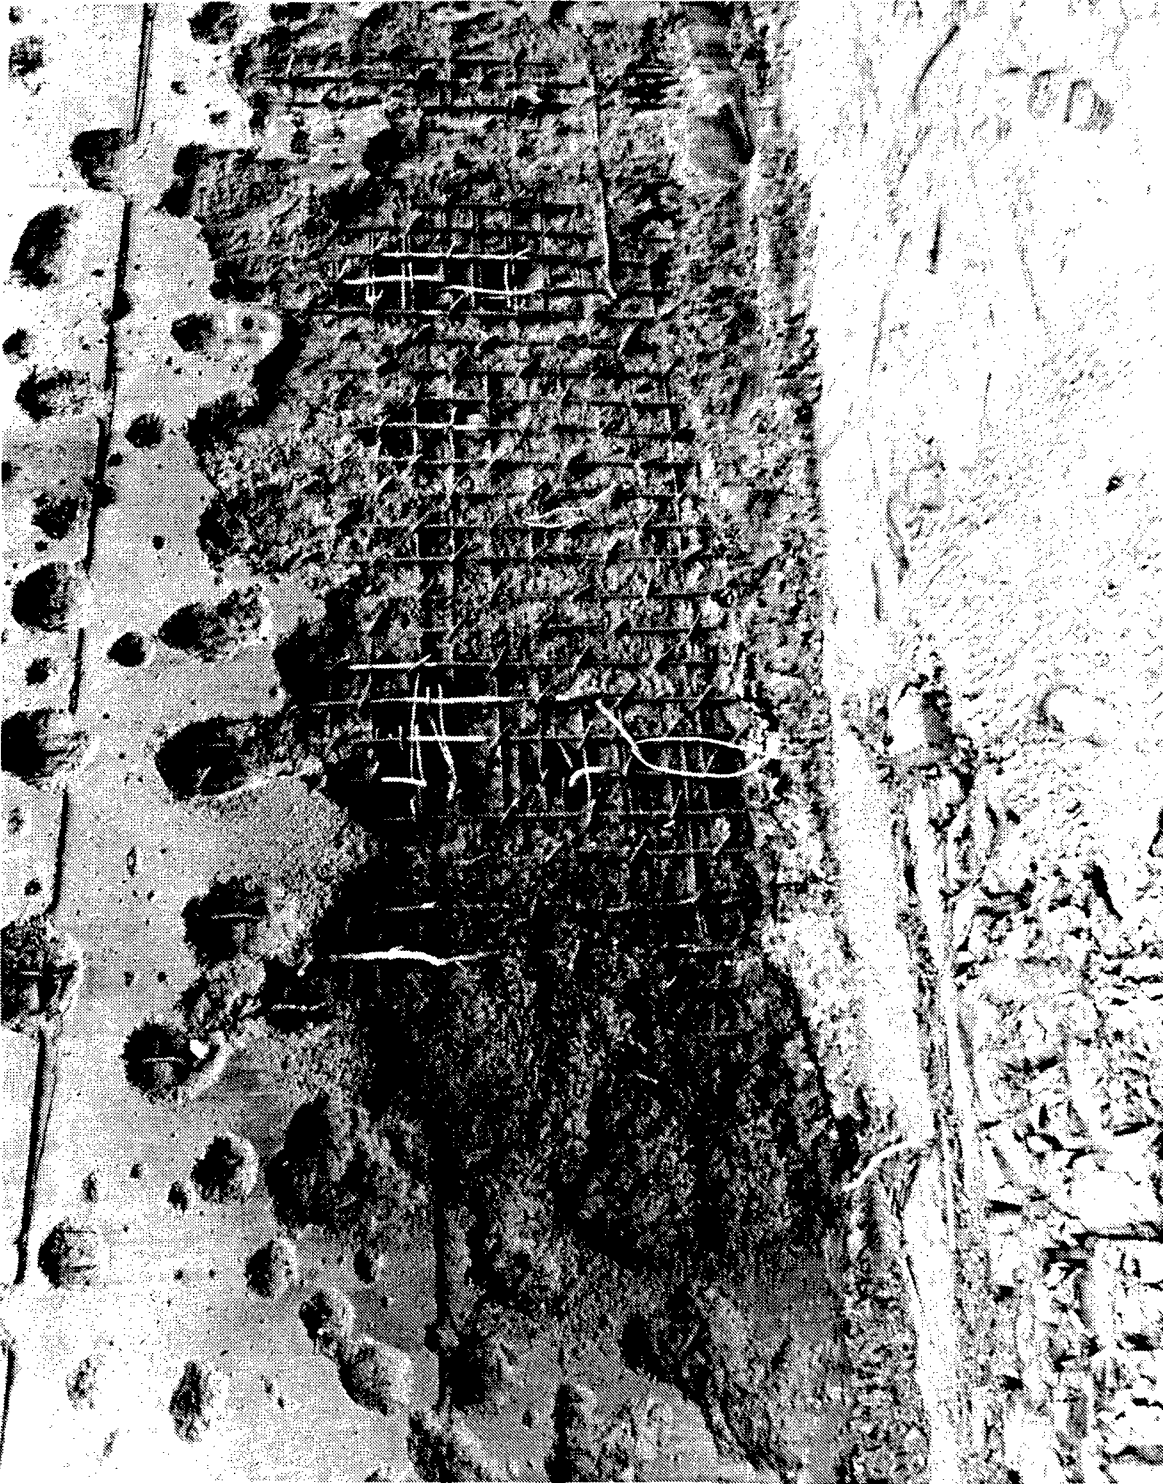
The repair area after shotcreting is shown in Figure 70, while the clogged feed cylinders of the shotcrete gun are shown in Figure 71. Upon investigation, it was determined that clogging of the cylinders was caused by having too large a surcharge of material in the gun hopper and wood feed funnel above the hopper. To alleviate this problem, the wood funnel was discarded, and only 3 or 4 inches of material was maintained in the hopper. Consequently, continuous monitoring of the shotcrete hopper was required, with frequent small feedings of material from the concrete bucket into the hopper. These new procedures were used during the wall replacement demonstration described below.

Figure 70. Completed Simulated Shotcrete Wall Breach Repair.
