Periodic Inspection Report No. 4  
West River  
Townshend, Vermont

# Townshend Lake

October 1996

US Army Corps  
of Engineers

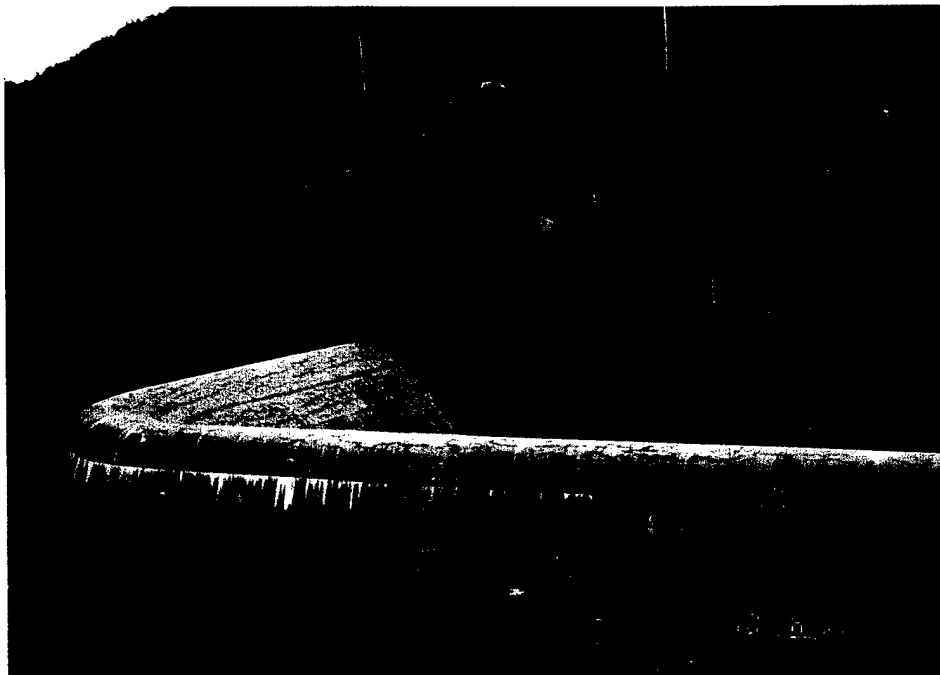
PHOTO A-1. General view of upstream face of spillway.

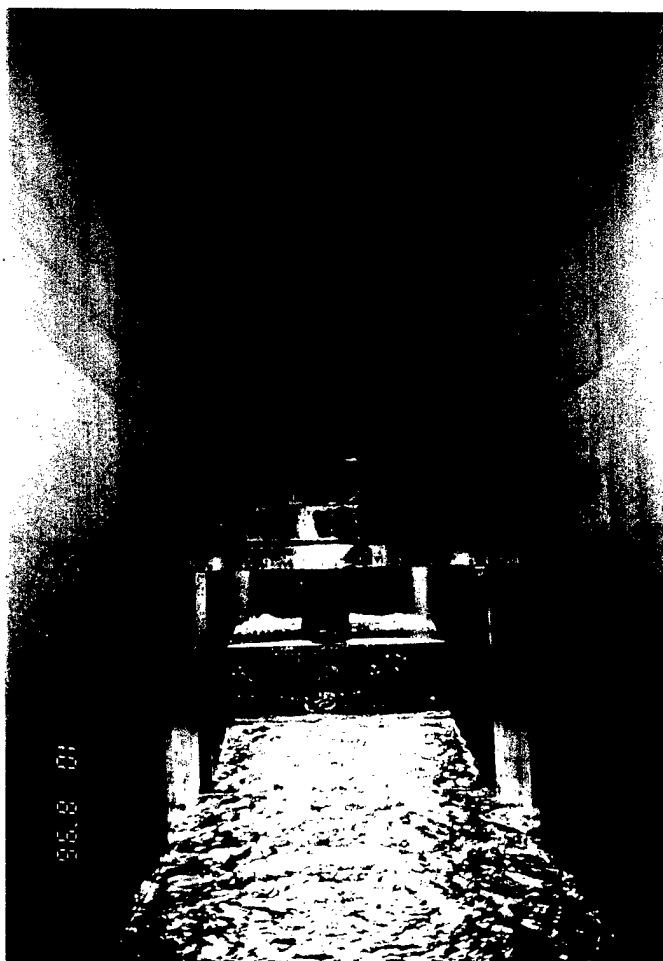
PHOTO A-12. Downstream face of service gate No. 2.

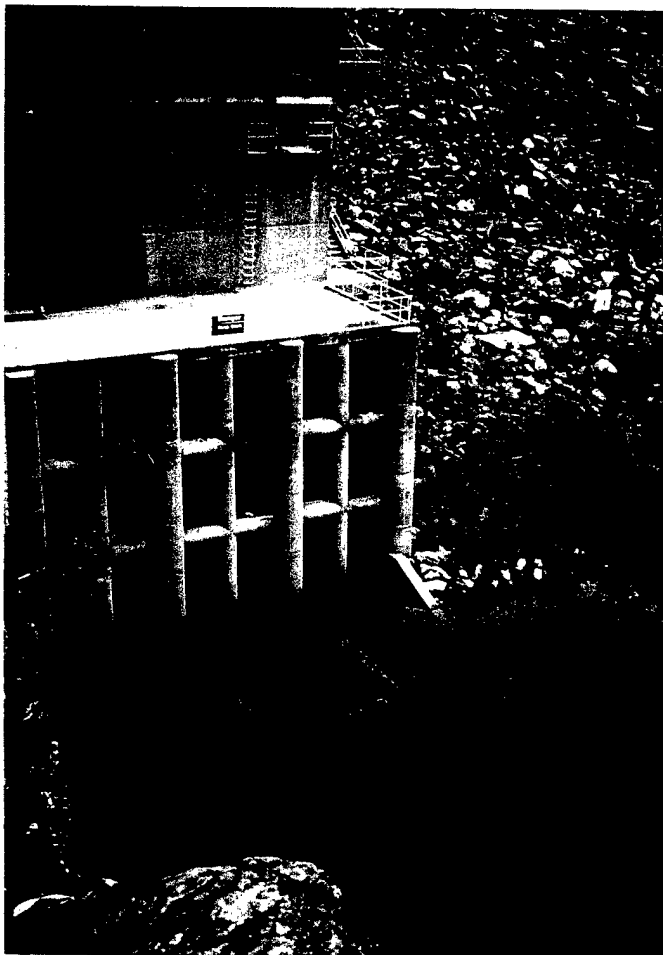
PHOTO A-14. General  
view of upstream  
control weir and trash  
rack.

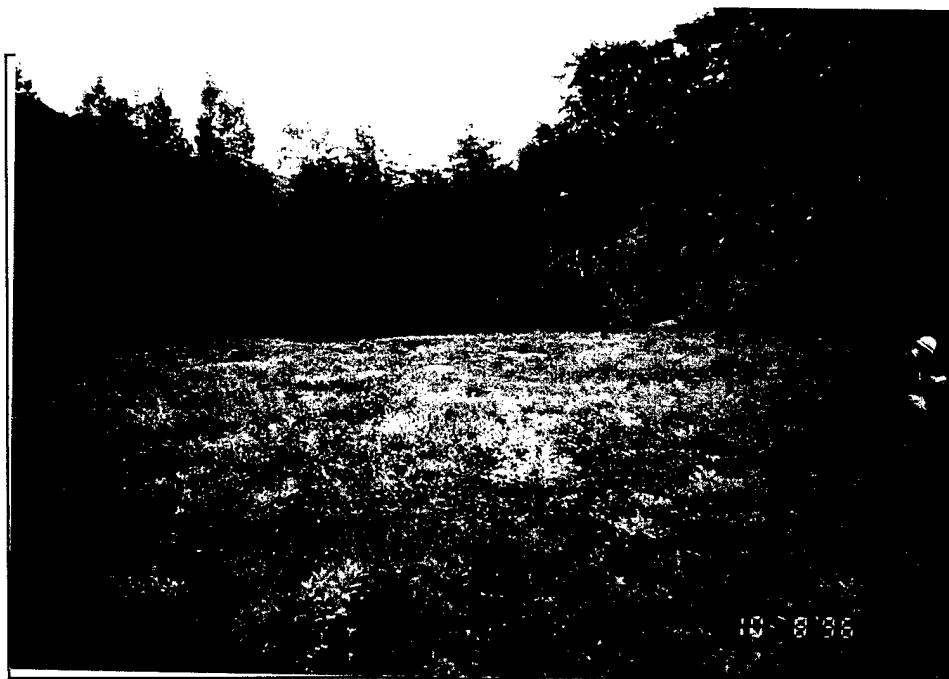
Photo D-1 Spillway approach looking upstream

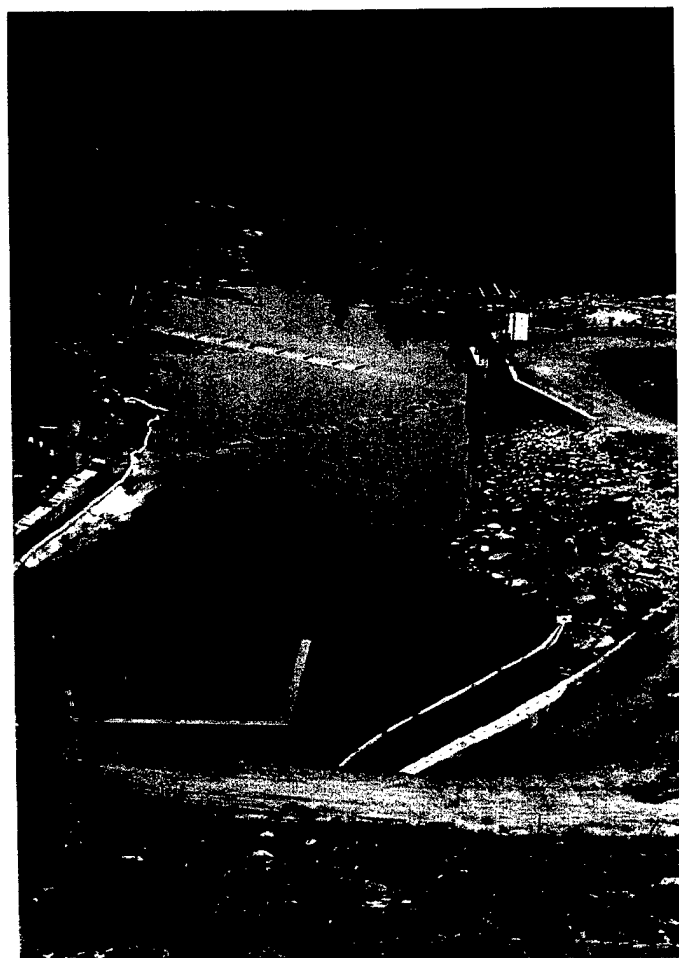
Photo D-4 Exit channel looking downstream

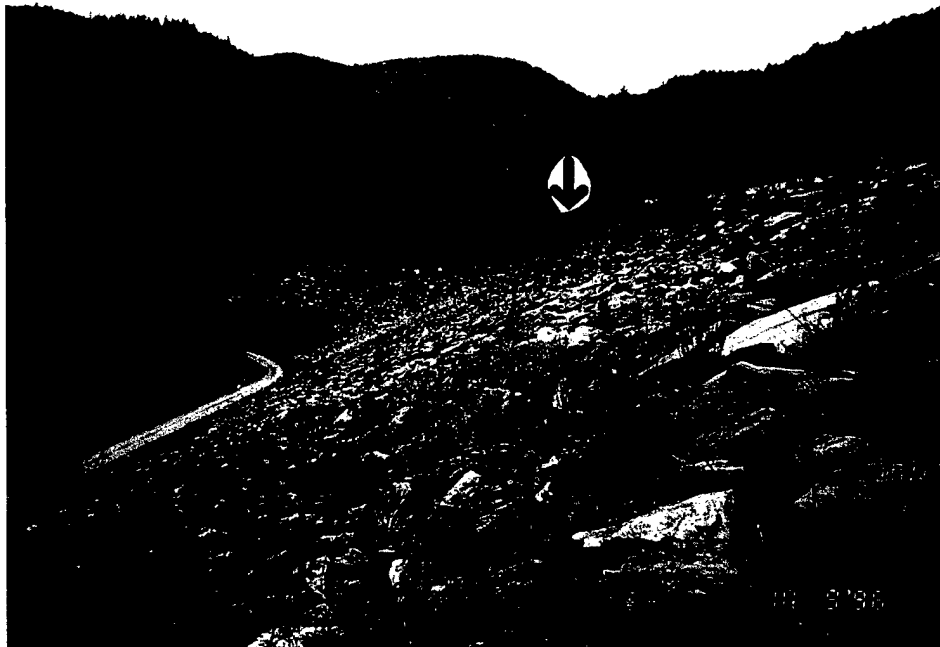
PHOTO E-7: General view of downstream slope of dam.  
Note tree growth at top of rock fill blanket (at  
arrow).

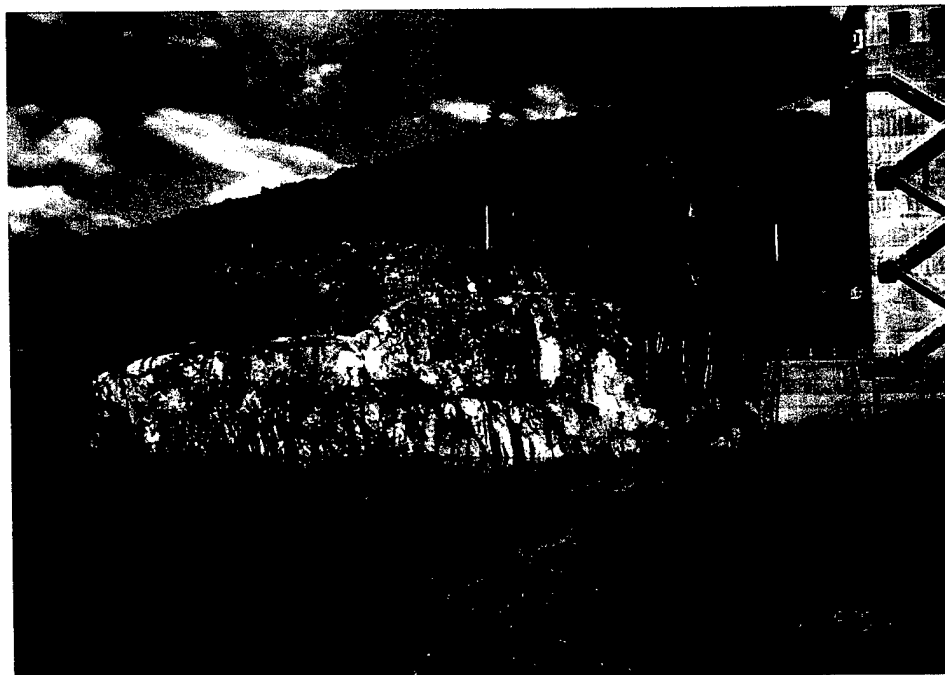
PHOTO E-12: Rock face at intake channel. Note  
impervious blanket in foreground.
